**Forest
Practices
Board**

Impacts of Harvesting and Road Construction on Water Quality in McClure Creek

Complaint Investigation #16041

October 2017

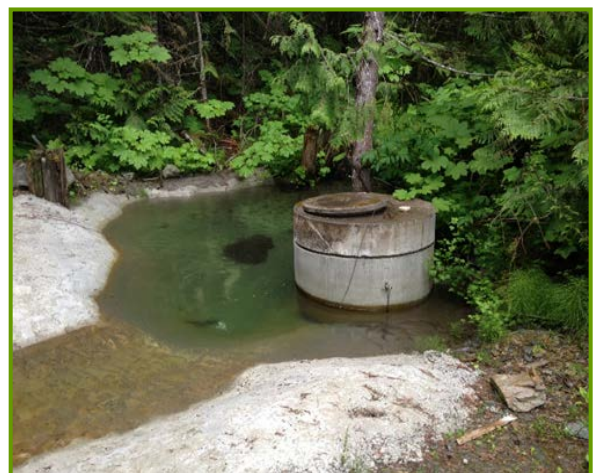
Figure 1. Intake dam and pond on McClure Creek that supplies the water to the licenced water users.

The intake pond collects sediment and its maintenance is an ongoing responsibility of the water licensees. The complainants periodically cleaned the intake pond prior to 2013. However, the complainants said the intake pond has filled with sediment in the spring for three out of four years since 2012 when the new concrete dam was installed and road construction and harvesting had started. According to the complainants, the volume of sediment is greater than they experienced prior to 2013.

The Board investigators did not observe any physical damage to the water intake. However, when the intake pond is filled with sediment, the ability of the waterworks to function is impeded and it may be considered damaged.

Field reviews identified numerous sediment sources, some of which are attributed to Interfor’s forestry activities while others are not. In addition, the design of the dam may have contributed to the buildup of sediment at the intake. The investigators were not able to quantify the contribution of the various sediment sources, nor the impact of the new dam, to the sediment buildup at the water intake.

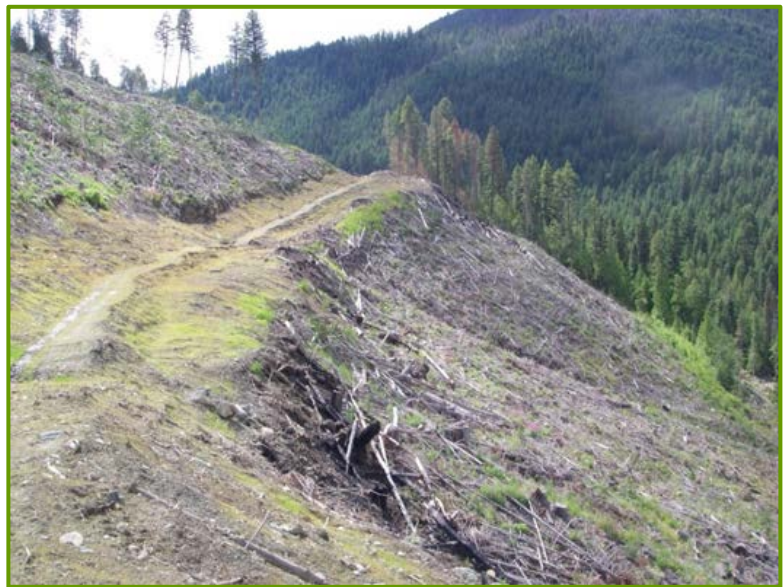
Figure 2. Deactivated roads in HEF028

Interfor has prepared and implemented several deactivation plans since 2013. Deactivation usually involves removing culverts and stabilizing the road prism. In this case, the deactivation also included pulling back some of the road surface and fill slope and placing it in the ditch and cut slope, which exposed more soil and increased erosion potential. Interfor grass seeded the exposed soil following the deactivation and the grass is establishing itself, which will help to reduce erosion over time.

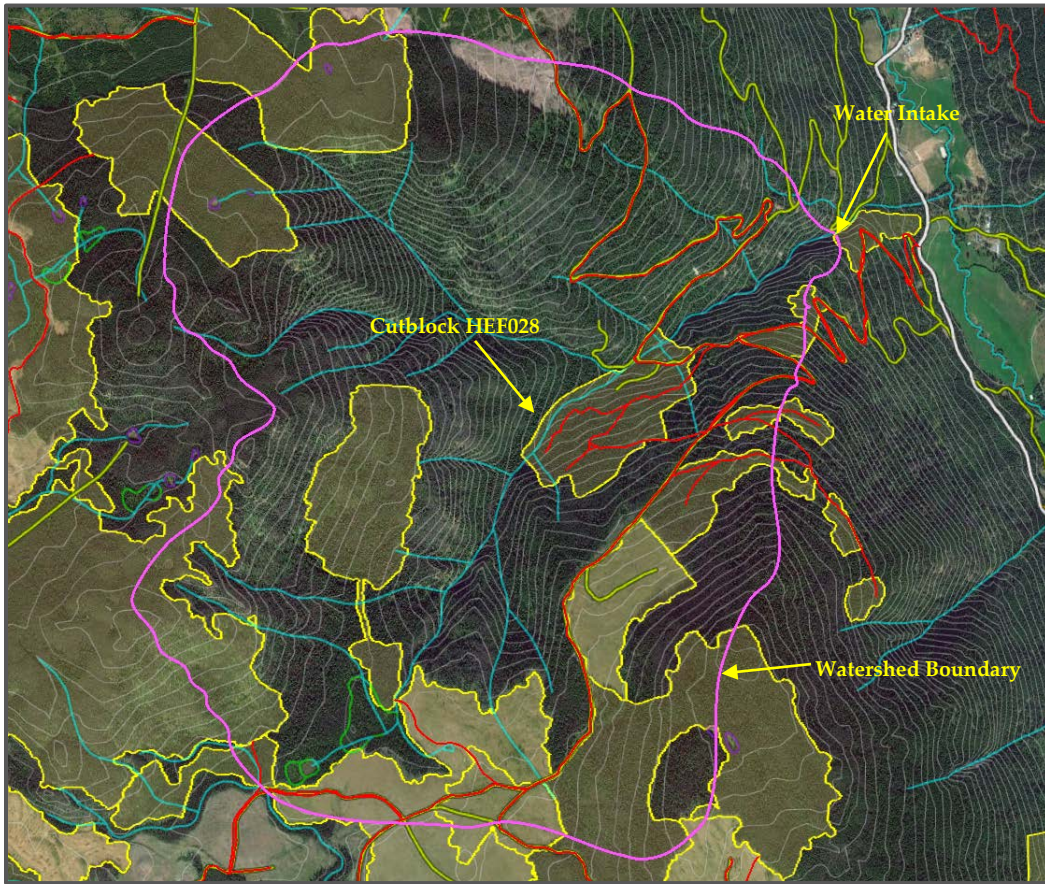
The Board's ECA calculation showed that approximately 30 percent¹⁰ of the watershed was harvested over the past 12 years and had not hydrologically recovered. Interfor calculated the ECA for the watershed at 29 percent.¹¹ Both of these ECAs are greater than the 20 percent identified in the *Watershed Assessment Procedure Guidebook*. Most of the harvesting occurred in the upper half of the watershed where most of the runoff at peak flow is generated. However, an ECA by itself does not confirm whether a watershed assessment is required. Additional fieldwork by a qualified professional is required to make that determination.

Figure 3. McClure Creek drainage and recent harvesting. All cutblocks outlined in yellow have been harvested, roads under permit to the licensee are in red.

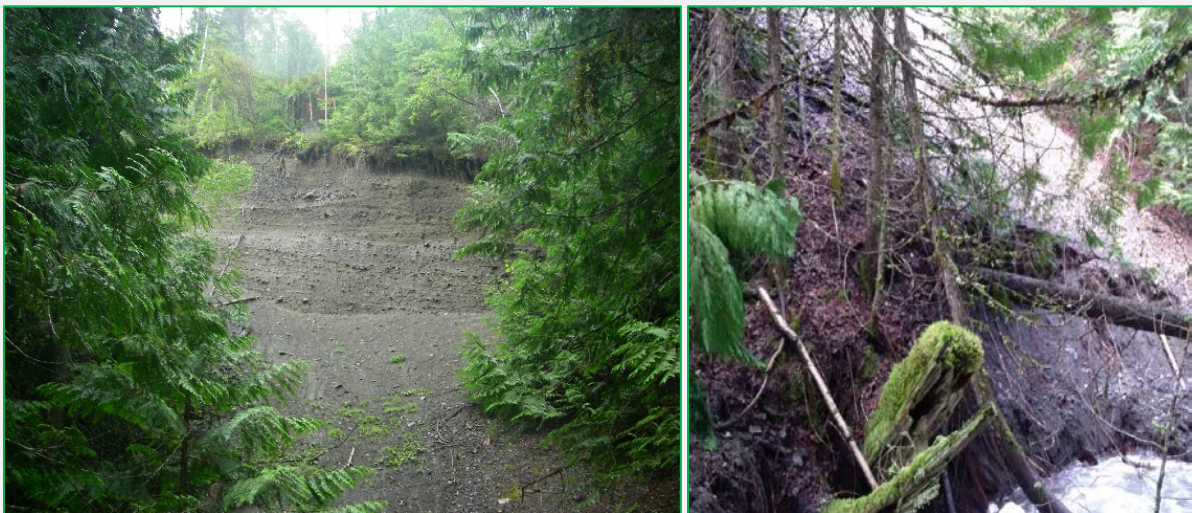
The Board hired a qualified professional to conduct a preliminary review of the watershed condition to determine if other factors would warrant a detailed watershed-level assessment (Figure 3). The preliminary review found several legacy issues, including water management on non-status roads, historic selective logging access trails, an old skid trail downstream of HEF028 that runs adjacent to McClure Creek and crosses the creek in several locations, and both historic and recent landslides that deposited material directly into McClure Creek (Figures 4 and 5). These landslides are significant point sources of sediment, but are not active all of the time.

Figures 4 & 5. Sediment source from a slide just above the water intake on McClure Creek. This slide was not related to Interfor's forestry activities.

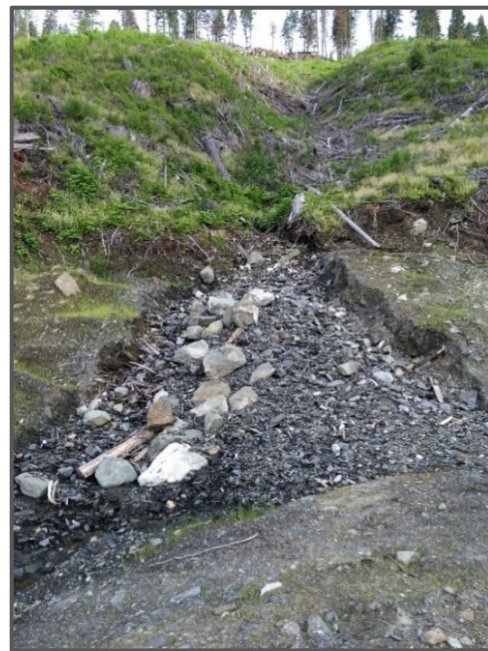
When Board investigators visited the site, they saw evidence of fine sediment from HEF028 entering McClure Creek (Figure 7), but did not observe any significant sources, such as landslides, resulting from the cutblock. The investigators also looked at the implementation of the sediment-control plan and considered that it was poorly implemented and ineffective, primarily because no machinery had been used. (This was due to Interfor and the complainants' previous agreement to not bring machinery back on site.)

Figure 7. Seasonal stream in HEF028 showing the fine particles washed out, some were transported to McClure Creek.

After the investigation field work had been completed, Interfor engaged a hydrologist familiar with the McClure Creek drainage and a geotechnical engineer to review HEF028. The hydrologist developed a remediation plan to address the future risk of sediment entering McClure Creek from HEF028. Interfor reviewed the plan with the complainants and committed to implementing the plan.
