## **Logging in the Deroche Creek Community Watershed**

*Complaint Investigation 100969*

**FPB/IRC/176**

July 2011

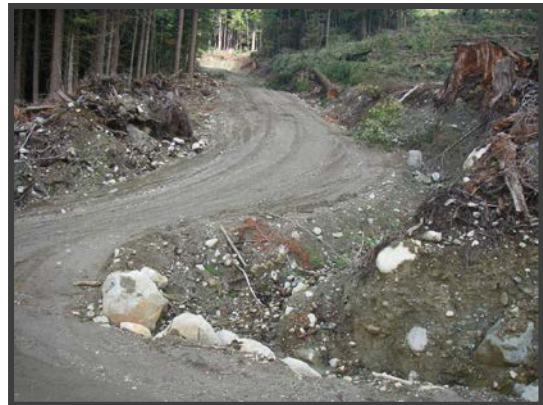
**Photo 2.** Location of new culvert.

At the second location, the complainant was concerned that he had seen no culvert in a section of the newly built road and felt a culvert was needed. This concern relates to section 39 of FPPR, which requires that a person constructing a road or a temporary or permanent access structure must, “maintain natural surface drainage patterns on the area both during and after construction.” The investigator found that the licensee had since installed a culvert at the location.

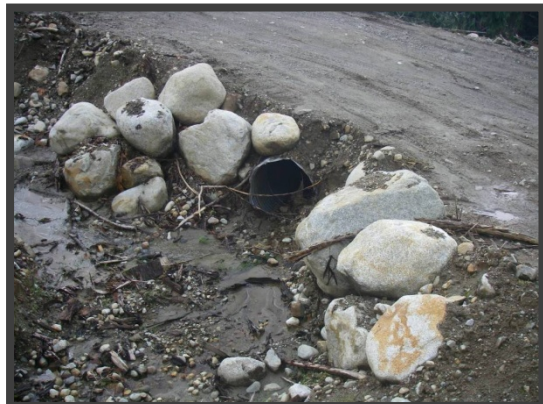
**Photo 3.** Upslope end of culvert.

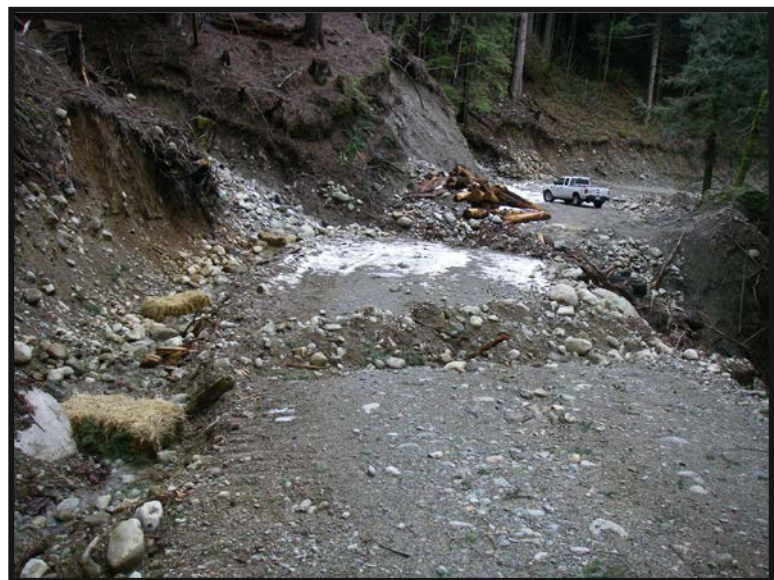
**Photo 4.** Hay bales in ditch leading to feeder creek during winter deactivation.

Board staff revisited the watershed in March 2011, and viewed the sediment control activities associated with the winter road deactivation. The licensee had placed several hay bales within the ditch and the tributary stream to control sediment. Hay bales are intended to function as check dams to slow the velocity of water within a ditch, allowing sediment to drop out of suspension. However, to be effective, check dams need to be embedded in the ground, must span the entire width of the ditch, and must be monitored regularly.

During the March site visit, Board staff observed that not all the hay bales were functioning as intended because they were not embedded and did not span the width of the ditch, which allowed water and sediment to get around them. The licensee advised the Board, and provided evidence, that it is replacing old hay bales with new ones.

In late March 2011, the licensee reactivated the road and dry-seeded the road cut and fill to stabilize the surfaces. The cross ditches were filled in and a new metal culvert was placed above the creek (shown in photo 4), at the location suggested by the geoscientist. With a ditch block in place, this is expected to divert flow from the ditch line onto a stable slope and prevent sediment from the ditch and cutslope above the culvert from entering the feeder stream.

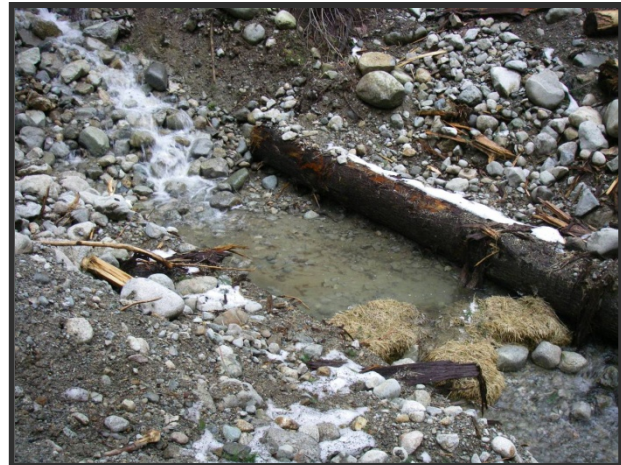
As well, in response to another concern from the geoscientist that the log culvert may not have the capacity to handle peak flows, the licensee also took the surface structure off of a log culvert at one of the stream crossings to increase flow capacity during the heavier rain periods of the winter months while the road was inactive.

**Photo 5.** Opened log culvert where feeder creek crosses road deactivation.

The licensee covered the log culvert again (shown in photo 5) and excavated a sump at the entrance to the culvert, within the tributary stream, to trap sediment and increase the flow capacity for entrance of the culvert. Geotextile material has been placed at the entrance of the culvert to trap sediment. In the Board's view, relying on geotextile material for this purpose is

not effective. A recent information bulletin on sediment control recommends against using this material directly as a filter in water.<sup>7</sup>

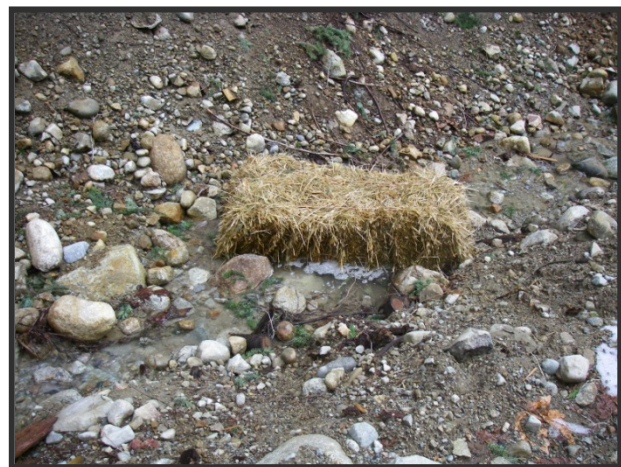
**Photo 6.** Water getting around hay bale.

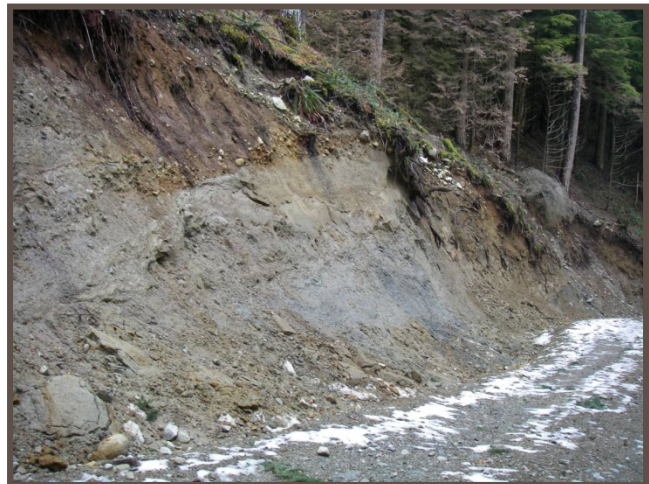
The Board notes that the steep cutslopes containing glacial fluvial sediments (photo 7) will likely continue to erode and fill in the ditch with sediment and silt, and this will need to be considered in the deactivation plan.

**Photo 7.** Cutslope above tributary creek in photo 6.
