Logging in the Deroche Creek Community Watershed

Complaint Investigation 100969

FPB/IRC/176

July 2011

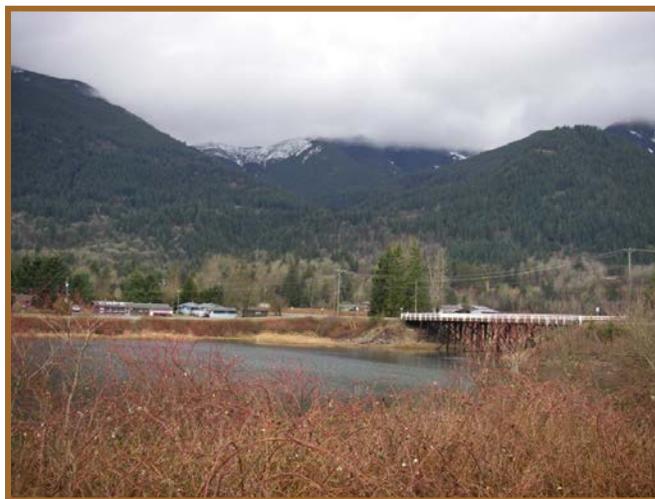
Photo 1. View of watershed above the community of Deroche.

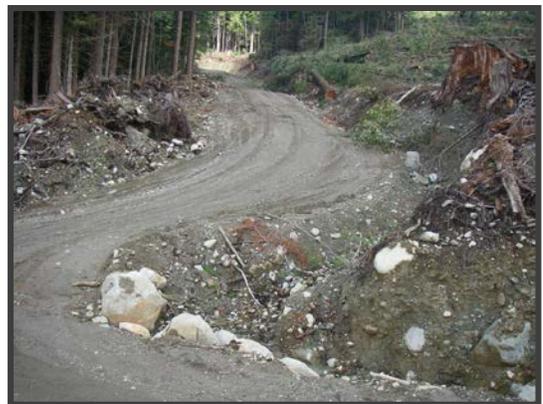
Photo 2. Location of new culvert.

At the second location, the complainant was concerned that he had seen no culvert in a section of the newly built road and felt a culvert was needed. This concern relates to section 39 of FPPR, which requires that a person constructing a road or a temporary or permanent access structure must, “maintain natural surface drainage patterns on the area both during and after construction.” The investigator found that the licensee had since installed a culvert at the location.

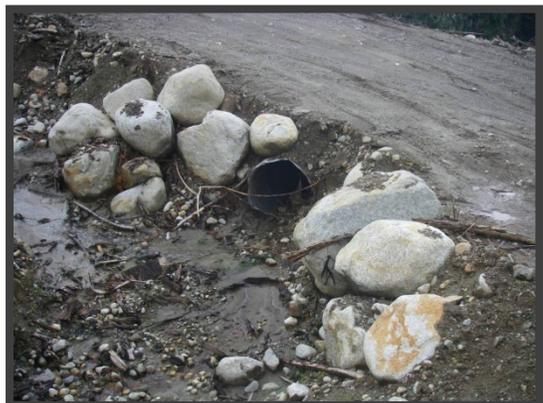
Photo 3. Upslope end of culvert.

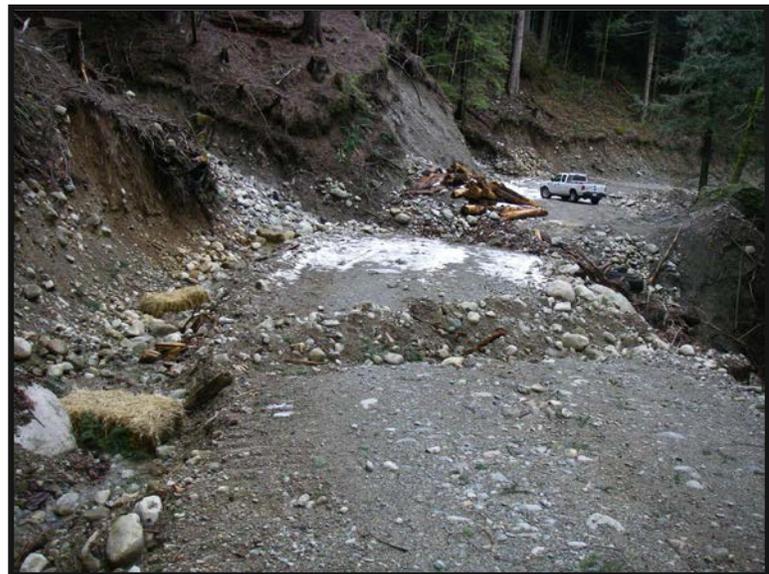
Photo 4. Hay bales in ditch leading to feeder creek during winter deactivation.

Board staff revisited the watershed in March 2011, and viewed the sediment control activities associated with the winter road deactivation. The licensee had placed several hay bales within the ditch and the tributary stream to control sediment. Hay bales are intended to function as check dams to slow the velocity of water within a ditch, allowing sediment to drop out of suspension. However, to be effective, check dams need to be embedded in the ground, must span the entire width of the ditch, and must be monitored regularly.

In late March 2011, the licensee reactivated the road and dry-seeded the road cut and fill to stabilize the surfaces. The cross ditches were filled in and a new metal culvert was placed above the creek (shown in photo 4), at the location suggested by the geoscientist. With a ditch block in place, this is expected to divert flow from the ditch line onto a stable slope and prevent sediment from the ditch and cutslope above the culvert from entering the feeder stream.

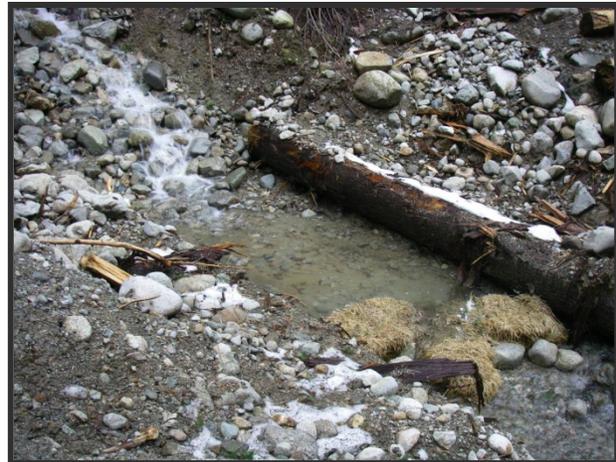
As well, in response to another concern from the geoscientist that the log culvert may not have the capacity to handle peak flows, the licensee also took the surface structure off of a log culvert at one of the stream crossings to increase flow capacity during the heavier rain periods of the winter months while the road was inactive.

Photo 5. Opened log culvert where feeder creek crosses road deactivation.

The licensee covered the log culvert again (shown in photo 5) and excavated a sump at the entrance to the culvert, within the tributary stream, to trap sediment and increase the flow capacity for entrance of the culvert. Geotextile material has been placed at the entrance of the culvert to trap sediment. In the Board's view, relying on geotextile material for this purpose is

not effective. A recent information bulletin on sediment control recommends against using this material directly as a filter in water.⁷

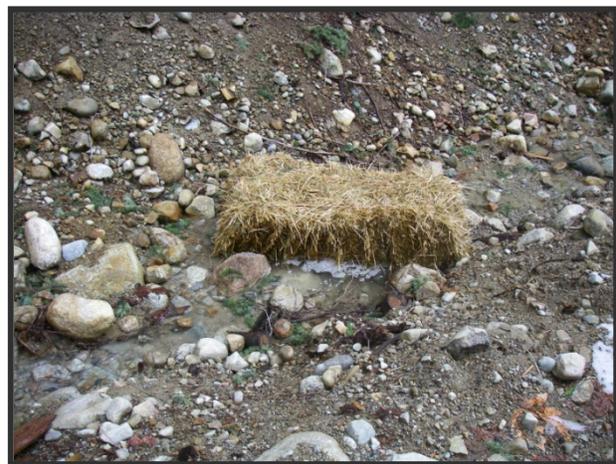
During the March site visit, Board staff observed that not all the hay bales were functioning as intended because they were not embedded and did not span the width of the ditch, which allowed water and sediment to get around them. The licensee advised the Board, and provided evidence, that it is replacing old hay bales with new ones.

Photo 6. Water getting around hay bale.

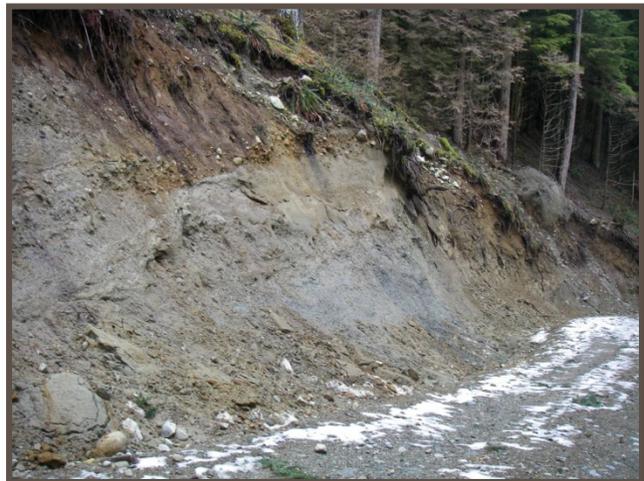
The Board notes that the steep cutslopes containing glacial fluvial sediments (photo 7) will likely continue to erode and fill in the ditch with sediment and silt, and this will need to be considered in the deactivation plan.

Photo 7. Cutslope above tributary creek in photo 6.
