# **Post-fire Site Rehabilitation: Final Report**

**Special Investigation**

**FPB/SIR/12**

**February 2005**

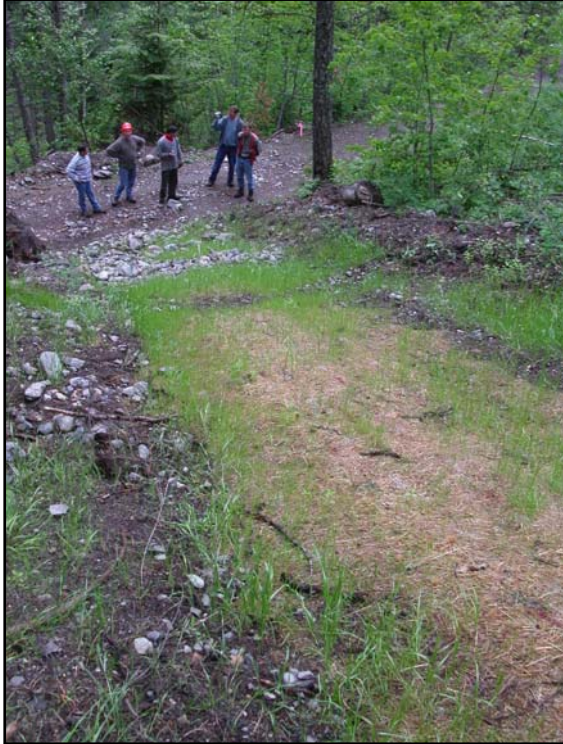
**Erosion control blanket near Peterson Creek - McLure fire**

On some steeper sites, prescriptions were prepared by professionals where necessary to guide rehabilitation. For example, on the McLure fire at Peterson Creek, a fireguard was constructed down a 60 percent slope perpendicular to the stream. An erosion control blanket was installed and the guard was seeded. The prescription was implemented effectively and the site was stable.

At Peterson Creek, a bulldozer constructed guard down a 70 percent slope above a domestic water intake. A rehabilitation prescription called for the installation of an erosion control blanket on the slope and seeding. The prescription was implemented and we found the treatment to be very effective. Slash was pulled back and scattered and the erosion control

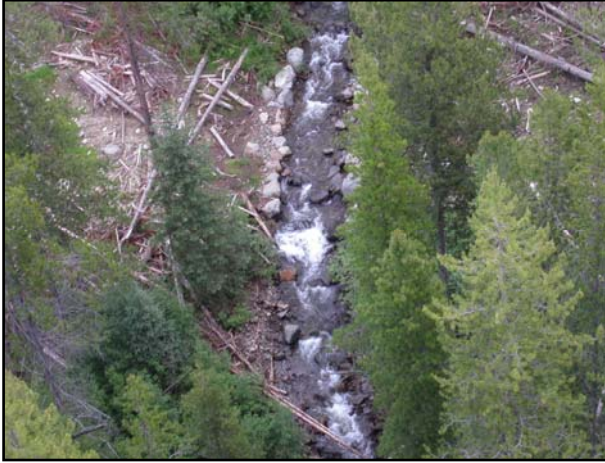
Where trails and fireguards crossed streams, the general approach was to re-establish the stream banks, armour the banks with rock if required, and to revegetate the site with grass seed or willow whips. Trails were also decompacted on some sites. In special situations where streamside slopes were steep or the risk to water users and forest resources was high, specialists were employed to develop prescriptions and, in some cases, engineered designs to rehabilitate the site.

**Armoured stream - Lamb Creek fire**

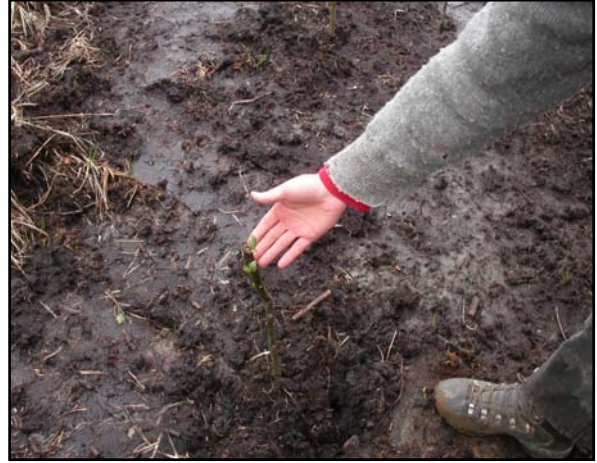
**Willow whip - McLure fire**

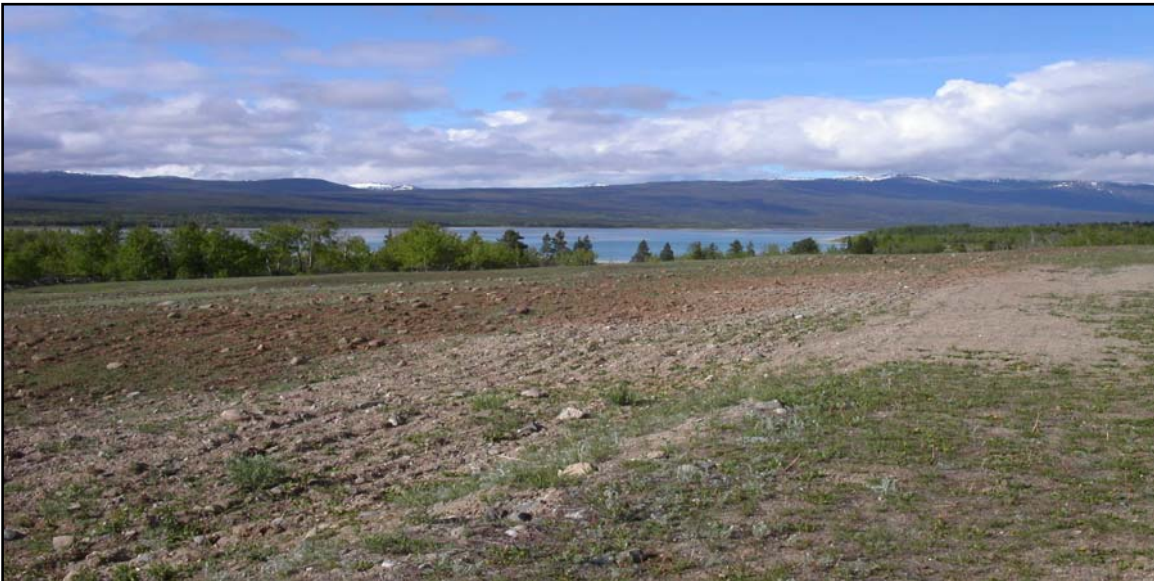
Where staging areas, campsites or helicopter landing sites were established, the sites were recontoured and in some cases seeded with grass.

**Rehabilitated fire campsite at Choelquoit Lake - Chilko fire**
