**FSR Bridges  
Inspections and Maintenance  
Special Investigation**

**FPB/SIR/13  
May 2005**

# FSR Bridges Special Report

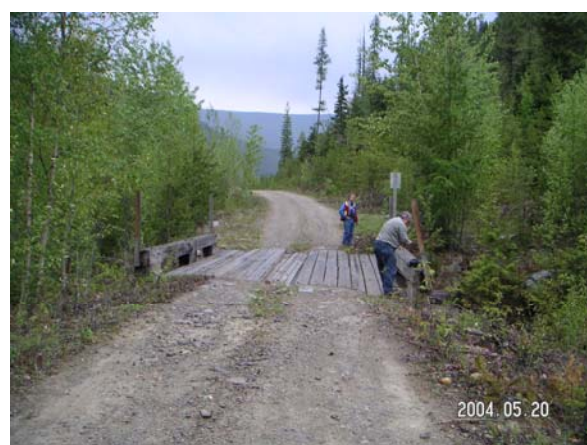
- The investigation concluded that six bridges were unsafe in their current condition. There was a safety risk for five bridges where engineers had reduced their load ratings, but they were not posted with appropriate load rating signs. These bridges (N7-039, N7-044, N7-114, N7-173 and N7-196) are all in the Kootenay Lake Forest District. In addition, there was a safety concern involving a bridge in the Headwaters Forest District (bridge K-045) that had a sign stating the bridge was closed and unsafe to carry any loads (0 tonne load rating). However, it was not blocked to prevent vehicle traffic so it continued to be a safety hazard.

**Figure 4** - Bridge N7-114 – no load rating sign or bridge delineators.

Subsequent to the investigation, MOF has remedied 5 of the 10 deficient bridges, including removal of the bridge that had been posted at 0 tonnes but not blocked (K-045). Also, two bridges were repaired (G3-051 and N7-039). Bridge N7-039 was also posted with an appropriate load rating sign, as were two other bridges (N7-044 and N7-173).
