**FSR Bridges
Inspections and Maintenance
Special Investigation**

**FPB/SIR/13
May 2005**

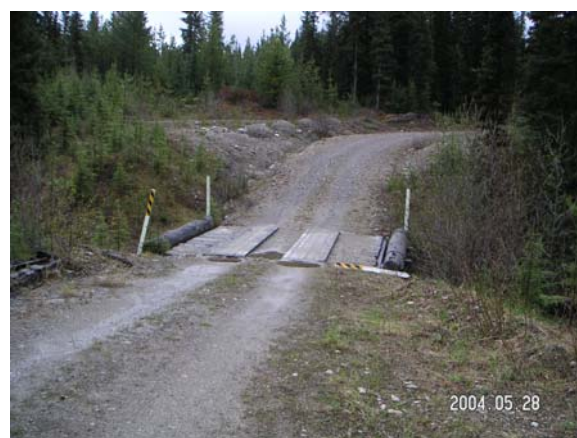
- Four bridges were determined to be a potential safety concern, all in the Headwaters Forest District. Bridges K-750 and K-1051 have substantial rot in the log stringers but were not load rated because there was confusion over road status and whether the bridges were the responsibility of MOF or the licensee. Bridges G3-051 and G3-060 had structural deficiencies that were communicated to the road use permit holder to address, but the necessary work was not undertaken.

Figure 3 - Bridge K-1051 – not load rated, although MOF inspections note significant rot in stringers. One of the bridge delineators is knocked down.
