Road Failures on Vedder Mountain near Chilliwack

Complaint Investigation 020398

FPB/IRC/90

December 2002

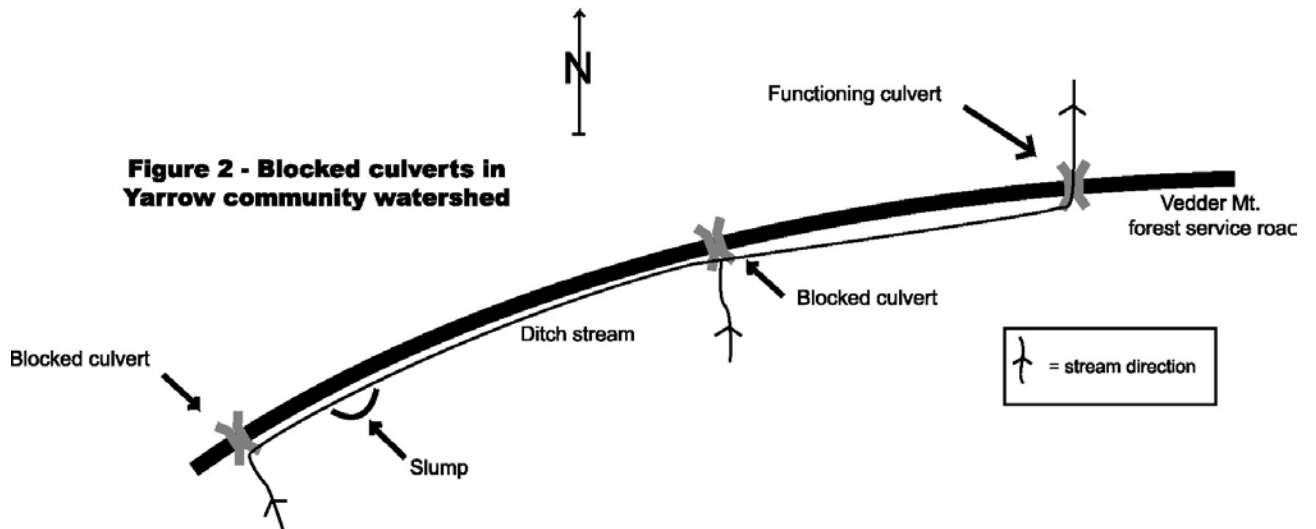
In addition to identifying the two slides, the complainant identified two blocked culverts on the road, in the Yarrow Community Watershed, that diverted two streams down the road's ditch into a third culvert (see figure 2).

District staff knew that members of the Yarrow Community Watershed had diverted the streams to increase the flow into their reservoir. Inspections of the road identified the blocked culverts, but they were not repaired because the community wanted the water for the reservoir, the diversion was not considered an environmental risk, the ditch had not failed, and the last culvert was sufficient in size to carry all the water. Although the culverts are blocked, the road drainage system in the Yarrow Community Watershed continues to function. Therefore, the Board considers that inspection and maintenance concerning the blocked culverts was adequate. However, the Ministry of Water, Land and Air Protection, the district, and representatives of the Yarrow Community Watershed are currently trying to resolve the ongoing water supply issue.

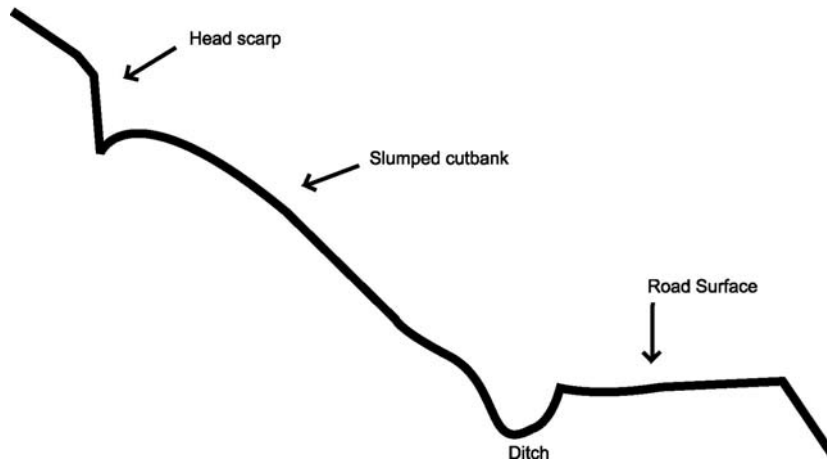
Figure 3 - Slump Cross Section

The complainant also identified a slump on the cut-slope where the diverted water ran down the ditch (see Figure 3).

The complainant thinks that the stream in the road's ditch may have caused the slump. The slump did not divert the water from the road's ditch and the third culvert carried the combined water flow.

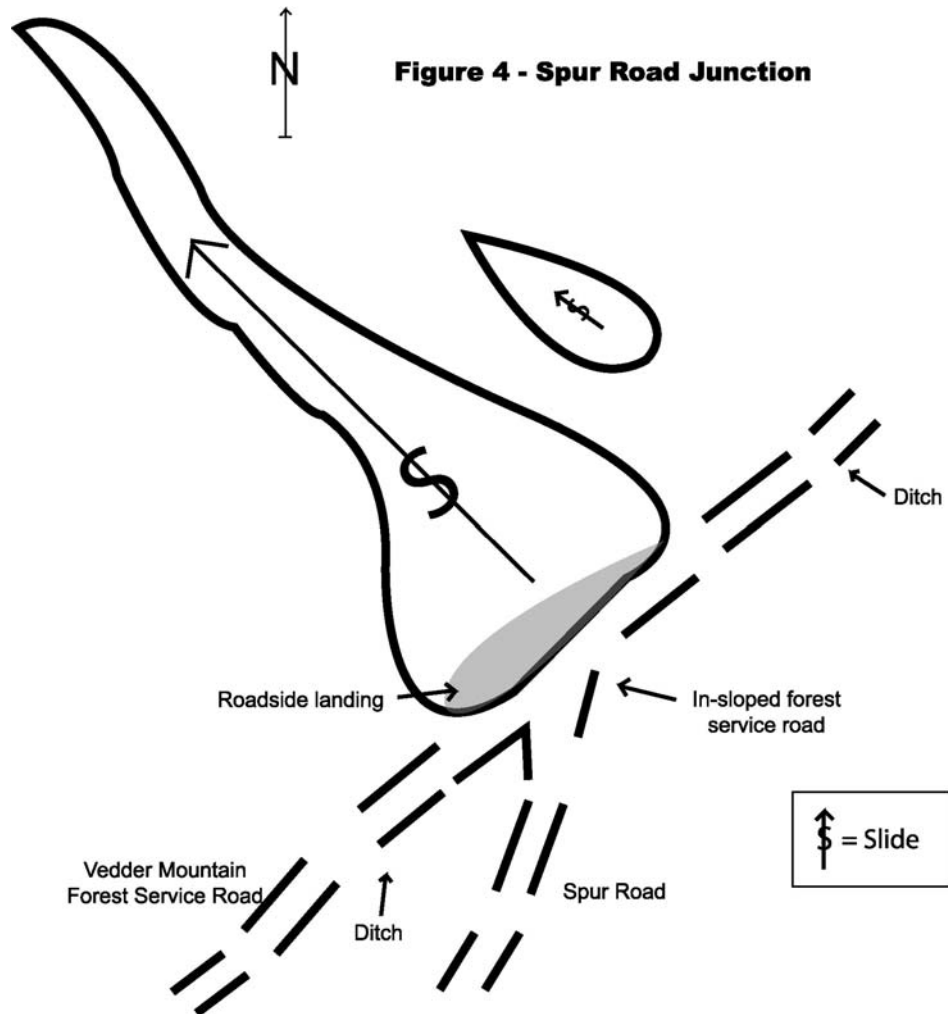
Figure 4 - Spur Road Junction

On December 28, 2001, after a prolonged period of precipitation, the roadside landing fill slope failed. Water channelled down the spur road surface to the FSR because the spur road had no drainage structures. The FSR was in-sloped, so its ditch water would cross the spur road junction to stay in the ditch of the FSR. Sediment was deposited on the spur road and blocked the in-sloped drainage structure so that drain water caught by the spur road and ditch water from the FSR pooled on the surface of the roadside landing. The water gradually saturated the roadside landing, adding weight to, and weakening, the fill slope. (See Figure 4.)

Both the complainant and district agree on the sequence of events: water draining from the spur road pooled on the road surface, saturated the roadside landing, and caused the fill slope to fail.

Since the failures, the district has constructed water bars on the spur road to stop water from channelling onto the FSR. The Vedder Mountain FSR has been further in-sloped to better control drainage and prevent pooling at that point. MOF has removed some of the fill-slope material at the failure site to reduce the risk of further failures.

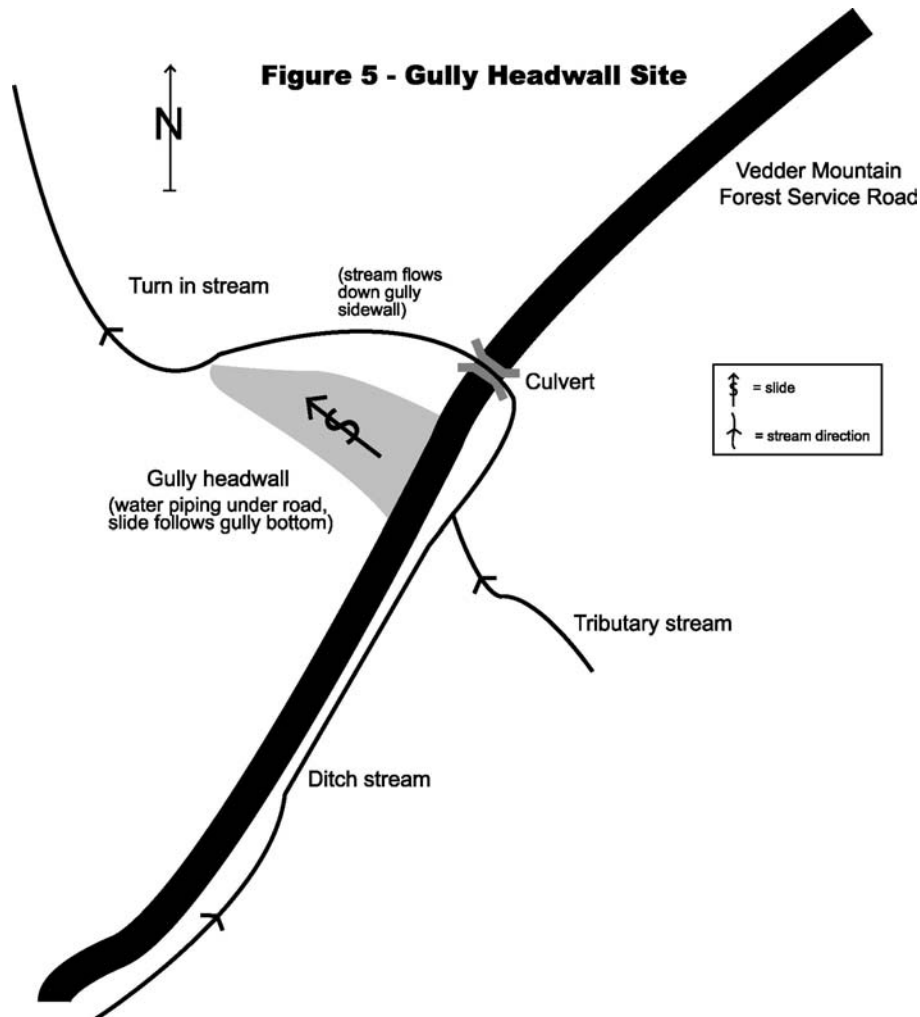
The other section of the road that failed on January 9, 2002, after the prolonged wet weather, goes across the slope break on a gentle sloping bench. The road is on the headwall of a gully that extends from the slope break, down a steeper slope to the base of the mountain (see Figure 5).

In this area there is no cut slope—the old railway grade is constructed entirely on fill. The fill is approximately five feet high on the uphill side of the road. Therefore, the road disrupts the natural drainage pattern, causing the road ditch to be a permanent streambed. This ditch was overgrown with woody brush. A culvert passed the ditch stream under the road approximately 50 metres downstream from the road failure site. After the failure, district staff observed the water piping under the road prism at the point of failure. In an attempt to stop the water flow through the road prism, the district cleaned the ditch to increase the stream velocity where the water was piping under the road. However, cleaning the ditch did not stop the piping action.

The complainant inspected the road approximately one week after the failure of the fill slope and observed sediment obstructing one-third of the culvert. The complainant suspects that this condition, together with the overgrown ditch, caused water to pool upstream from the culvert and to saturate the road. The complainant asserts the water pressure increased, causing water to pipe under the road, which in turn weakened the fill slope, causing it to fail. Further, it asserts that this fill-slope failure moved down the gully and caused a debris dam on the creek. The complainant maintains that the dam subsequently broke and caused a debris torrent that scoured the stream draw, resulting in a large sediment deposit in a subdivision at the base of the mountain.

MOF agrees that water piping across the road fill contributed to the fill-slope failure. Although some material from the slide entered the stream channel, MOF feels it was an insignificant amount. The district asserts that the cause of the debris torrent occurred 40 metres downslope. Once across the road, the ditch stream heads down the gully sidewall. Approximately 40 metres down the gully from the road failure site, the stream reaches the bottom of the gully, turns and follows the gully to the base of the mountain. District staff believe the debris torrent started at the point the stream turns, and resulted from erosion of the natural slope. They believe the combination of the turn in the stream channel and volume of water in the extremely wet weather eroded the natural slope that supported the road. They claim this erosion of the natural slope initiated the debris torrent and contributed to the failure of the road fill slope.

When Board staff visited the site, a crew was repairing the road fill slope. There was no evidence that the ditch or culvert failed, allowing water to cross the road prism on the surface of the road. Despite the clean ditch and water flowing freely in the ditch stream, water was piping under the road into the gully. The Board did not explore if water would have been piping under the road if the ditch had been clean before the slide occurred, as that would involve speculation.
