**Forest  
Practices  
Board**

## **Gilpin Creek Debris Slide**

*Complaint Investigation #110983*

**FPB/IRC/181**

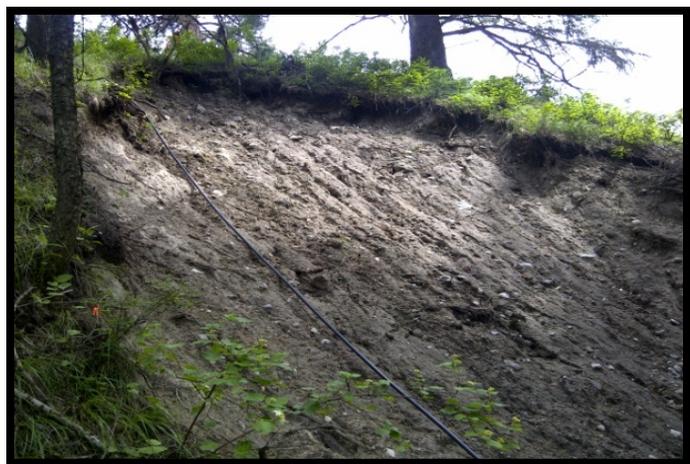
In the fall of 2010, the rancher disconnected the intake pipe for the winter. Later, for the trough in question, someone reconnected the inlet pipe but did not reconnect the outlet. Water flowed into the trough and out onto the ground. The ground became saturated and, in the early spring of 2011, a debris slide into Gilpin Creek occurred (see photos 1 and 2). A considerable volume of soil slid into Gilpin Creek, some of which was transported down the creek and deposited in the stream bed.

*Photo 1. The slide and the outflow pipe running down to the creek.*

The range licensee advised the Board that for the 2011/2012 winter he disconnected the intake pipe from its source at the dam and removed new fitting adapters for the intake on the trough, which he expected would prevent the intake from being either accidentally or intentionally re-connected before the system was set up for use again later in 2012.

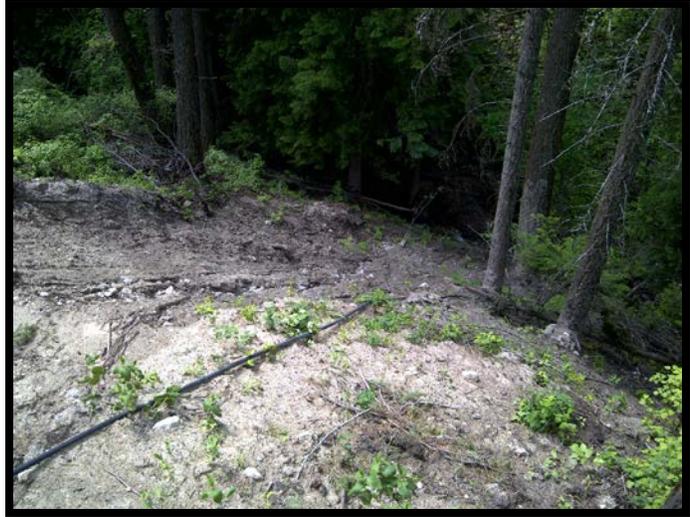
*Photo 2. The slide extends into Gilpin Creek.*

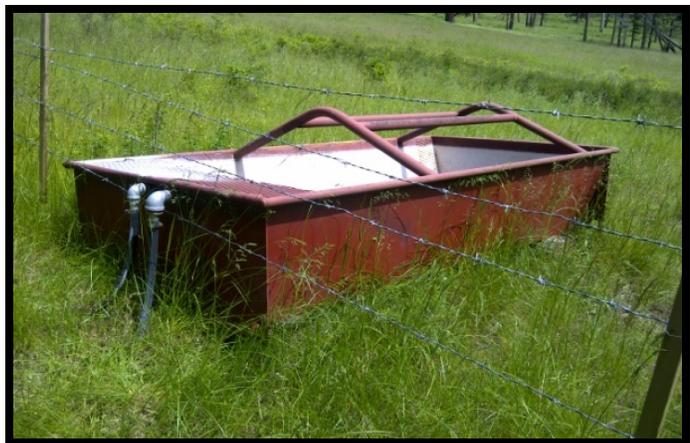
The trough above the slide area had a gravity-fed intake system from a small dam in the creek upslope and a return pipe as required (photo 3). The trough is

*Photo 3. Trough showing intake and outflow pipes.*

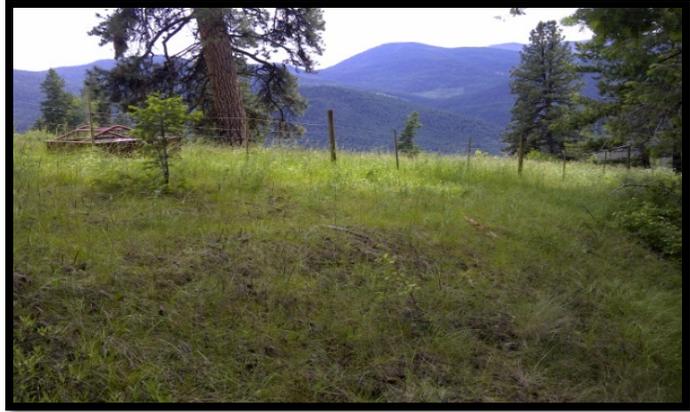
approximately 15 feet from the edge of the slope down to Gilpin Creek (photo 4).

*Photo 4. The trough is in upper left. Gilpin Creek is to the right of the photo.*

The trough itself seems to be functioning as intended, human error aside. But in terms of whether changes are needed to avoid future problems, the options are either to move the trough further from the slope edge or to modify it. MFLNRO staff and the licensee explained that moving the trough further away from the creek would require bringing equipment in to dig up the currently buried intake pipe, adding more pipe and digging a new trench for the pipe. However, if the overflow was the result of vandalism, moving the trough would not necessarily alleviate the problem, and soil damage might still occur from overflow further back, if not discovered quickly.

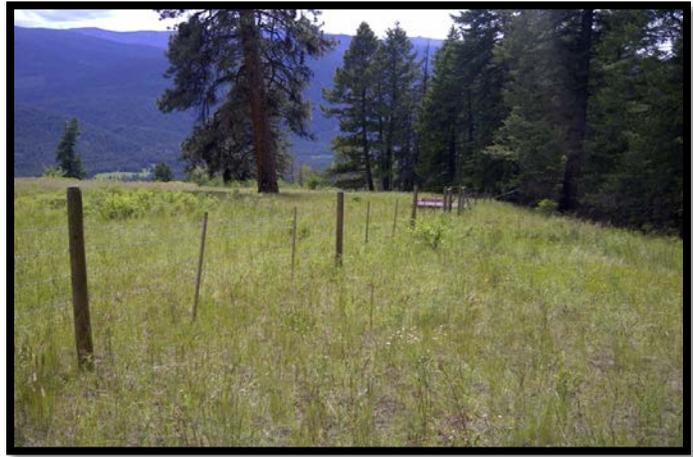
As part of the range improvements in 2009, fences were constructed near the new water troughs to restrict cattle access to Gilpin Creek (photos 5 and 6). Four-strand barbed wire was used with loose vertical supports and a raised lower strand to facilitate wildlife getting under the fence. In the August 2009 approval letter for the range improvements, the MFLNRO district manager stated that fences should be constructed to wildlife standards supplied by the MOE. MFLNRO

*Photo 5. New fence with water trough in the distance.*

The fences around the troughs have a flexible bottom wire for wildlife, but do not meet the MOE criteria for the top wires. On this point, both government range staff and the licensee feel that a smooth wire fence at this site would be pushed down or damaged by either cattle or wildlife. The gates are open for the approximately 11 months of the year when cattle are not using the area, but it is not clear whether wildlife use the gates and the guide outfitter feels that the gates should be wider.

**Finding:** The fences are not wildlife friendly as set out by MOE criteria. Modifications may be necessary.

In the Board's opinion a wildlife expert should assess the location and construction of the fences and decide whether modifications are necessary. Such modifications could include wooden top rails, caution tape or snow fencing to make the fences more visible to wildlife.

The Ministry of Environment should assess the fences that were installed near the water troughs in 2009 to determine whether any modifications to make them more wildlife friendly are necessary.

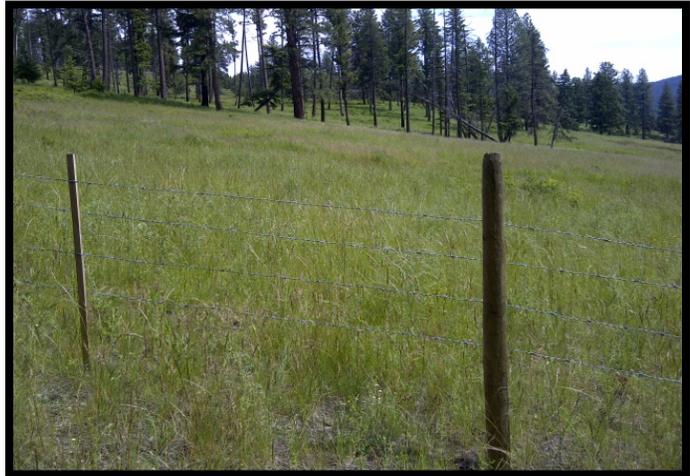
*Photo 6. New fence near the water trough.*
