**Forest  
Practices  
Board**

## **Gilpin Creek Debris Slide**

*Complaint Investigation #110983*

**FPB/IRC/181**

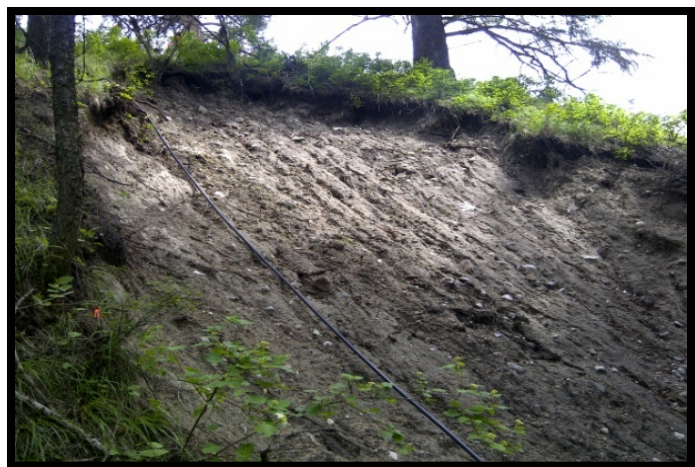
In the fall of 2010, the rancher disconnected the intake pipe for the winter. Later, for the trough in question, someone reconnected the inlet pipe but did not reconnect the outlet. Water flowed into the trough and out onto the ground. The ground became saturated and, in the early spring of 2011, a debris slide into Gilpin Creek occurred (see photos 1 and 2). A considerable volume of soil slid into Gilpin Creek, some of which was transported down the creek and deposited in the stream bed.

*Photo 1. The slide and the outflow pipe running down to the creek.*

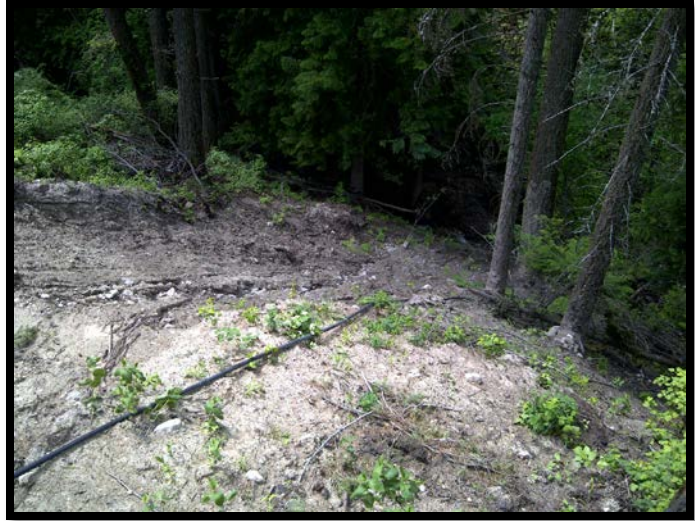
*Photo 2. The slide extends into Gilpin Creek.*

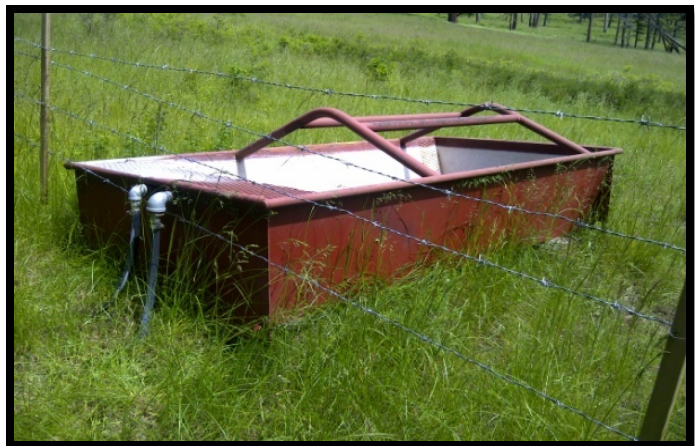
The trough above the slide area had a gravity-fed intake system from a small dam in the creek upslope and a return pipe as required (photo 3). The trough is

*Photo 3. Trough showing intake and outflow pipes.*

The range licensee advised the Board that for the 2011/2012 winter he disconnected the intake pipe from its source at the dam and removed new fitting adapters for the intake on the trough, which he expected would prevent the intake from being either accidentally or intentionally re-connected before the system was set up for use again later in 2012.

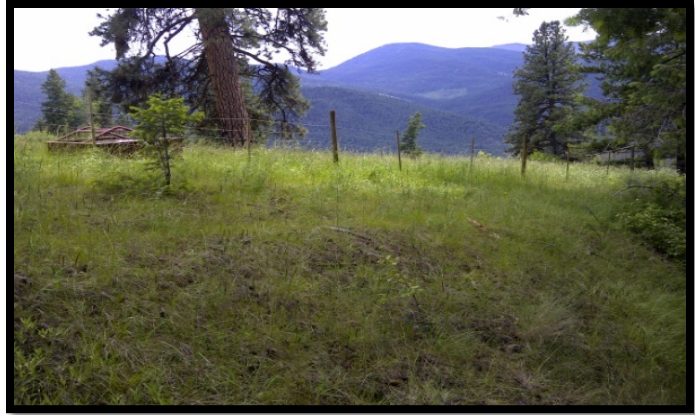
approximately 15 feet from the edge of the slope down to Gilpin Creek (photo 4).

*Photo 4. The trough is in upper left. Gilpin Creek is to the right of the photo.*

The trough itself seems to be functioning as intended, human error aside. But in terms of whether changes are needed to avoid future problems, the options are either to move the trough further from the slope edge or to modify it. MFLNRO staff and the licensee explained that moving the trough further away from the creek would require bringing equipment in to dig up the currently buried intake pipe, adding more pipe and digging a new trench for the pipe. However, if the overflow was the result of vandalism, moving the trough would not necessarily alleviate the problem, and soil damage might still occur from overflow further back, if not discovered quickly.

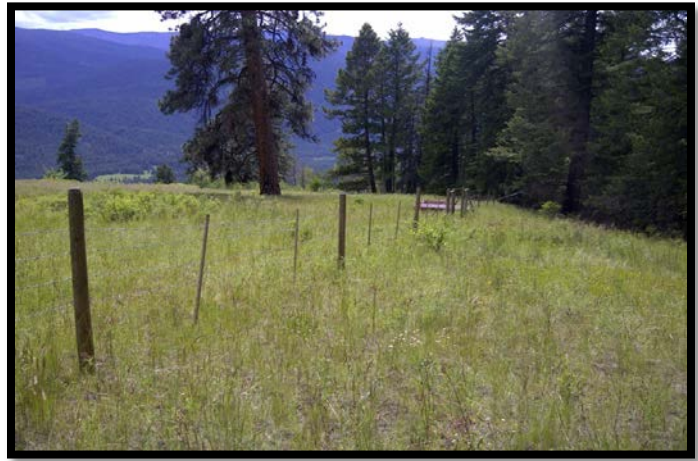
As part of the range improvements in 2009, fences were constructed near the new water troughs to restrict cattle access to Gilpin Creek (photos 5 and 6). Four-strand barbed wire was used with loose vertical supports and a raised lower strand to facilitate wildlife getting under the fence. In the August 2009 approval letter for the range improvements, the MFLNRO district manager stated that fences should be constructed to wildlife standards supplied by the MOE. MFLNRO

*Photo 5. New fence with water trough in the distance.*

The fences around the troughs have a flexible bottom wire for wildlife, but do not meet the MOE criteria for the top wires. On this point, both government range staff and the licensee feel that a smooth wire fence at this site would be pushed down or damaged by either cattle or wildlife. The gates are open for the approximately 11 months of the year when cattle are not using the area, but it is not clear whether wildlife use the gates and the guide outfitter feels that the gates should be wider.

**Finding:** The fences are not wildlife friendly as set out by MOE criteria. Modifications may be necessary.

In the Board's opinion a wildlife expert should assess the location and construction of the fences and decide whether modifications are necessary. Such modifications could include wooden top rails, caution tape or snow fencing to make the fences more visible to wildlife.

The Ministry of Environment should assess the fences that were installed near the water troughs in 2009 to determine whether any modifications to make them more wildlife friendly are necessary.

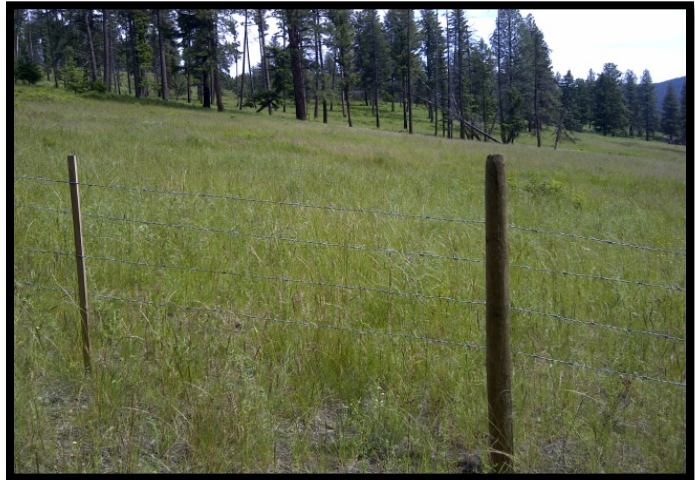
*Photo 6. New fence near the water trough.*
