**Forest  
Practices  
Board**

## **Impacts of Harvesting and Road Construction to Malakwa Creek**

*Complaint Investigation #16081*

**FPB/IRC/207**

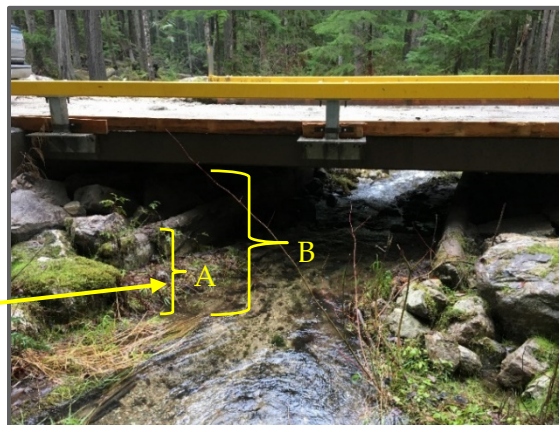
The new bridge design has a longer span, is higher, and incorporates gentle elevated approaches to the bridge from each end (see Figures 4 and 5). The elevated approach helps keep road surface water away from the crossing. Tolko also installed sumps in the ditches to allow sediment in the ditch water to settle out and then direct the water into the standing timber, not directly into the stream.

**Figure 5.** New bridge November 2016. (A) is the height of the old bridge and (B) is the height of the new bridge above Malakwa Creek.

Both the complainant and Tolko confirm that there was silt and sand on the bridge deck. The material was likely the result of industrial traffic and heavy rains eroding the road surface and depositing the material on the bridge deck. Some of this may have washed into Malakwa Creek and been transported as suspended sediment to the intake. The complainant asserts this was the main source of sediment entering Malakwa Creek and the reason his water system plugged. The Board could not determine that the sediment plugging the water system was from the material on the bridge deck.

Tolko installed splash guards<sup>3</sup> at this location on October 25<sup>th</sup>, and two other bridge locations at about the same time. Splash guards reduce the risk of sediment from the bridge deck being washed into Malakwa Creek. Tolko said it does this where the risk and hazard of erosion and sedimentation are high. Tolko also completed additional rehabilitation of the temporary access structures, and cleaned the sand and silt off the bridge deck and disposed of it away from the creek. Tolko said it completed additional water controls and trail deactivation in response to the very wet conditions observed on site, and to the concerns the complainant had.

While Tolko acted promptly once the complaint was received it could have taken preventative measures to mitigate potential impacts to water quality. These could have included capping the road with non-erodible material, installing the splash guards immediately after the bridge was constructed and installing signs at the bridge crossing indicating that extreme care must be taken due to the proximity of a domestic water intake to the bridge. Tolko could also have seasonally deactivated the approaches to the bridge with effective water bars when it pulled out in September.
