**Forest  
Practices  
Board**

## **Impacts of Harvesting and Road Construction to Malakwa Creek**

*Complaint Investigation #16081*

**FPB/IRC/207**

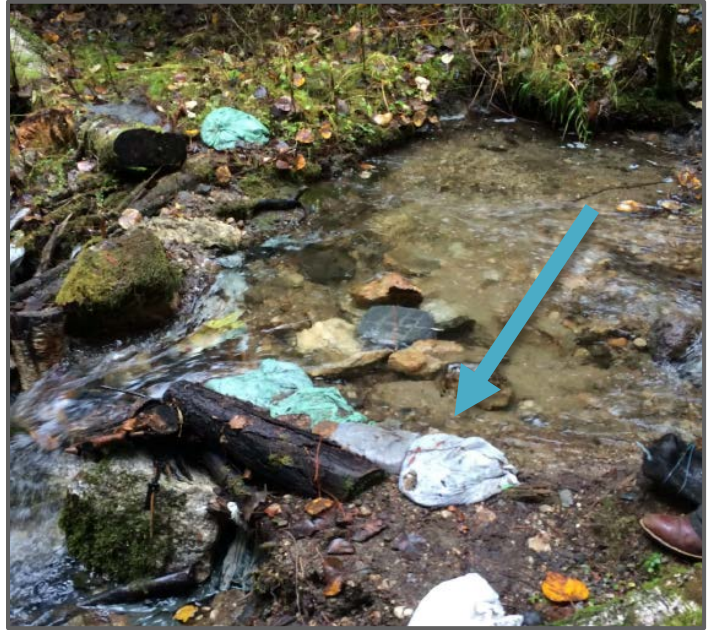
On October 21, 2016, five weeks after Tolko finished logging and hauling, the complainant says the water to his house stopped running for the first time since he installed his water system. The following day he checked his intake and found the intake pond was full of mud and silt, and that the intake screen was plugged. He cleaned the intake, but still could not get water to his house. He notified Tolko of the issue and then visited the bridge. He said it was covered with silt and sand, and that fine sand was in the back eddies and ponds above and below the bridge. Tolko met the complainant on site that day to review the bridge site and the water intake. The complainant said the sedimentation in the creek was above normal levels, but Tolko did not agree with that. Both parties also reviewed the cutblock, and Tolko said it could not find any significant sediment source into

Figure 2. Complainant's water intake—October 26, 2016.

In the Board's opinion, the complainant's water system may be considered damaged when plugged with sediment that is restricting the ability of the system to deliver water. The complainant has cleaned the intake pond in the past and it requires ongoing maintenance. However, the complainant asserts that the material he saw at the intake pond, immediately after his water stopped running, was finer than observed in the past. The Board investigators could find no evidence that the sediment at the intake in 2016 was different from previous years.

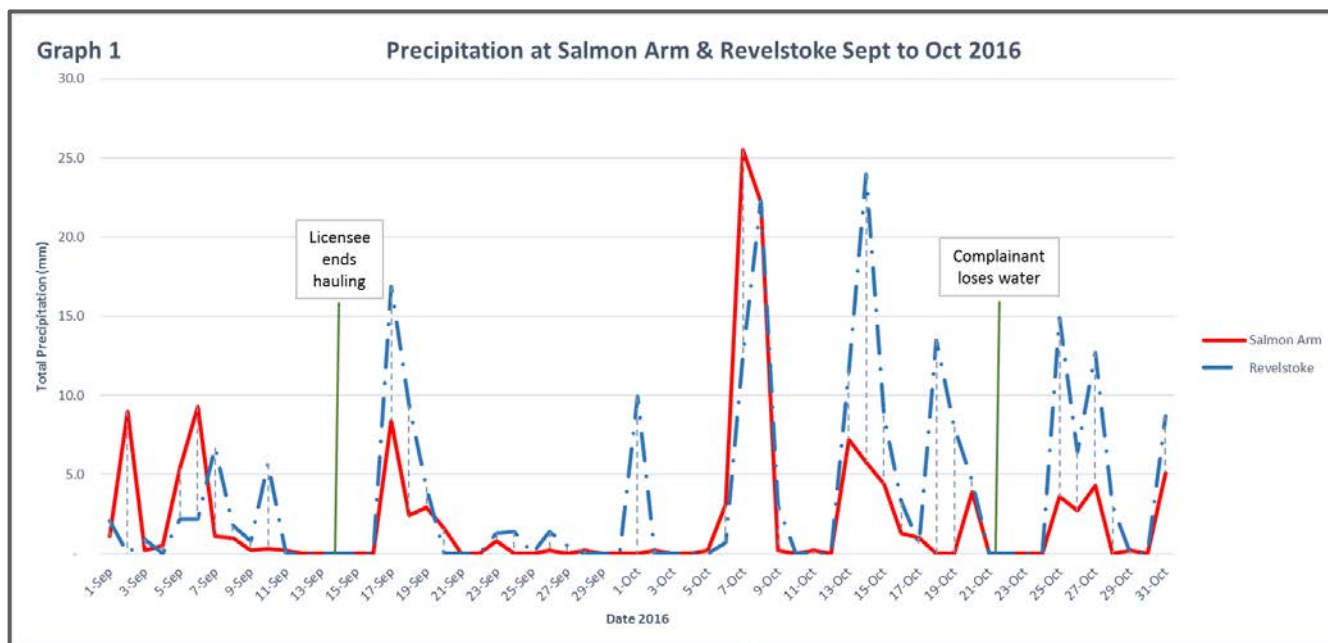
Tolko and the complainant both said that the autumn of 2016 was one of the wettest they can remember. The Salmon Arm and Revelstoke weather station recorded heavy rain for two weeks before the complainant's water stopped running (see figure 3). Heavy rains can cause stream flows to increase, which can contribute sediment by eroding stream banks and stream channels.

Figure 3. Precipitation record for the months of September 2016 and October 2016 at Salmon Arm and Revelstoke.<sup>1</sup>

<sup>1</sup> The average precipitation in October for Salmon Arm recorded between 1981 and 2010 was 54.2 millimetres, which is considerably less when compared to 91.1 millimetres recorded for the same area in 2016.

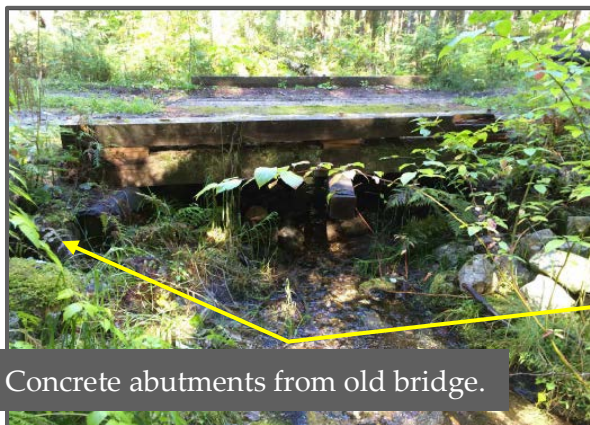
**Figure 4.** Old bridge with deteriorating wooden deck and stringers. The wood stringers rested on concrete abutments.
