**Forest
Practices
Board**

Road Maintenance at Little Cayuse Creek

Complaint Investigation #17029

June 2018

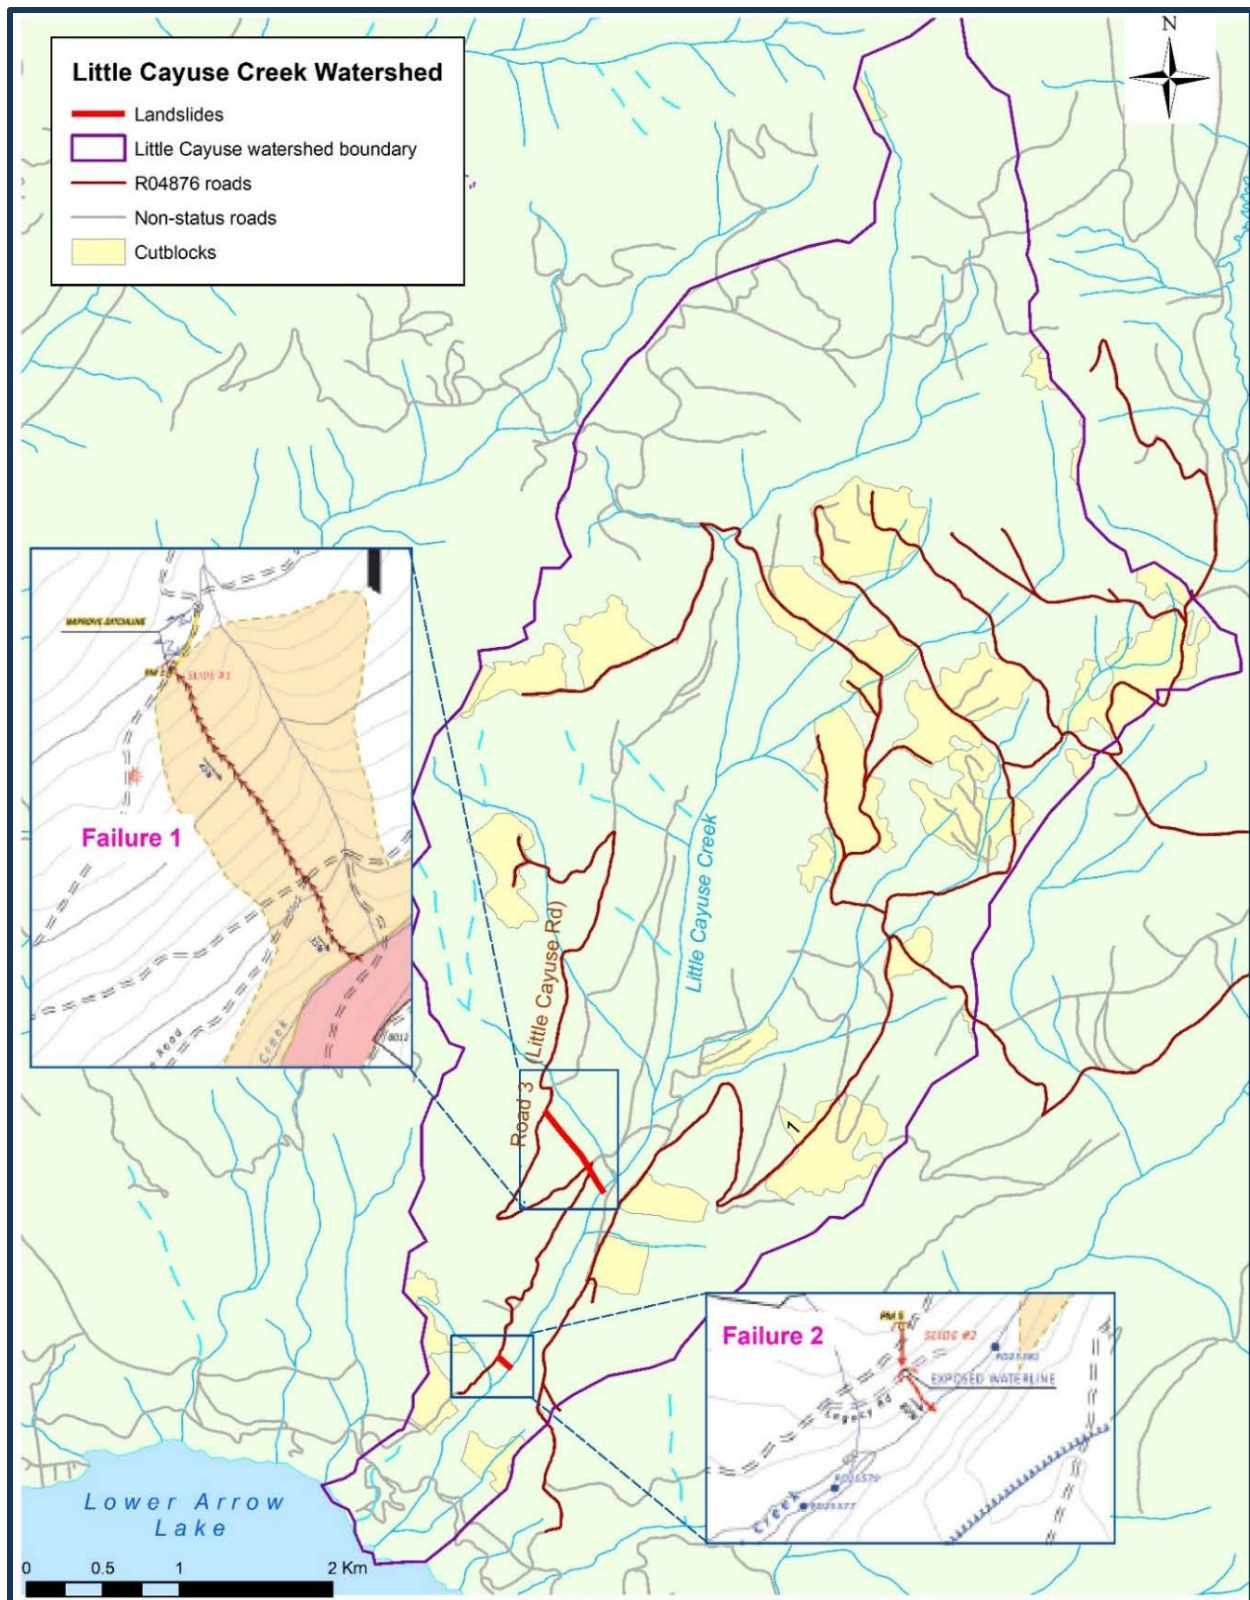
Figure 2. Road permit roads and fill slope failures.

When the complainant contacted Interfor in April 2017 about the sediment in the stream, Interfor investigated. On April 19, 2017, Interfor staff found a fill-slope failure at the 4.5 kilometre point on the Little Cayuse Road, which is on the west side of Little Cayuse Creek (Figure 2). Interfor hired a professional geoscientist to investigate. On April 21, 2017, the geoscientist examined the failure, and also discovered a second road fill-slope failure at the 1.2 kilometre point of the Little Cayuse Road (Figure 2).

The geoscientist found that the failure at the 4.5 kilometre point occurred at a broad cross ditch,¹ installed in 1997, where the road crossed a gully. Ditch water went subsurface at the cross ditch and saturated the fill. An unusually high water table and water piping² at the bottom of the fill also contributed to the slide. Much of the slide material deposited on a road below the initiation point, but approximately 10 cubic metres of material entered Little Cayuse Creek about 875 metres above the complainant's water intake.

In the fall of 2017, Interfor prepared and executed a temporary⁴ deactivation prescription for four of the approximately seven kilometres of road they have under a road permit for the Little Cayuse Road system. Interfor has committed to inspecting the remainder of the road system in 2018. Interfor also prepared a map showing maintenance requirements for many of its roads on the east side of Little Cayuse Creek.

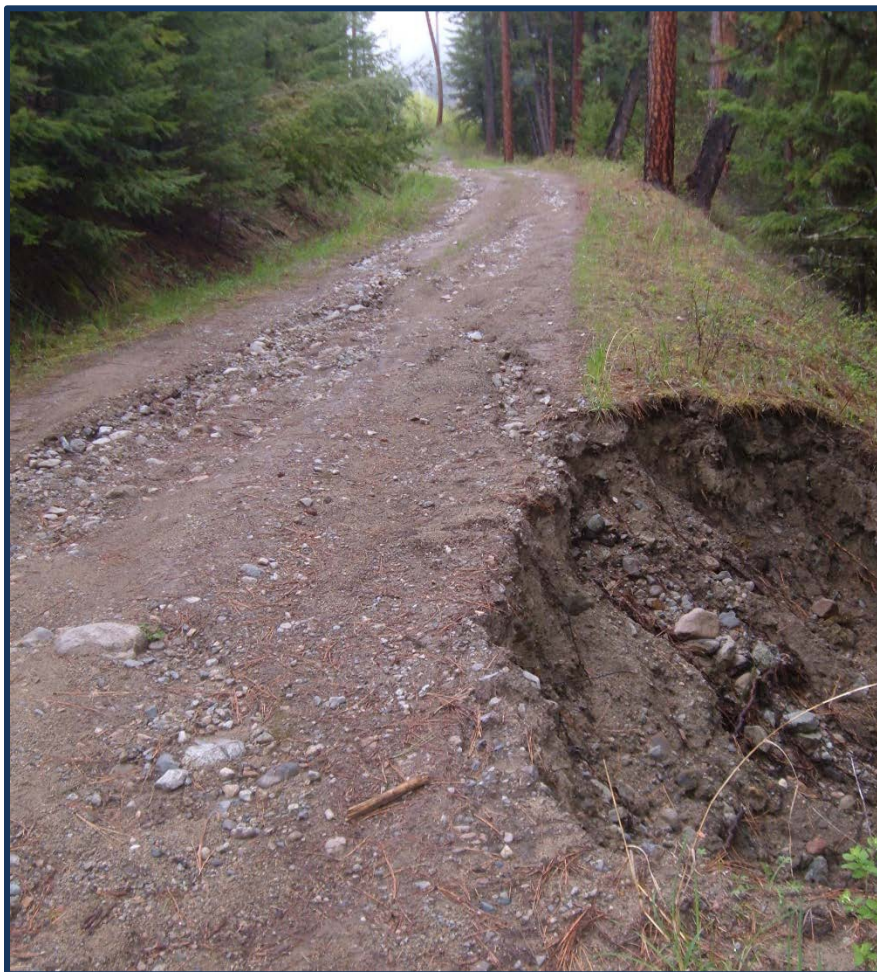
At the 1.2 kilometre point, the geoscientist found that water running down the road surface by-passed a sediment-filled cross ditch, continued 200 metres down the road, saturated the fill slope, and caused a small slump (Figure 3). The slumped fill slope material remained just below the road, but significant surface water flowed off the road at the slump and traveled about 100 metres downslope and saturated the fill slope of another road below. The fill slope of that road then failed and deposited about 100 to 150 cubic metres of material into Little Cayuse Creek just below the complainant's water intake.

Figure 3. Surface run water saturated the road fill and caused a slump. Re-directed surface run water continued down slope and initiated a larger slide.
