**Forest
Practices
Board**

Forest Practices near Wilson Creek on the Sunshine Coast

Complaint Investigation #18032

January 2019

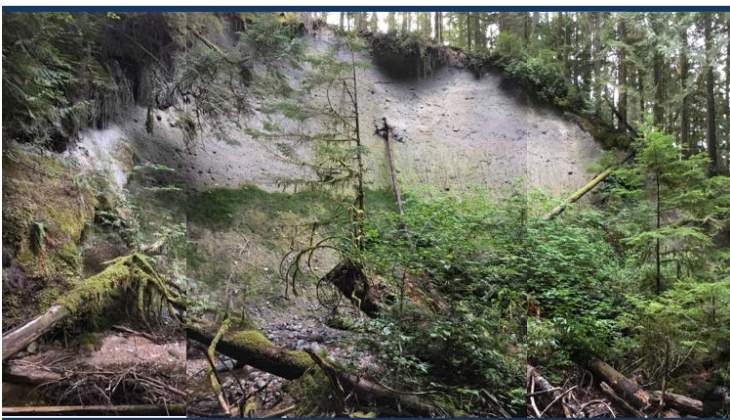
Picture 1. The retrogressive slump adjacent to Wilson Creek. Note the revegetation of the toe of the slump.

The forest activities of SCCF did not cause the slump that the complainant identified: the slump was a natural event that occurred before any primary forest activity took place. The design and development of cutblock EW002 did not affect or increase the sedimentation that is naturally occurring from the slump. Further, Board investigators observed that the toe of the slump is beginning to revegetate, which will reduce the amount of sediment from the slump introduced into Wilson Creek in the future.

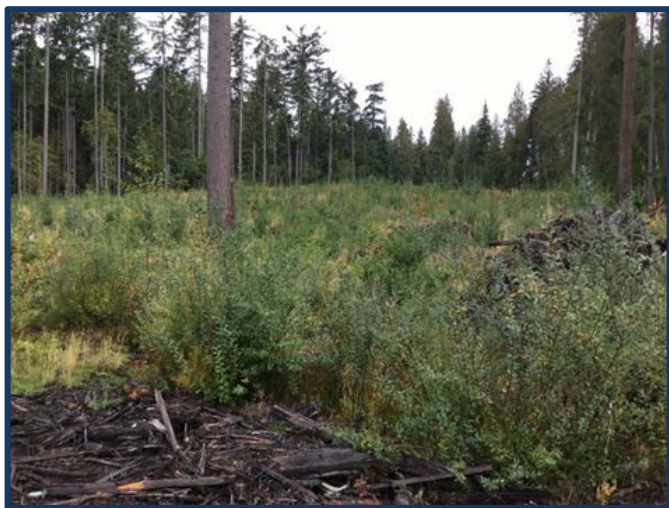
Figure 5. Cutblock EW002. Note the gentle terrain and vigorous regeneration and thick shrub component. Wilson Creek is to the left of the cutblock.
