**Forest
Practices
Board**

Forestry Activities in the Peachland and Trepanier Creek Community Watersheds

Complaint Investigation #17046

September 2019

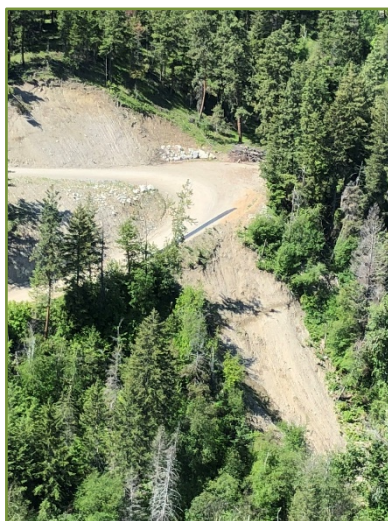
In late March 2017, a landslide occurred downslope of the switchback on the Munroe FSR (not within the road prism), releasing sediment into Peachland Creek and triggering a boil water advisory. Gorman Bros. contracted the same engineering firm to investigate the landslide. The assessment concluded that the landslide event was caused by erosion and undercutting by Peachland Creek at the toe of the slope (below the road fill slope), combined with a significant precipitation and snowmelt that increased saturation of the slope and resulted in the onset of slope movement.

Picture 5. Slope failure below Munroe FSR.

The engineering firm's assessment also concluded that, immediately following the landslide event, the road prism above the headscarp of the landslide was still intact and safe for passage of pickup vehicles. The assessment also made three recommendations that could be implemented immediately, which Gorman Bros. said they followed. In addition, the assessment identified a residual risk of more landslides and erosion events, regardless of these works. The assessment recommended that the Munro FSR be considered for permanent deactivation upon completion of harvesting activities accessed by this road to mitigate the residual risk. Gorman Bros. said it will recommend to the FLNRORD that the road section be permanently deactivated upon completion of harvesting activities. However, FLNRORD will make the final decision on the deactivation because this is a Forest Service Road.

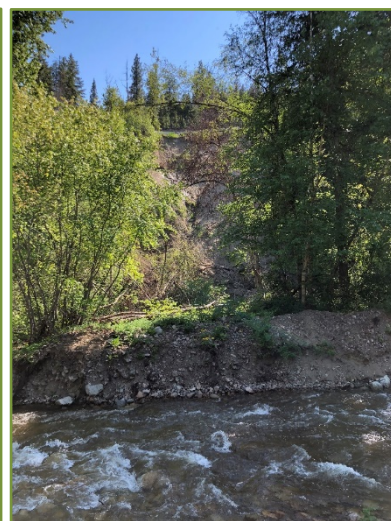
Picture 6. Peachland Creek re-channeled away from toe of the landslide.

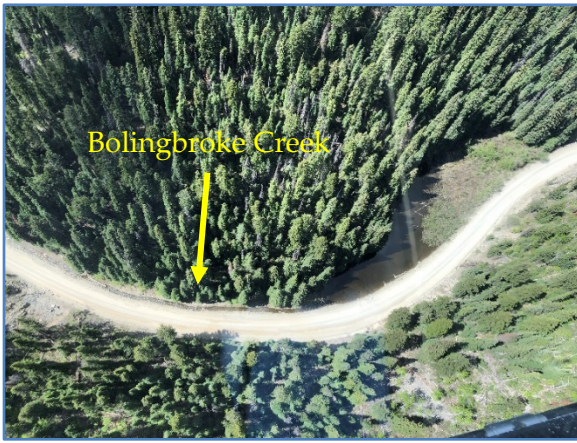
Picture 7. Peachland FSR adjacent to Bolingbroke Creek. Bolingbroke Creek is immediately adjacent to the Peachland FSR.

1. Review cross drain culvert spacing on sections of continuous grade to any major stream crossing. Although natural drainage was maintained (i.e., culverts at stream crossings and non-classified drainages) and there was no evidence of slope failures, investigators determined that additional cross drains in these sections would help to better manage spring runoff and major rainfall events by dissipating ditch water away from the crossing instead of concentrating it at the crossing.
2. Review culvert size on older roads, especially the Brenda Mines road and power line right-of-way access roads, and replace them if they are undersized.
3. Review the Peachland FSR adjacent to Bolingbroke Creek (pictures 7 and 8) to evaluate opportunities to mitigate the sediment from the road and ditch into Bolingbroke Creek.

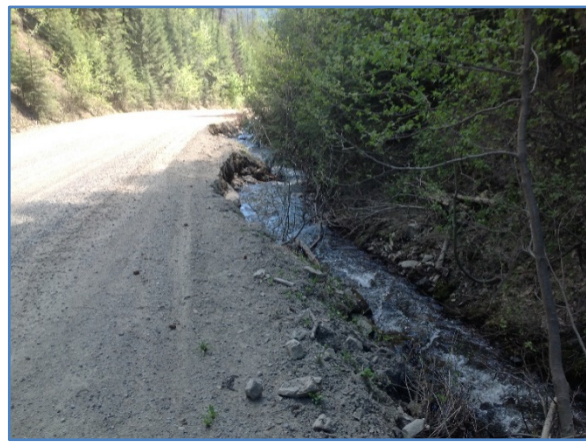
Picture 8. Peachland FSR adjacent to Bolingbroke Creek. Note the road prism erosion.

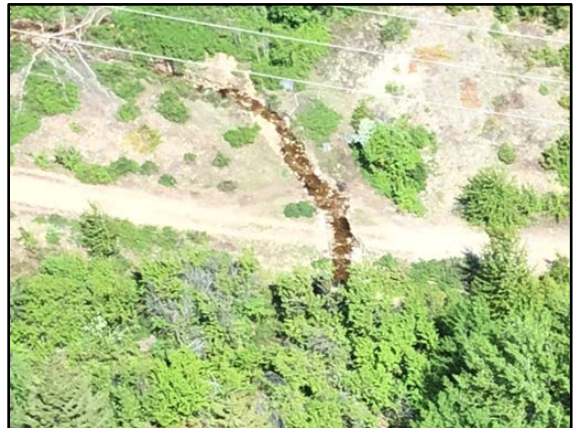
Forestry activities may have an impact at an individual stream drainage level. For example, investigators observed a washed-out culvert on a power line right-of-way within the Wilson Lakes catchment area (picture 9). Forestry activities may have contributed to this event. However, the Board could not determine the extent to

Picture 9. Stream eroding around a culvert across a BC Hydro access road in spring of 2017 & 2018.

which logging contributed to the wash-out (pictures 10 and 11), given the cumulative effect of the high snow pack, high spring runoff and lack of information on the culvert sizing (picture 12) or road maintenance history.

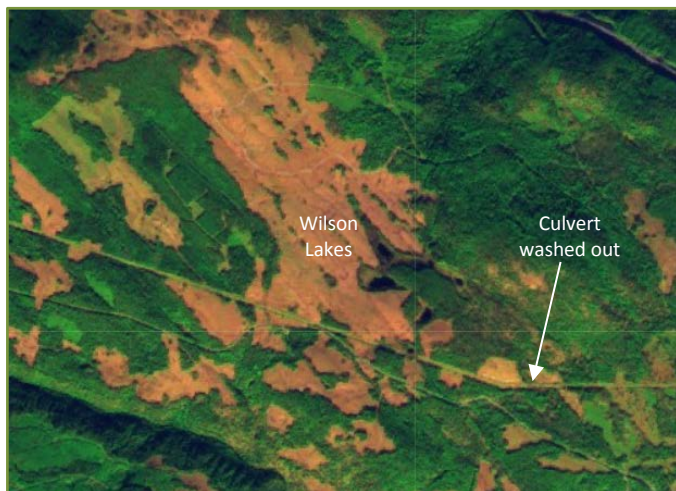
Picture 11. Wilson Lakes after harvesting. About 275 hectares were harvested from the Wilson Lake catchment area, increasing peak flows for that specific catchment.

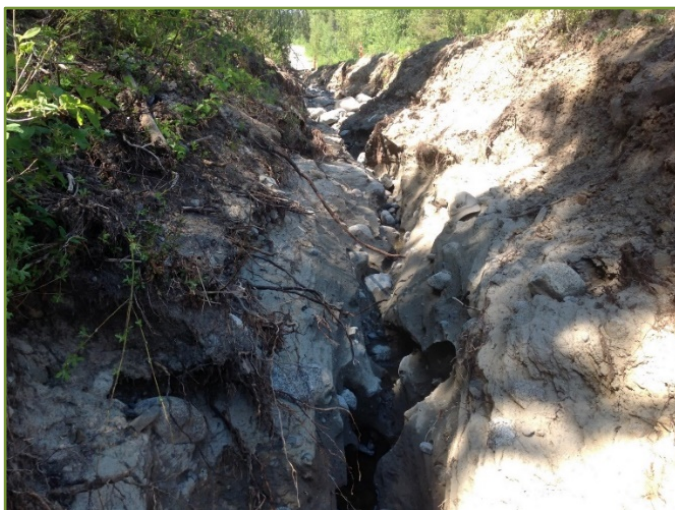
Picture 11. Picture 12. An example of a non-forestry related factor. Ditch line erosion resulting from a plugged culvert on the Brenda Mines Road.
