**Forest
Practices
Board**

Audit of Forest Planning and Practices

*Cooper Creek Cedar Ltd.
Forest Licence A30171*

FPB/ARC/237

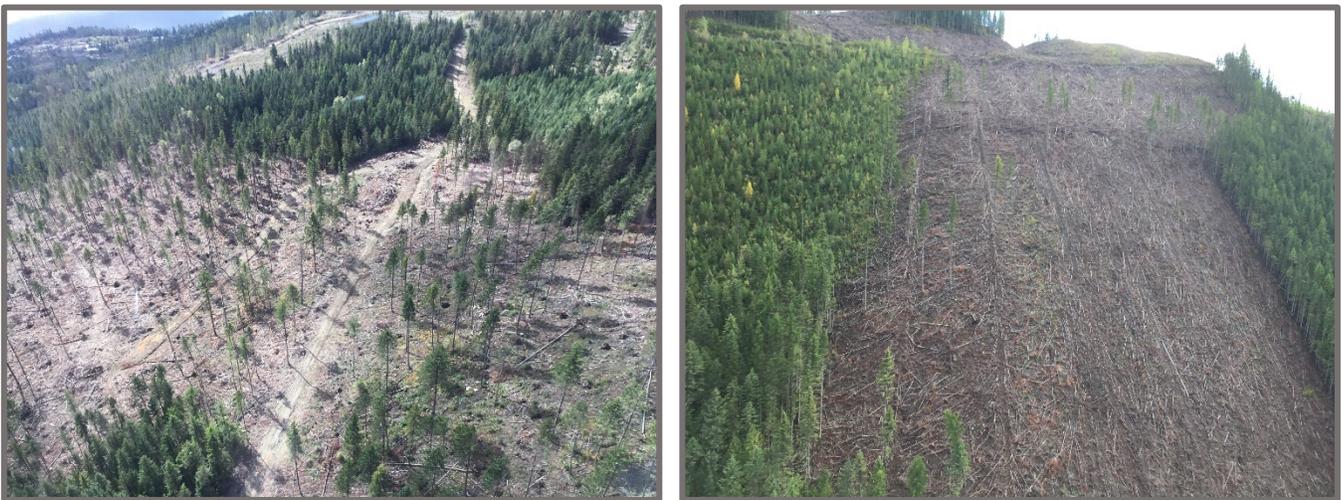
Harvesting met the requirements of legislation and conformed to SPs. Topography in the operating areas ranged from gently rolling to steep-mountainous terrain. Harvesting was done with ground-based and cable systems.

Cooper Creek's harvesting ranged from ground-based harvesting with internal leave tree retention (left) to steep-cable harvesting using intermediate supports (right).

Natural drainage patterns were maintained, and streams were managed consistent with the FSP obligations. Site disturbance was well managed and below allowable limits.

Cooper Creek maintained an average of 14 percent of the gross block area in wildlife trees. The FSP required a minimum of 7 percent. Wildlife trees were retained around riparian features whenever possible.

In summary, auditors found no issues with harvesting practices.

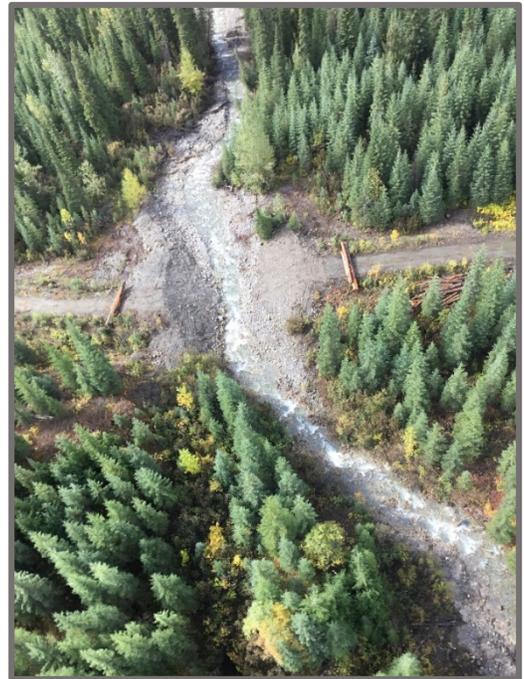
Road deactivation was well done. Deactivation of the two bridges was also well done, with the stream banks armoured, thereby mitigating the potential for sediment delivery into the channels. Cooper Creek blocked vehicular traffic at both locations.

Road crossing of Tea Creek after Cooper Creek removed the bridge.
