## **Road Maintenance and Landslides at Bernard Creek, on Kootenay Lake**

*Complaint Investigation #19073*

**FPB/IRC/234**

November 2020

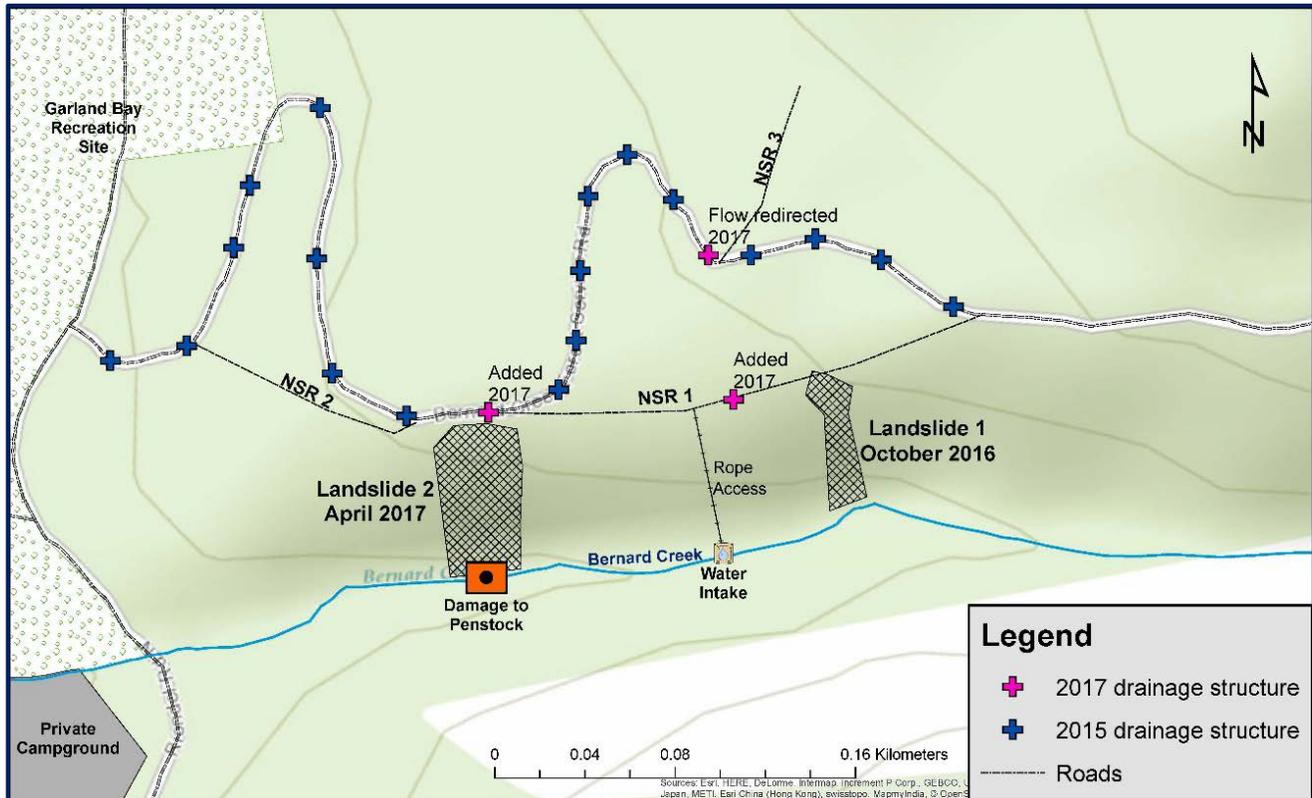
When the district began to implement the professional engineer’s recommendations in 2017, residents of the campground again asked that no drainage structures be installed on NSR #1. As a compromise, the district installed one of the two planned drainage structures on NSR #1 that avoided the water intake access point and one long drainage structure on the FSR at the intersection with NSR#1. (Figure 2 shows the general locations of the landslides and drainage structures installed on the FSR in 2015 and on NSR #1 in 2017).

Figure 2. Location of landslides, water intake and drainage structures.

After landslide #2, in early May 2017, district engineering staff and the professional engineer inspected the site. Along the FSR, in the area upslope of landslide #2, the professional engineer recommended that a drainage structure installed in 2015 be inverted so that surface runoff would be directed away from the slope below. The professional engineer also recommended installation of several new drainage structures on NSR #1. A resident from the campground, again, requested that no cross ditches be installed on the staging location of the NSR#1. The professional engineer's recommendations were followed, except for installation of one of the recommended cross ditches on NSR #1, as requested by the residents. This work was completed in 2017 and 2018.
