Streamside Protection, Sediment Control and the Pacific Water Shrew

Complaint Investigation 060699

FPB/IRC/119 August 2006

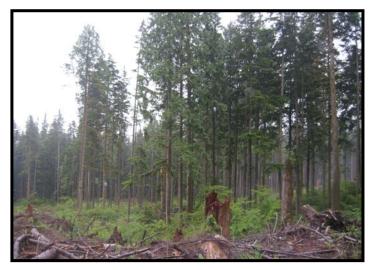
Tree retention in a riparian management zone of a small fish stream.

On the ground, the licensee has complied with Code requirements for riparian reserves, and has left additional discretionary reserves as shown on its plans. Board staff did not measure the basal area of trees left within logged riparian management zones, but saw that the licensee had retained a substantial number of trees in those zones. Overall, the retained trees have remained standing, although in two locations, the wind had caused some streamside trees to fall down. At one location, the
