Gilpin Creek Debris Slide

Complaint Investigation #110983

FPB/IRC/181 May 2012

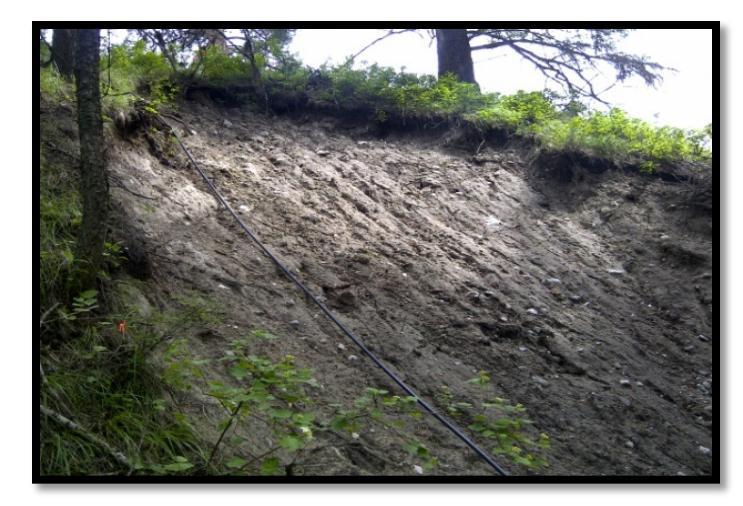
In the fall of 2010, the rancher disconnected the intake pipe for the winter. Later, for the trough in question, someone reconnected the inlet pipe but did not reconnect the outlet. Water flowed into the trough and out onto the ground. The ground became saturated and, in the early spring of 2011, a debris slide into Gilpin Creek occurred (see photos 1 and 2). A considerable volume of soil slid into Gilpin Creek, some of which was transported down the creek and deposited in the stream bed.

Photo 1. The slide and the outflow pipe running down to the creek.

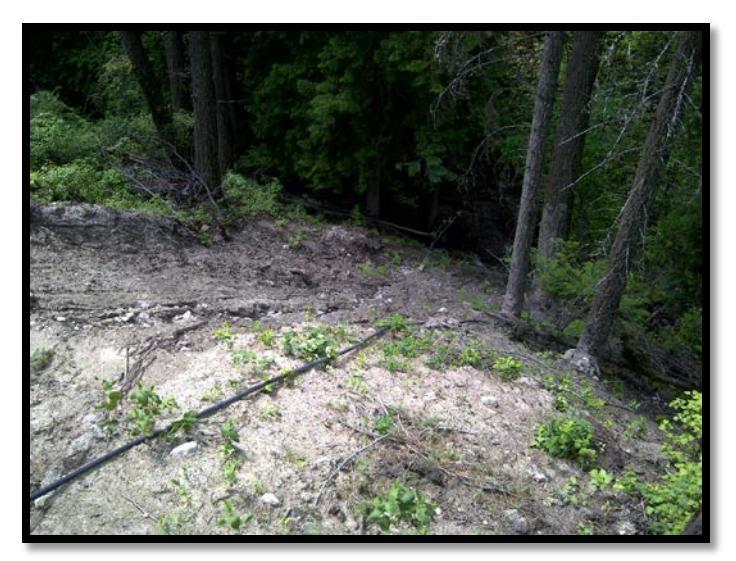
Photo 2. The slide extends into Gilpin Creek.

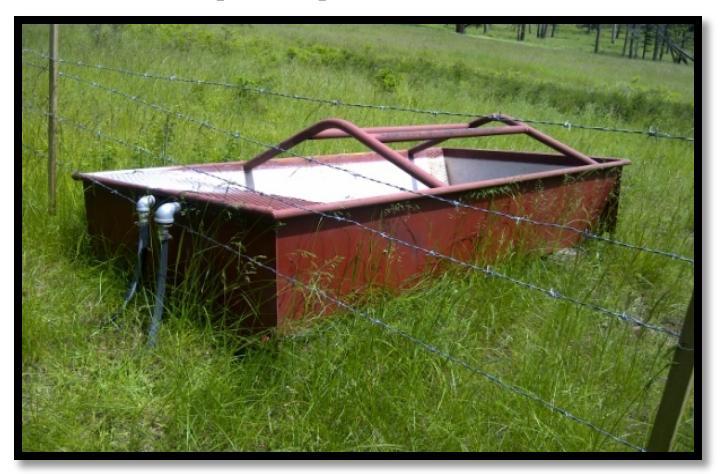
The trough above the slide area had a gravity-fed intake system from a small dam in the creek upslope and a return pipe as required (photo 3). The trough is

Photo 3. Trough showing intake and outflow pipes.

The range licensee advised the Board that for the 2011/2012 winter he disconnected the intake pipe from its source at the dam and removed new fitting adapters for the intake on the trough, which he expected would prevent the intake from being either accidentally or intentionally reconnected before the system was set up for use again later in 2012.

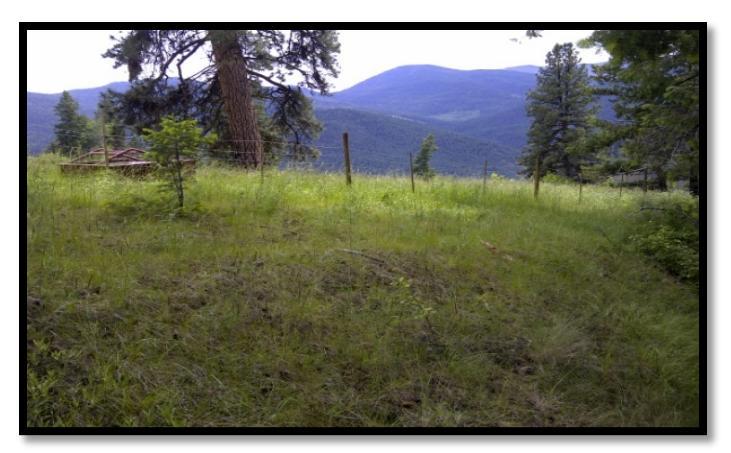
approximately 15 feet from the edge of the slope down to Gilpin Creek (photo 4).

Photo 4. The trough is in upper left. Gilpin Creek is to the right of the photo.

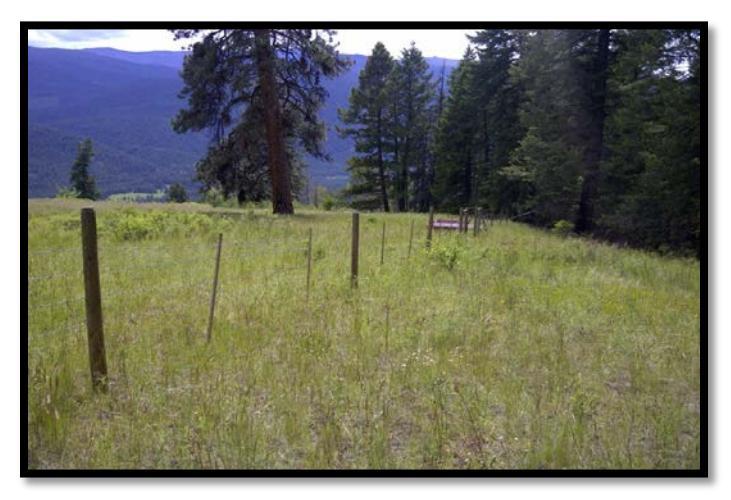
Photo 5. New fence with water trough in the distance.

The fences around the troughs have a flexible bottom wire for wildlife, but do not meet the MOE criteria for the top wires. On this point, both government range staff and the licensee feel that a smooth wire fence at this site would be pushed down or damaged by either cattle or wildlife.

Finding: The fences are not wildlife friendly as set out by MOE criteria. Modifications may be necessary.

In the Board's opinion a wildlife expert should assess the location and construction of the fences and decide whether modifications are necessary. Such modifications could include wooden top rails, caution tape or snow fencing to make the fences more visible to wildlife.

The Ministry of Environment should assess the fences that were installed near the water troughs in 2009 to determine whether any modifications to make them more wildlife friendly are necessary.

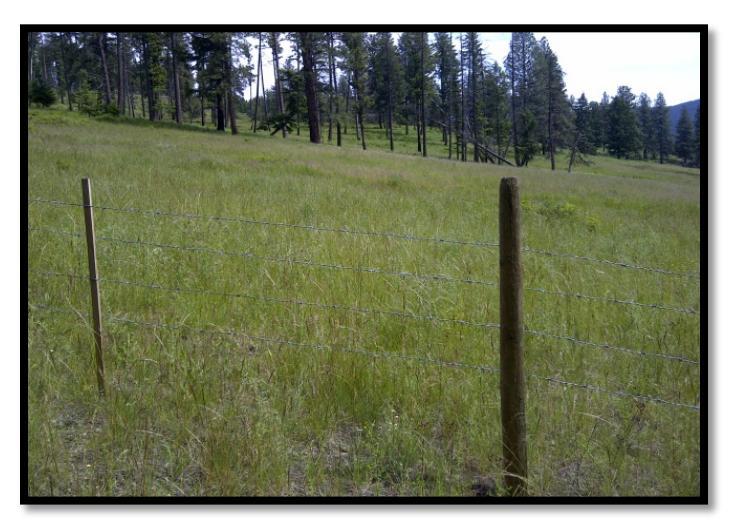
Photo 6. New fence near the water trough.
