# Timber Harvesting Impacts on Water Flows near Clearwater

Complaint Investigation #15022

FPB/IRC/199 March 2016

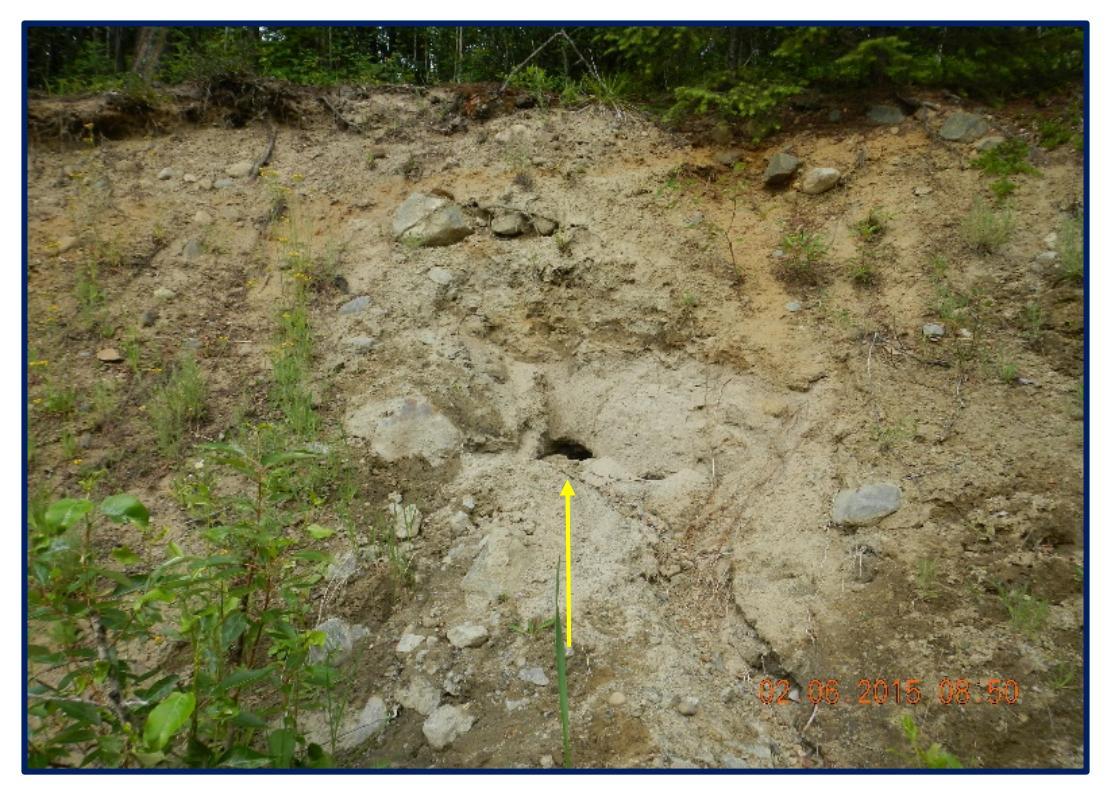
Following timber harvesting, the complainant noticed more water than usual coming out of a cutbank beside several mobile homes. The water collected around and under some of the homes and the storage yard. He was concerned the increased flows were the result of timber harvesting by the community forest on the hillside above the property.

**Figure 1**. Subsurface flows from infiltration seeped out through openings such as this one in the cut bank beside the mobile home park (piping). The opening shown here is about 20 centimetres x 10 centimetres.

The complainant observed higher than normal seepage into May, after the snow on the hillside had melted and the water from the pond stopped running down the road. This may imply that some or all of the increased seepage could be attributed to subsurface flows from the intermittent pond and elongated depression. However, according to the hydrologist hired by the Board, a detailed geotechnical investigation of the entire hillside would be required to determine, with any certainty, if the water moved from the intermittent pond and elongated depression downslope to the mobile home park through subsurface pathways. In the absence of such information, it is reasonable to

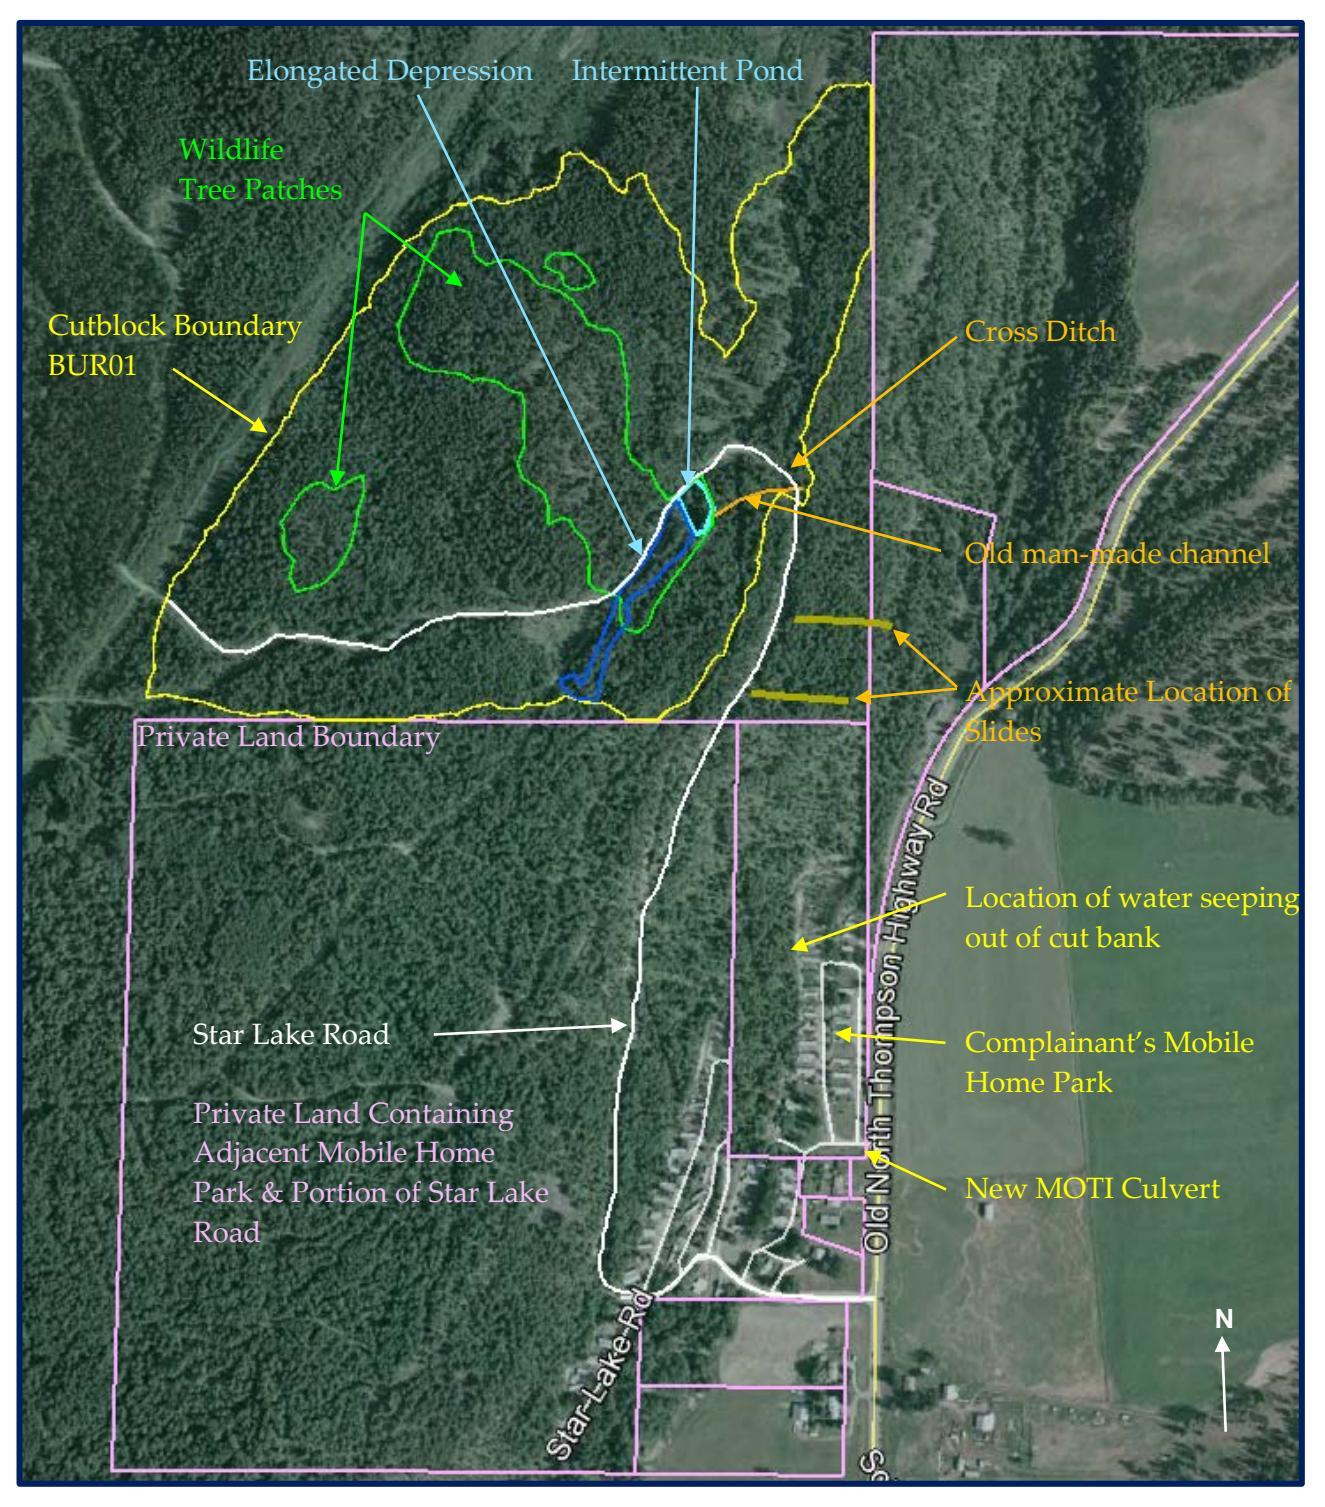
**Figure 2.** Overview of the roads, harvesting and other development features contributing to the hydrologic processes in the area. The cutblock slopes in a south easterly direction.

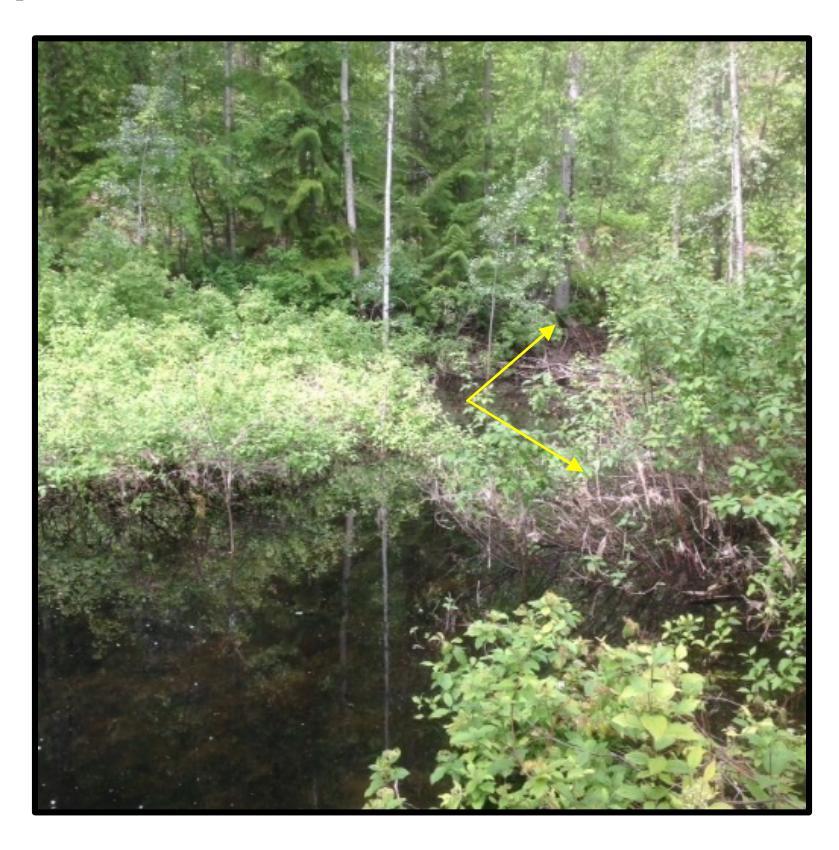
The community forest started harvesting in January 2014 and finished in June. The following winter, the area experienced a rain on snow event and warmer than normal temperatures. These events caused an increase in snowmelt rates and overland flow, which filled the intermittent pond in the cutblock and a 175-metre long depression connected to the pond. The water from the pond eventually spilled over its banks, running down an old man-made channel onto Star Lake Road, and travelled down the road.

**Figure 3.** The pond partially filled with water in June 2015. The yellow arrows show the high water line in February 2015. In August 2015 the pond was dry.

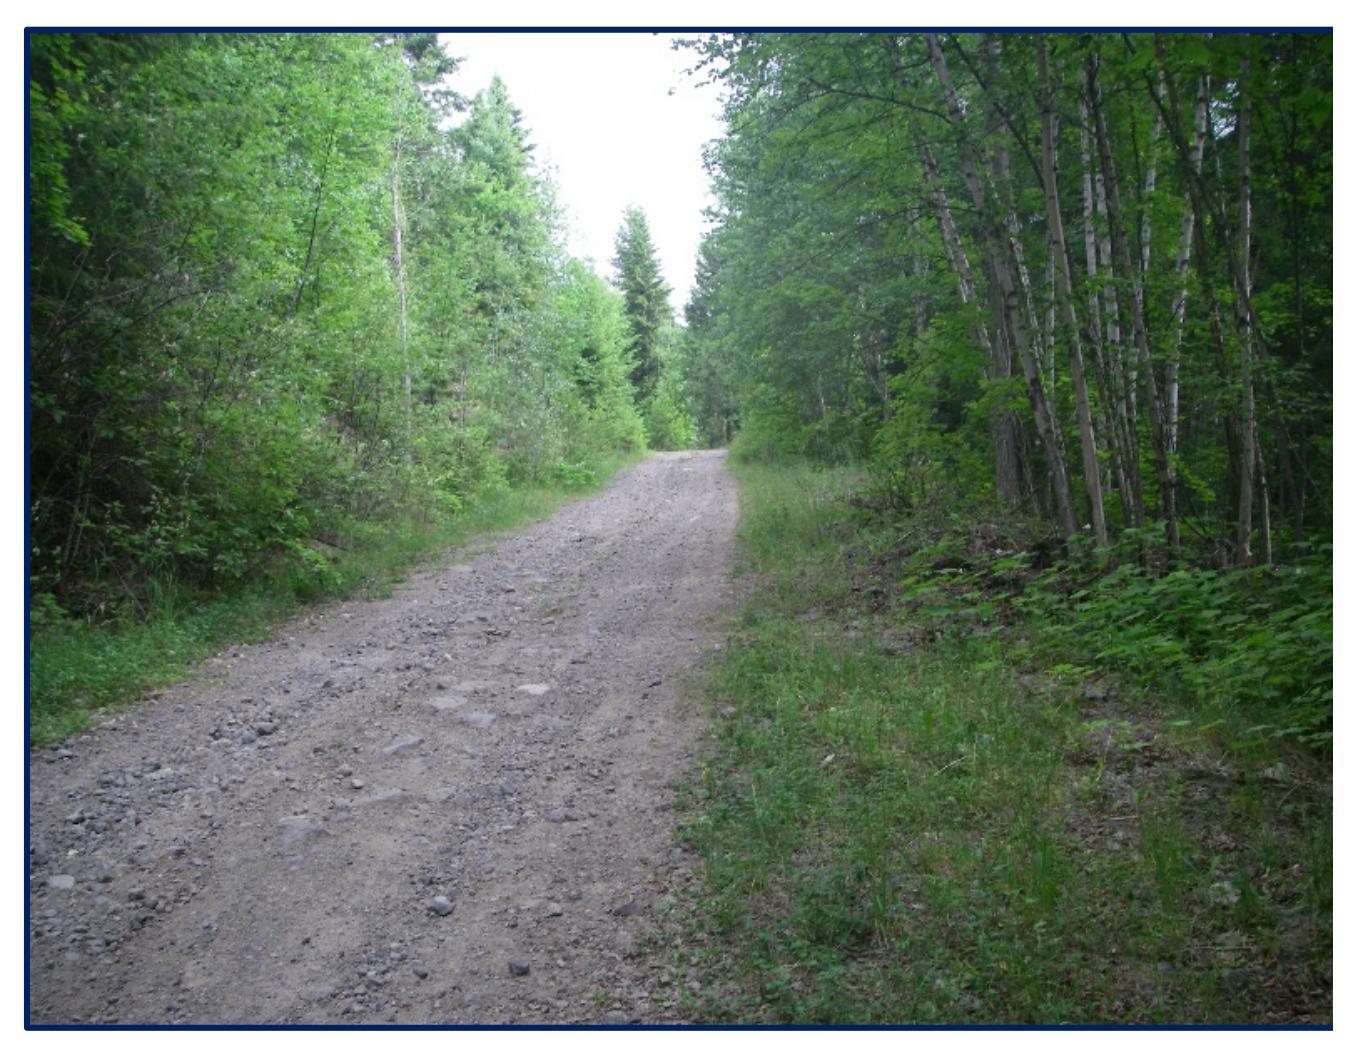
The Star Lake Road runs at a continuous grade from the cutblock for 500 metres, where it crosses the hillside about 300 metres upslope of the complainant's mobile home park. The road was constructed 50 years ago and there are no cross drains on the road beyond the mobile home park, so water accumulates and flows down the road surface. The fill of the road is a mixture of large rock, soil and bedrock, and likely is sufficiently permeable to drain surface runoff. This, coupled with any diversion of water off the road onto the ground above the complainant's mobile home park, may have contributed to the higher than average seepage observed by the complainant.

In hindsight, redirection of water by Star Lake Road may have been one of the major factors contributing to the increased seepage in the cutbank adjacent to the mobile homes. However, the community forest does not have jurisdiction to maintain the portion of the Star Lake Road on private land.

**Figure 4.** Continuous grade of Star Lake Road. Note the lack of drainage control and minor erosion of the running surface.

- Notifying the Ministry of Transportation and Infrastructure (MOTI) that the shoulder of the Star Lake Road at the landslides may be a public safety issue and should be repaired.
- Notifying MOTI that the drainage along the Star Lake Road leading up to the community forest should be assessed and drainage control measures should be implemented.

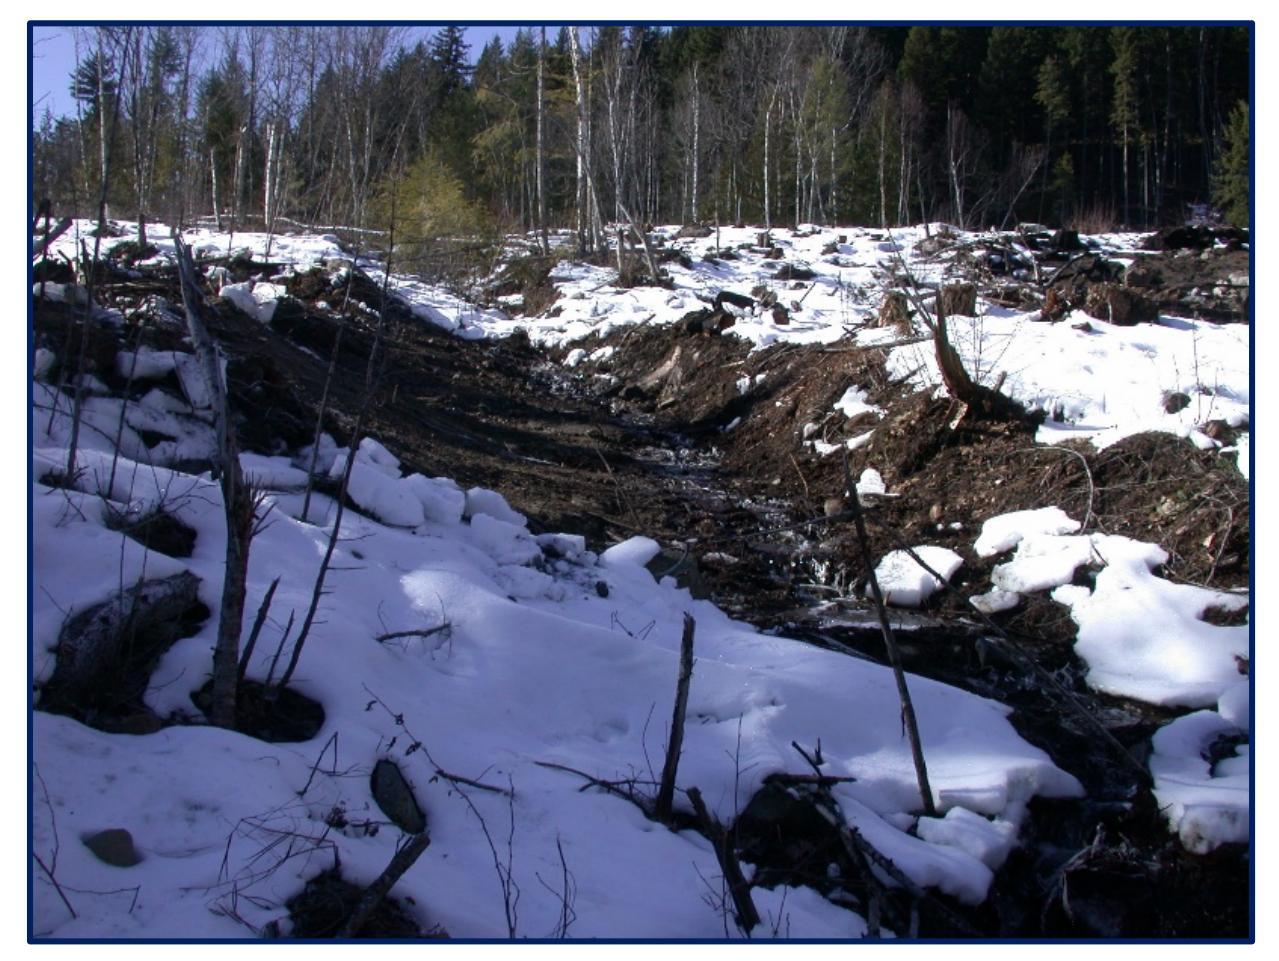
**Figure 5.** Water flowing from the pond down the man-made channel in February 2015. The pond is out of sight at the top of the photo near the tree line.

The specialists' review of the landslides that occurred following harvesting indicated that the harvesting was one of three main contributing factors. There were no cross ditches on Star Lake Road, so the water from the pond and other sources ran down the road until ice redirected it off the road onto steep slopes, where the landslides initiated. Section 37 of the FPPR requires licensees to ensure that their practices do not cause landslides that have a material adverse effect on soils on Crown land. The phrase "must ensure" means that a person must take positive steps to make certain of these outcomes, including putting a system of checks and balances in place. In this case, the positive steps included an eight-hectare wildlife tree patch established around the intermittent pond and a buffer of mature windfirm timber reserved along the top of the escarpment above the Star Lake Road. An assessment of hydrological risk by a qualified professional was not completed; a reasonable decision at the time in the Board's opinion, considering the lack of streams on the cutblock and the generally dry conditions in and around the cutblock.

Following the two landslides that occurred off Star Lake Road, a geotechnical engineer working under contract to the community forest recommended that Star Lake Road be cross ditched just below the switchback in the cutblock to drain water away from the road, onto a small bench and then over an escarpment, to prevent further landslides. However, it wasn't clear to the community forest who had responsibility for the road.

FLNR's cross-ditching work did cut off residents' access to the road. However, when Board investigators visited the site, someone had restored the access. The Ministry of Transportation and Infrastructure has since installed a cattleguard at the cross ditch location, which will address future runoff and maintain access.
