Managing Landslide Risk from Forest Practices in British Columbia

Special Investigation

FPB/SIR/14

July 2005

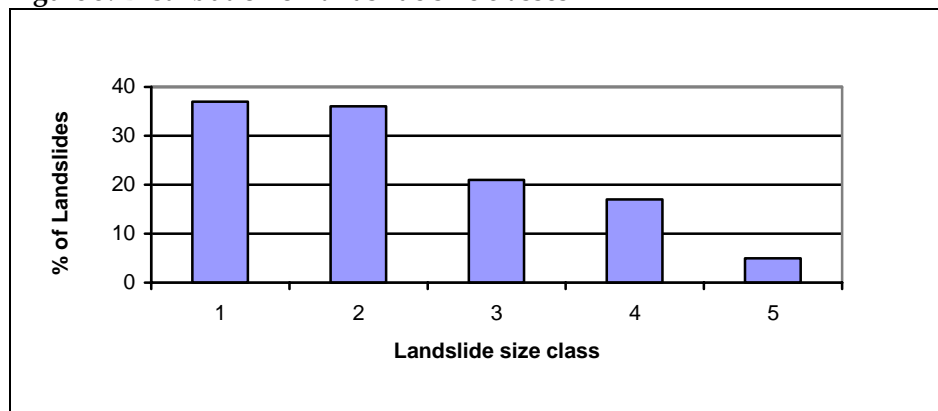
Figure 3: Distribution of landslide size classes

Figure 3 illustrates the distribution of the Code landslide size classes. Small and very small landslides make up 76 percent of the total, while very large landslides are only 5 percent of the total number of landslides.
