**Forest
Practices
Board**

Resource Road Construction in Steep Terrain

Special Investigation

FPB/SIR/47

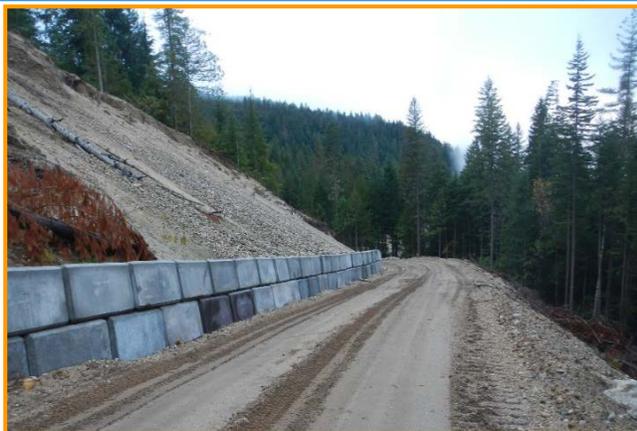
#1 – This is a new road that had professional oversight throughout all stages of construction. The licensee encountered unforeseen ground conditions at the initial construction stage and had to adjust the design and plan, involving a QRP. The end result is a good, safe road.

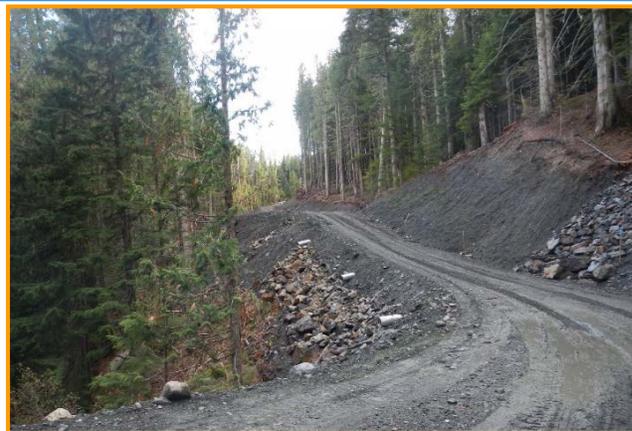
#2 – This is a road segment located through an area of imperfectly drained soils that required additional drainage structures and armoring of cutslopes and culvert outlets to avoid erosion. The work was well done.

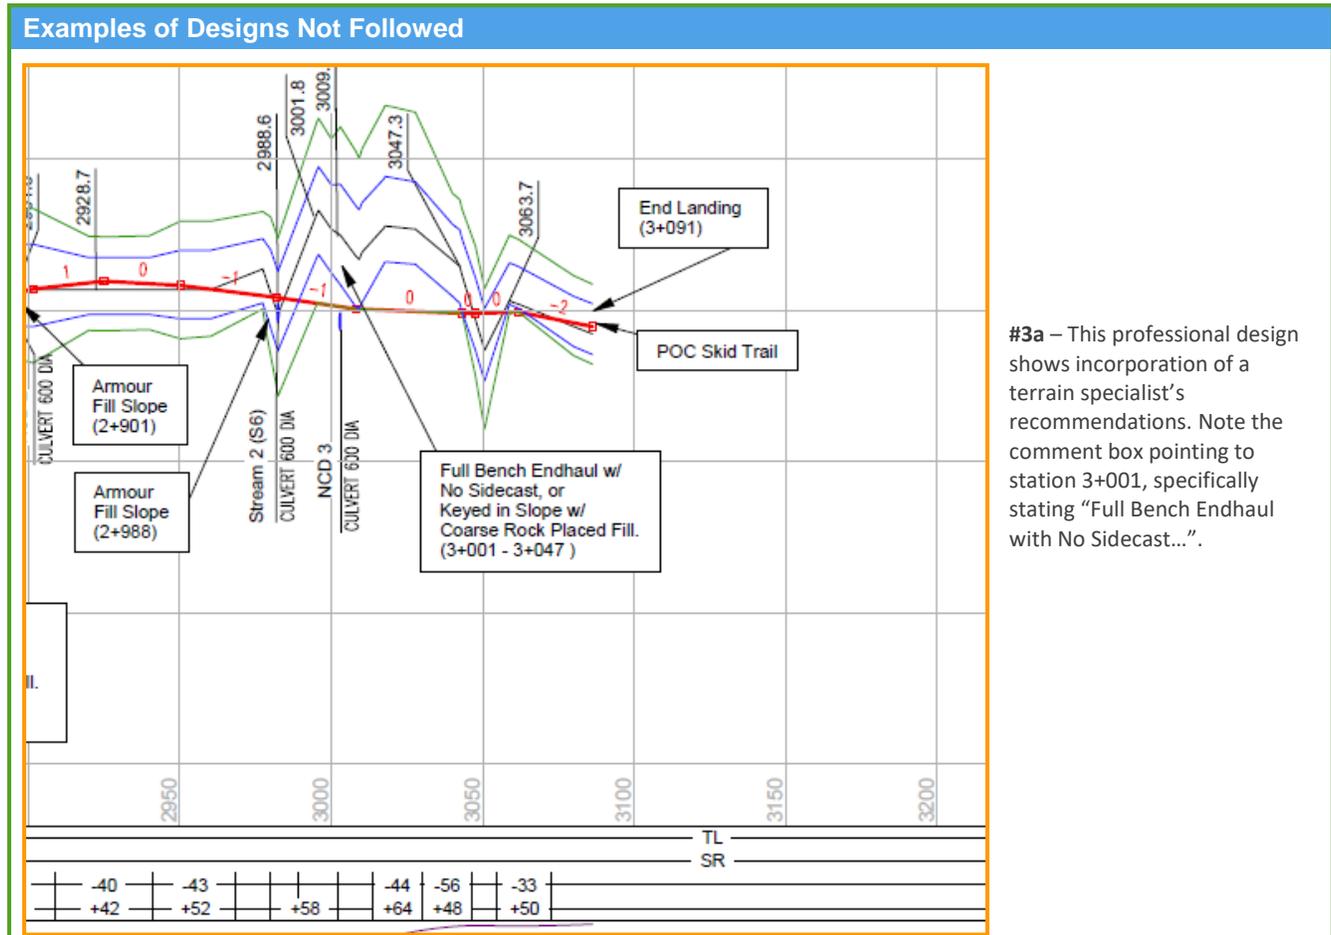
#3a – This professional design shows incorporation of a terrain specialist’s recommendations. Note the comment box pointing to station 3+001, specifically stating “Full Bench Endhaul with No Sidecast...”.

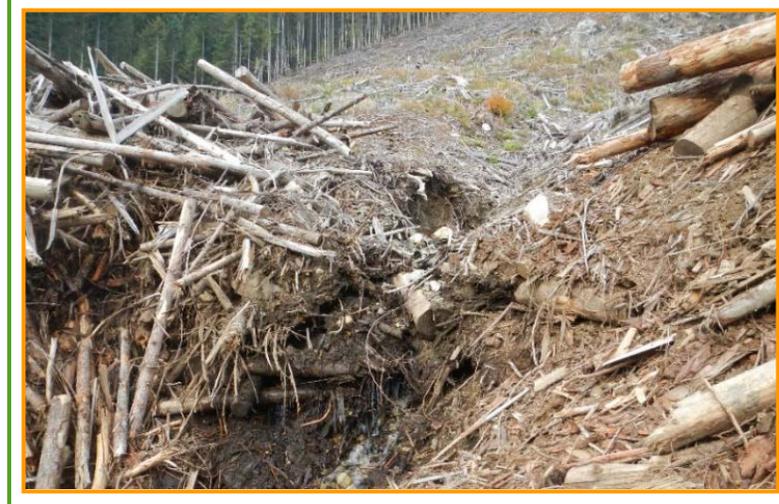
#3b – This is a photo of the actual constructed road at station 3+001. Note the overloaded slopes with no full benching attained and the logging debris cast over the steep slopes. The plan was clearly not followed.
(Photo was taken from downslope of the road looking up to the full bench section, indicating the level of sidecast and perched debris.)

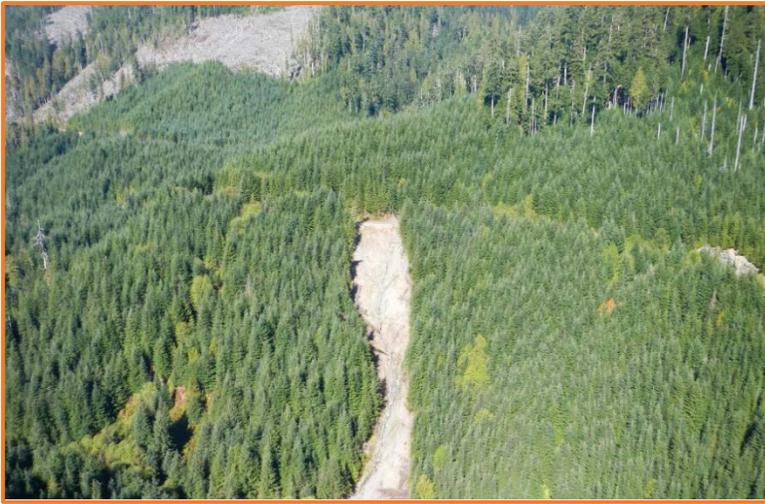
Example #5: Lack of Professional Involvement

The following example shows a lack of professional involvement. An older (pre-1995 Code) road was re-activated in order to access a cutblock. Older road construction techniques, in many cases, involved excessive sidecast of materials over steep, unstable slopes, as well as fill supported by stumps and logs. Over time, drainage structures can collapse or be infilled with debris, rendering them ineffective. This can result in redirected water flows over the unstable slopes.

This photo clearly indicates the results of a re-activated older road without professional assessments prior to use. In this case, redirected water from plugged ditchlines and drainage structures deposited water over the unstable fill slopes during a high precipitation season, resulting in a large debris slide deposited material in a fish stream.

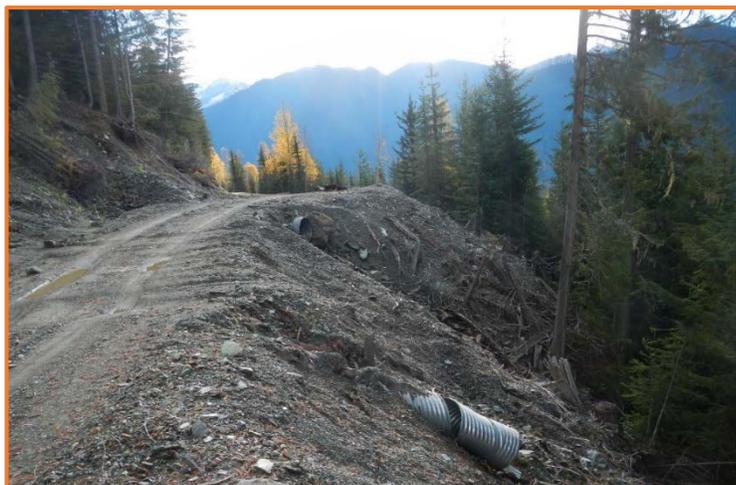
Example #6: Potential for Environmental Damage

The photo below shows a road that was terminated because there were no further plans for use. In this example, investigators were told that there were no plans for deactivation due to the potential costs involved. The photo shows that the road is insloped and the ditches were infilled due to cutslope failures. In addition, this road was constructed with woody debris (puncheon) in the subgrade, which is not a good practice when constructing on steep slopes. The potential for negative environmental impacts at this site will increase over time as the organics decay, and the road prism stability will be compromised.

This road prism is considered a wilderness road with no further plans for extension or deactivation. The road was constructed with organics in the prism, and insloped with ditches infilled due to failing cutslopes. Many of the drainage structures have been damaged or rendered ineffective. There are no plans for any deactivation measures.

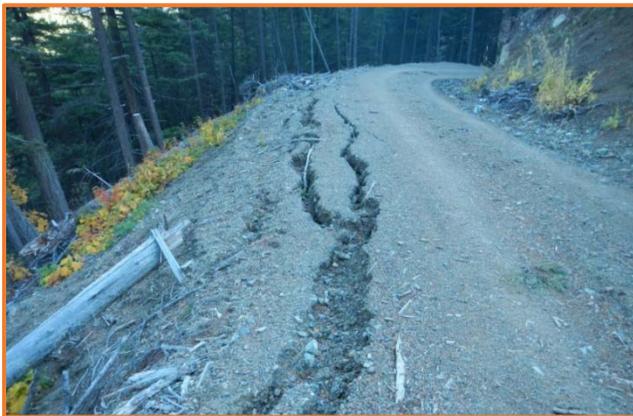
#7 – This photo is an example of fill materials side cast over steep slopes, resulting in tension cracks forming over the outer edges of the road. Lateral movement of the sidecast fill material often results in tension cracks forming along the edge of the road bed, as it did in this example. This is an indicator of an unstable road fill and that the fill may be moving downslope. Infiltration of water into tension cracks during heavy winter rains can trigger the road fill to fail completely. Where roads on steep slopes exhibit such tension cracks, the potential for large landslides to occur increases.

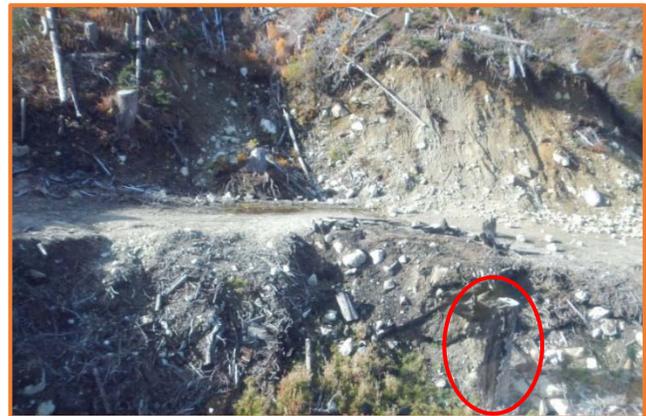
#8 – This is an example of a road segment constructed without any QRP involvement. The road was constructed across slopes greater than 60 percent through a series of draws with erodible soils sidecast over the steep slopes. In these situations, full benching and end hauling of the material is required, in particular at the transitioning zones into and out of the draws. Note the cut off tree in the lower right of the photograph indicating how much fill material was deposited over the slope. This resulted in the road prism failing.
