# Duhamel Creek Hydrogeomorphic Risk Assessment

APEX FILE HA-14-KL-01

January 2015

Prepared for: Tyler Hodgkinson, RPF  
Woodlands Manager  
Kalesnikoff Lumber Co. Ltd.  
Thrums, B.C.

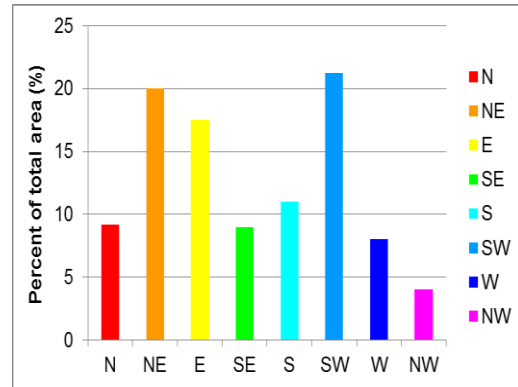
Figure 5. Aspect distribution of Duhamel Creek. Steep gradient east-west aspect slopes result in shading of either side during the spring snowmelt period during portions of the day. (See Figure 6)

A GIS analysis of the watershed indicates that slope aspect is generally east-west. The two major slope aspects are east-northeast (37.5%) and south-southwest-west (40.2%). North aspect slopes represent 9.2% of the total area, southeast aspect represent 9% of the total area while northwest represents 4 % respectively (Figure 5).

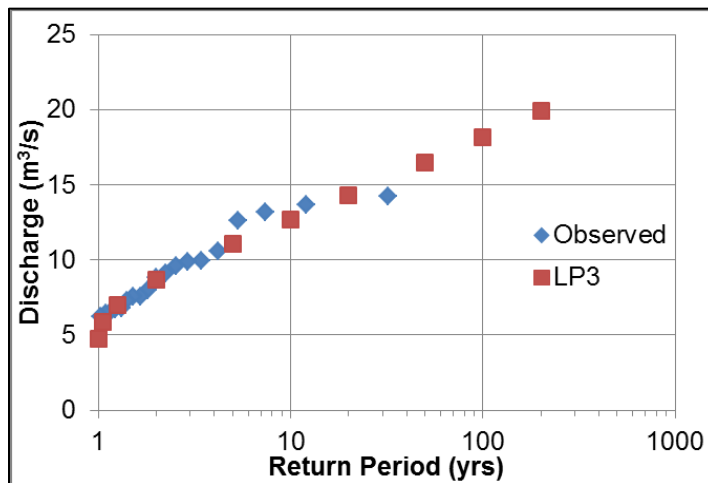
Figure 7. Flood frequency curve. Table on right is ranked historical frequency distribution. 2012 flood was largest flood on record with an estimated return period of greater than 1:30 yrs.

A flood frequency analysis using the 19 year record of peak flows in Duhamel Creek (Env. Canada station 08NJ026 downloaded July 2014 from <http://wateroffice.ec.gc.ca/>) yields the cumulative frequency distribution curve shown in Figure 7. The annual maximum daily flood in 2012, which recorded an average daily discharge of 14.2 m<sup>3</sup>/s, is the largest flood on record for the 19 year period of gauging. A flood frequency analysis using a Log Pearson III frequency distribution suggests that a 1:200 year flood event (minimum event for design works) is likely to reach 20 m<sup>3</sup>/s (Figure 7). A discussion on the possible impacts of climate change on the Duhamel Creek flood frequency analysis and the implications for forest development is presented in Appendix 3.

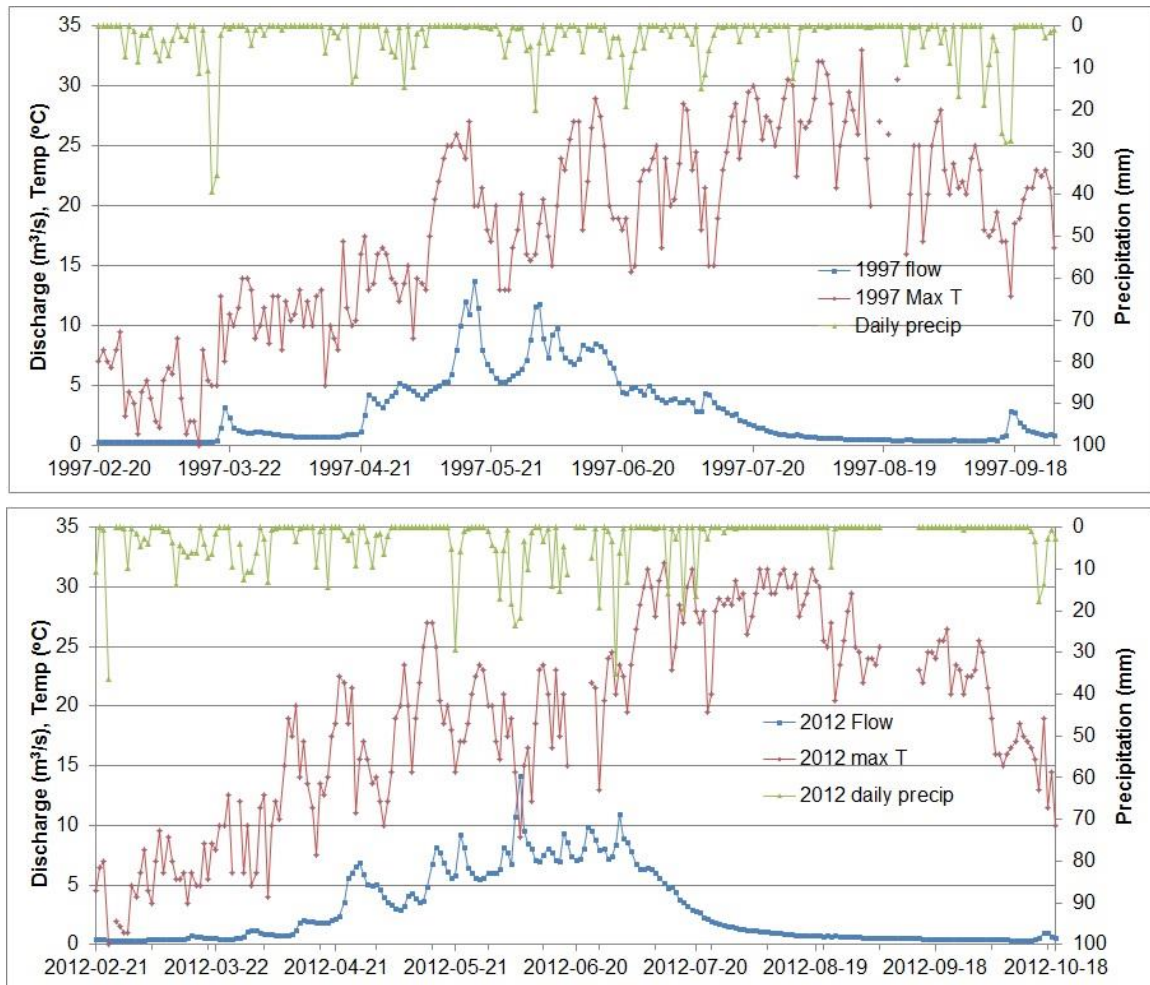
Figure 8. Relationships between temperature, precipitation and discharge in Duhamel Creek reveals that the 1997 flood (top) was due entirely to warm temperatures while the 2012 flood (bottom) was associated with a rain-on-snow event.

(2012) and snowmelt driven by heavy spring rain-on-snow are capable of causing large flood events (Figure 8).

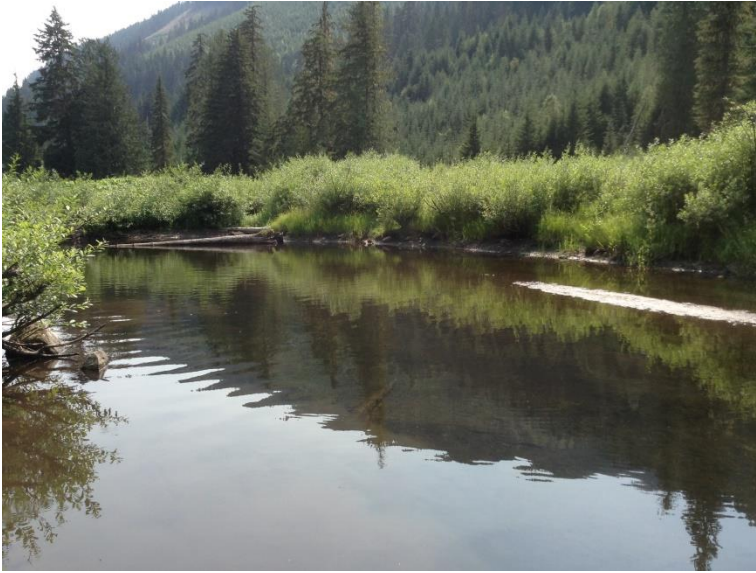
**Photo 1. Duhamel wetlands in Reach 6**

The wide U-shaped valley of Duhamel Creek above approximately 1000 meters elevation contains lakes and beaver dammed wetlands. Colluvial cones of avalanche/debris flow channels impinge into the valley bottom creating confined channel segments interspersed with lakes and wetland areas. The valley gradient ranges from less than 1 percent at lakes and wetlands to 4 percent in confined channel segments between colluvial cones. Mobile bed material is mostly comprised of gravel (<2cm) and sand material but locally increases to small cobbles (12cm) through the steeper (4%), confined channel reaches. Larger angular cobble and boulder material is covered in a thick layer of moss indicating it has not moved or moved very little in the past decade or more.

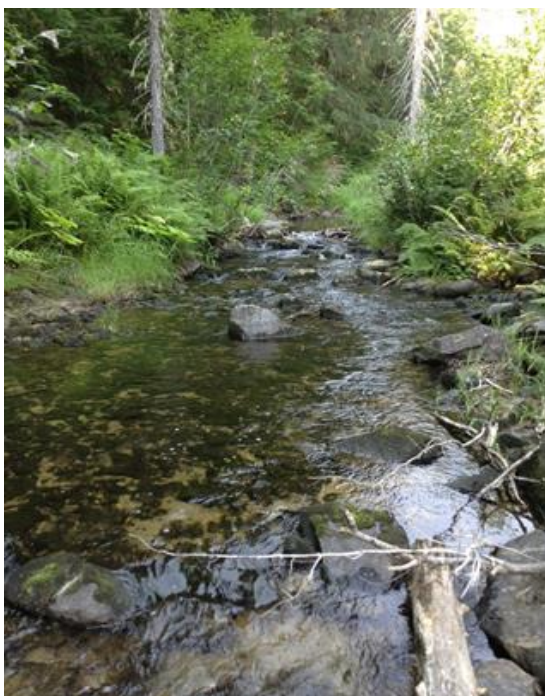
Photo 2. Confined channel segment of Reach 6. Mobile bedload is primarily gravel and sand. Larger angular colluvium in channel is mossy and appears immobile.

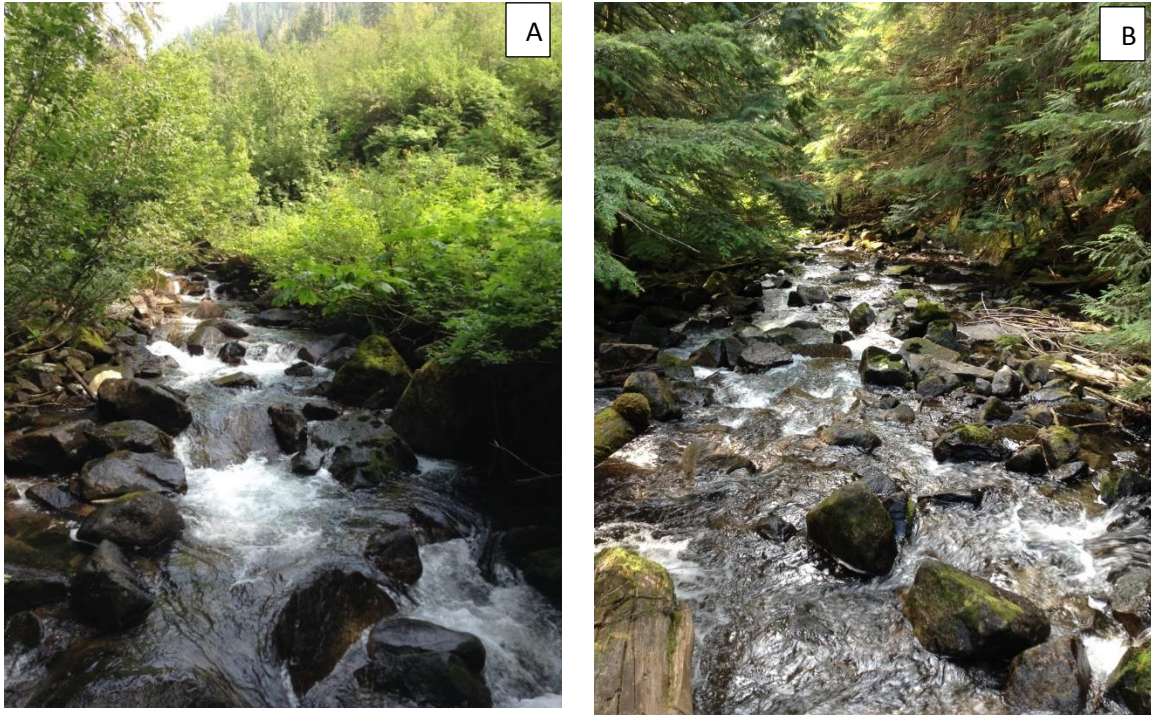
Photo 3. Duhamel Creek looking upstream (A) and downstream (B) in vicinity of survey site 14-14.

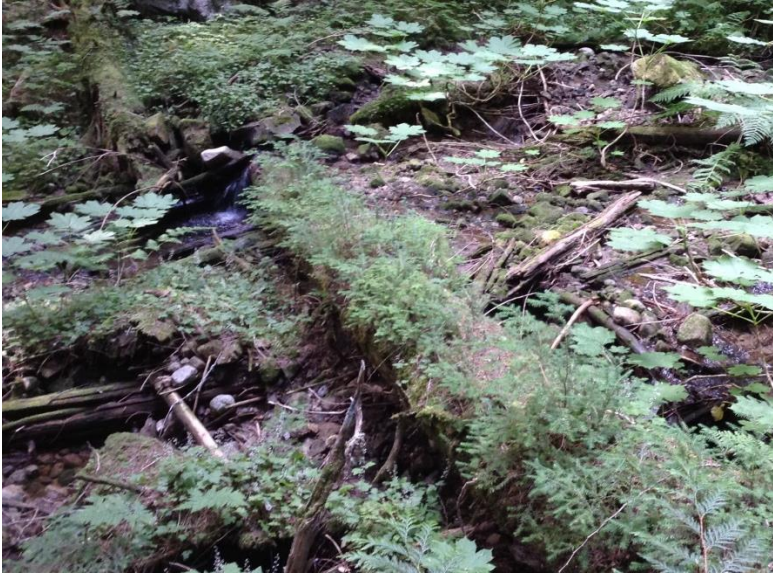
Photo 4. Tributary at Station 14-13 with small cobble and finer bedload is typical of natural sources of sediment to Duhamel annually.

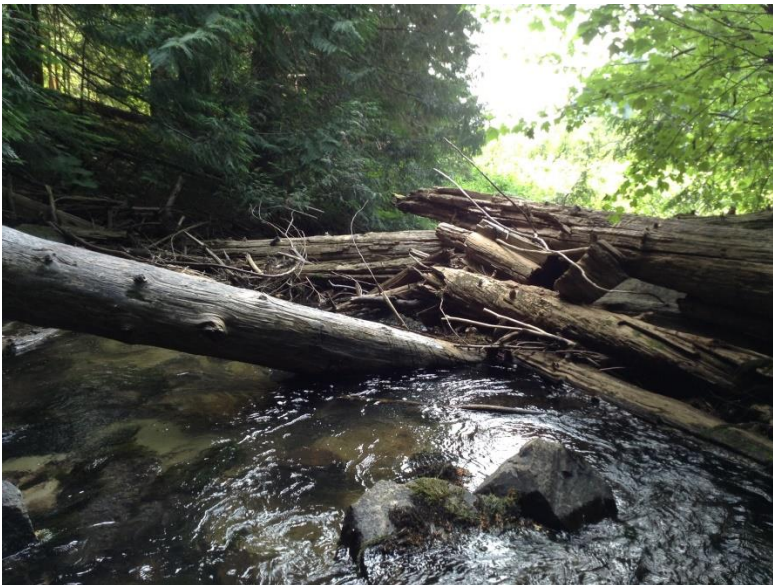
Much of the woody debris in this reach is very old and cut-ends suggest that it entered the channel during old logging activities. Old LWD debris is partially functioning in jams to retain bed sediment but most is broken and oriented parallel to channel margins.

Photo 5. Woody debris jam comprised of old woody debris, some have cut ends. Survey Site 14-16.

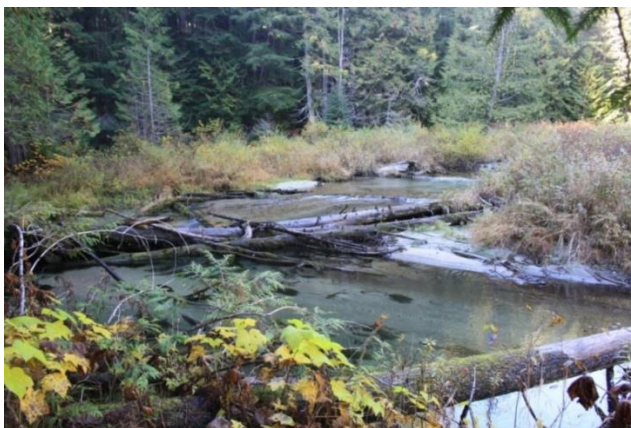
Photo 6. Sites 13-019 (below) and 13-021 (above) display the transition from wetland to step-pool morphology above colluvial cone confined valley bottom. Bedload consists of a very large volume of sand and gravel stored in these low gradient channel segments.

The lower channel gradient segments through Reach 3 contain a large volume of sand and gravel sized bedload that has been transported from upstream reaches. Large volumes of fine sediment are stored in the low gradient wetland sections. Sediment is also entering this section of Duhamel Creek from steep first order tributaries on either side of the valley.

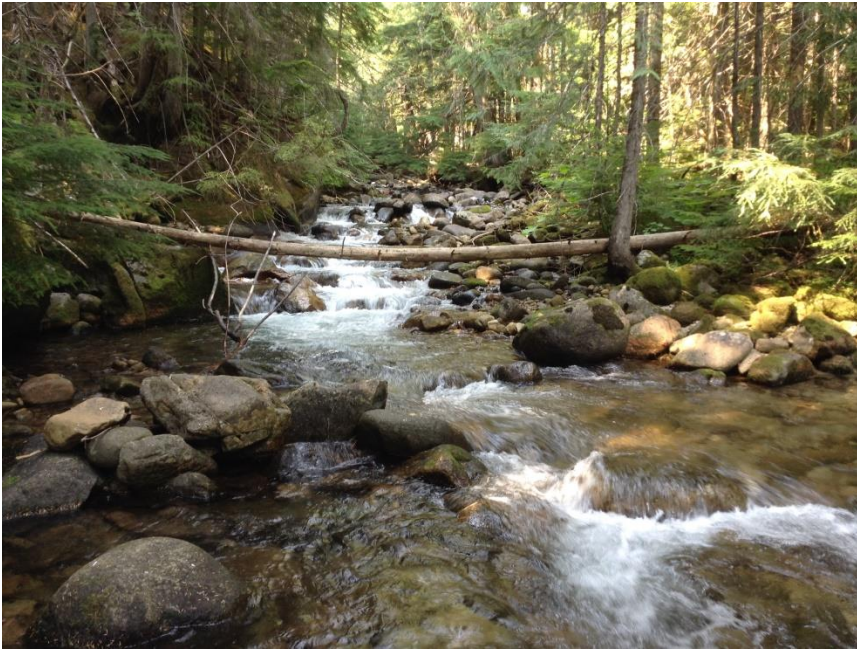
Photo 7. Looking upstream at 13-001.

Reach 2 has a boulder cascade to step pool morphology. Channel gradient ranges from 6 to 12 percent. Channel banks are generally mossy and vegetated but scoured in places due to recent large flood event. The channel is entrenched 1 meter or more into the valley flat and locally confined by bedrock and boulder levees. Most of the sediment in the channel is bright and appears mobile including large boulders up to approximately 80cm in diameter.

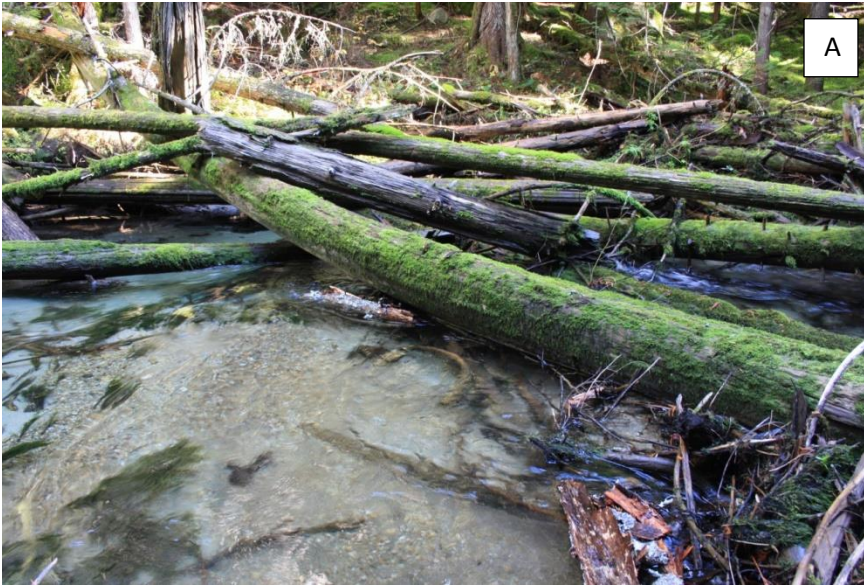
Disturbance indicators in the riparian area and the age of riparian vegetation indicate that the last channel forming flood event occurred roughly 20 to 30 years ago. This event pushed woody debris out of the channel and deposited it parallel to banks, eroded banks and deposited lateral cobble/boulder bars that now are vegetated with mosses, grasses, shrubs and sapling hemlock. The last very large flood that caused extensive disturbance to the riparian area and deposited a boulder levee that is upwards of 1 meter or more higher than the bankfull channel appears to have occurred roughly 50 years ago. This deposit has a mixed stand of birch, hemlock and cedar established on it that are roughly 20 cm (DBH). The largest woody debris jams in this reach of Duhamel Creek appear to have been in place since this last major flood event.

Photo 8. (A) Old LWD jam at Survey site 13-009. light coloured bed is fine sand and gravel stored upstream of the dam. Below: (B) looking downstream towards jam. Jam is roughly 3 meters high on the downstream side.

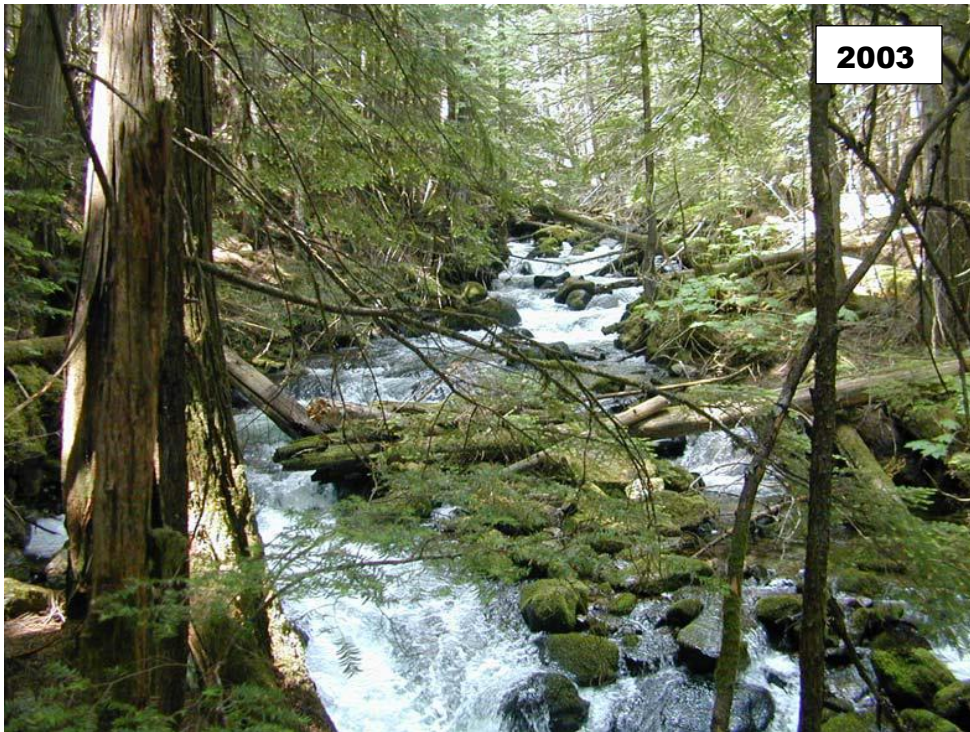
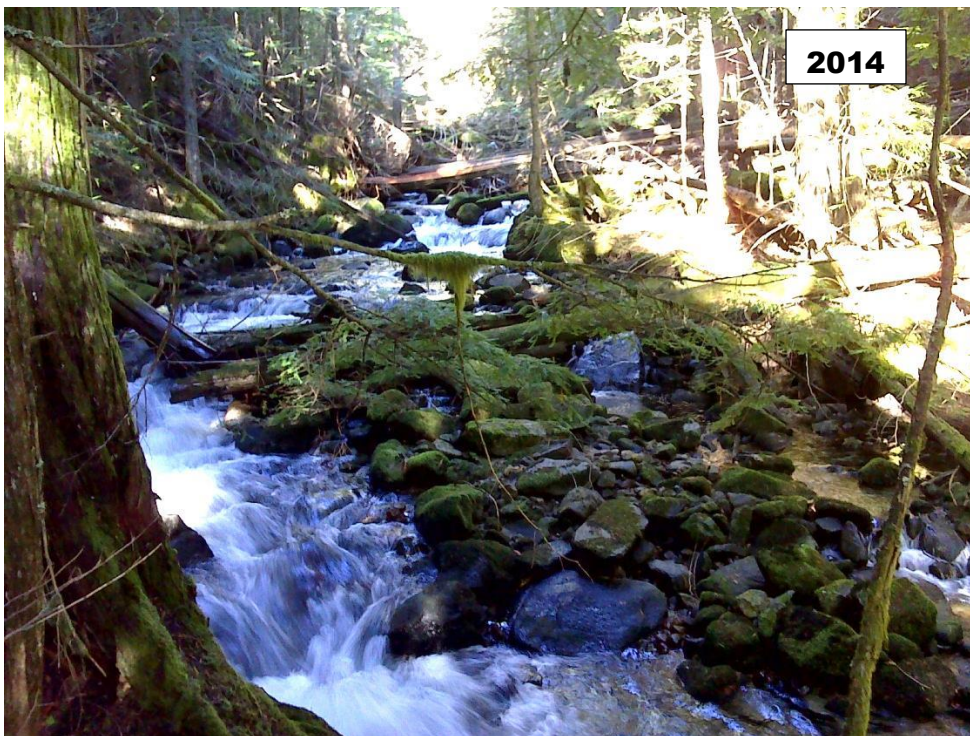
A visual comparison of the Duhamel Creek channel at a survey site immediately up stream of Tributary 1 confluence suggests that there has been no substantial change in channel morphology in this location over the past 10 years (Photo 9).

Photo 9. Photo taken at the same location on Duhamel Creek in 2003 and 2014 provides evidence that there has been no large channel forming flood in Duhamel Creek in the past 10 years.

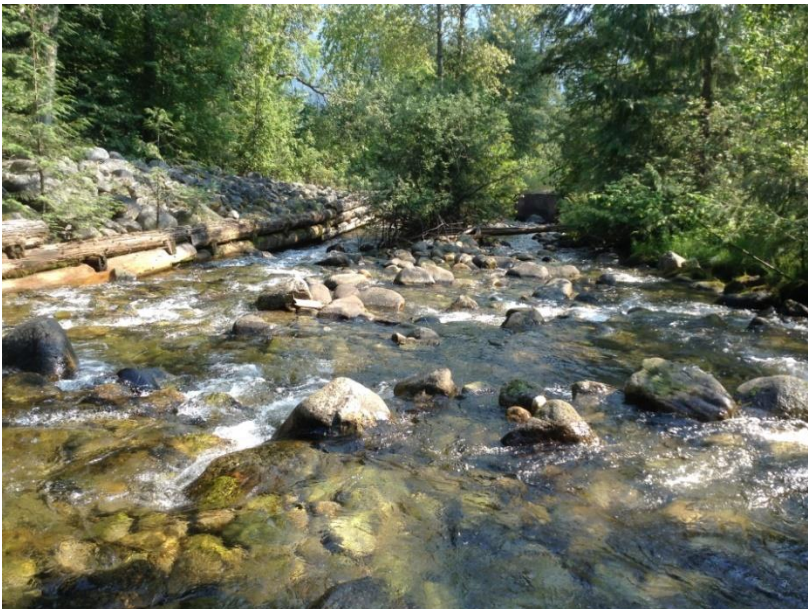
Log crib walls, which appear to have been built immediately after the large flood along the channel margins, are back-filled with the cobble/boulder material in an effort to contain Duhamel Creek in two channels during flood flows. The majority of logs in these crib walls are now rotten and beginning to collapse (Photo 10). Additional cobble/boulder material has been placed on top of the log crib walls in the recent past (2 years) to provide additional containment to the channel.

Photo 10. Looking downstream at 40 to 50 year old log crib wall along eastern bank that was built to contain Duhamel Creek during flood events. Additional material has been added to the top of this crib wall in the past few years.

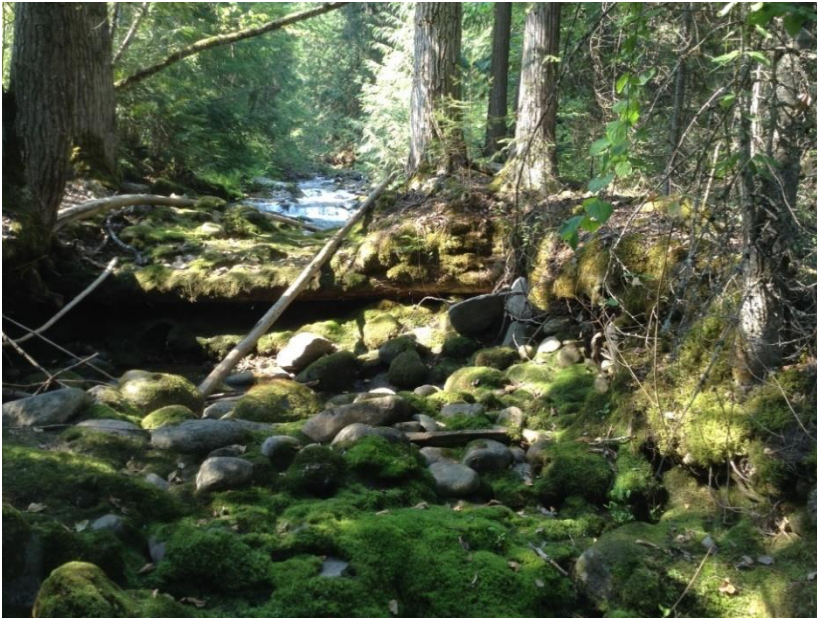
Near the apex of the fan (Site 14-23) disturbance indicators including an abandoned channel indicate that the very large flood that occurred roughly 40 to 50 years ago caused the channel of Duhamel Creek to shift laterally and deposited a cobble/boulder levee along the eastern bank that is approximately 1.3 to 1.5 meters higher than the existing bank full elevation.

Photo 11. Looking upstream near apex of Duhamel fan at old channel of Duhamel Creek that was abandoned during the last large flood (1983?)

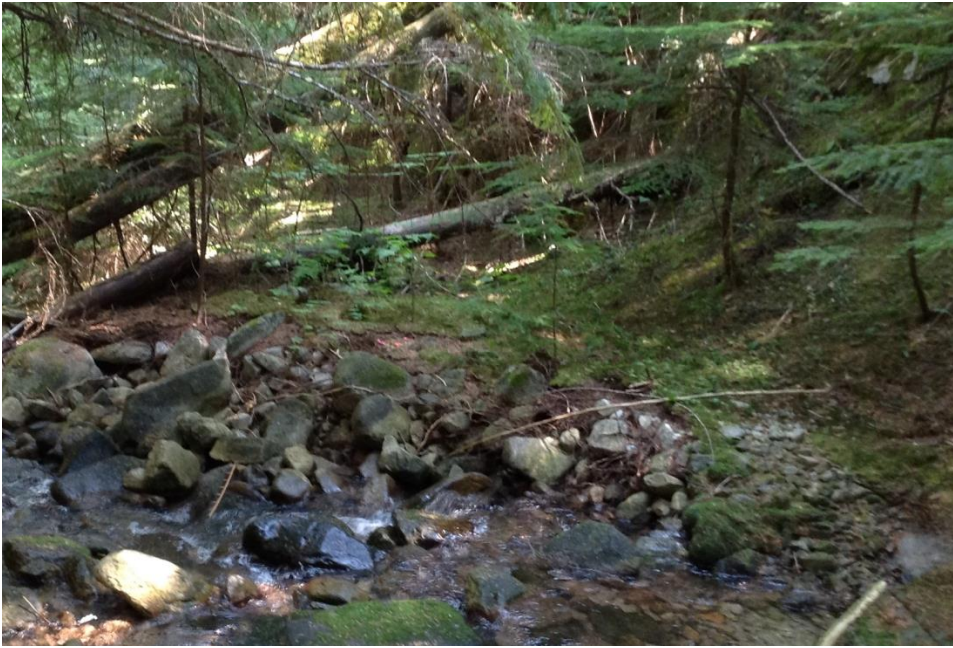
Multiple boulder levees on the fan of Tributary 1 of various ages indicate that the channel of Tributary 1 carries debris floods/flows with an apparent frequency of about 1:20 to 1:50 years. The last debris flood event that mobilized boulder-sized sediment and woody debris appears to have occurred roughly 20 to 30 years ago. Boulder levees from this last debris flood are moss covered and have 3 meter high hemlock saplings established on them (Photo 12). Archived hydrometric data for Duhamel Creek and nearby Five-Mile Creek, together with climate data for Nelson (NelsonNE climate station), show that large flood events occurred in 1983 and 1997 and that these floods were due to rapid snowmelt following several consecutive days of exceptionally warm spring weather.

Photo 12. Looking downstream at vegetated boulder deposit from last large debris flood. Age is estimated at between 20 and 30 years on the basis of vegetation.

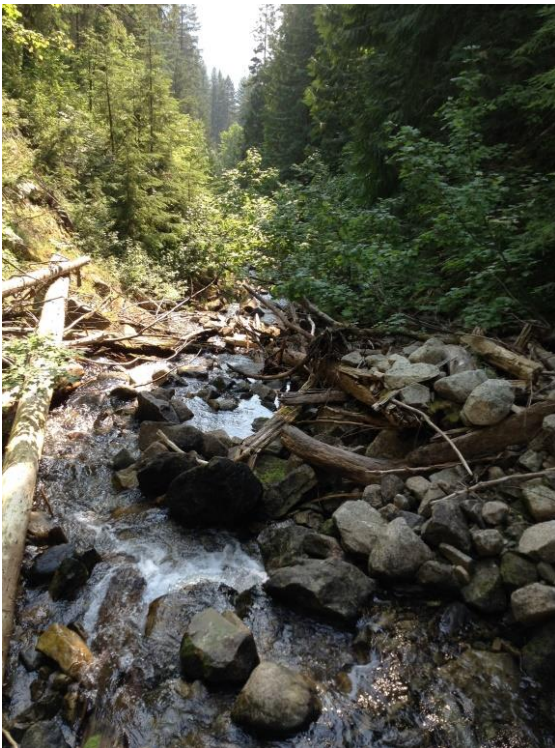
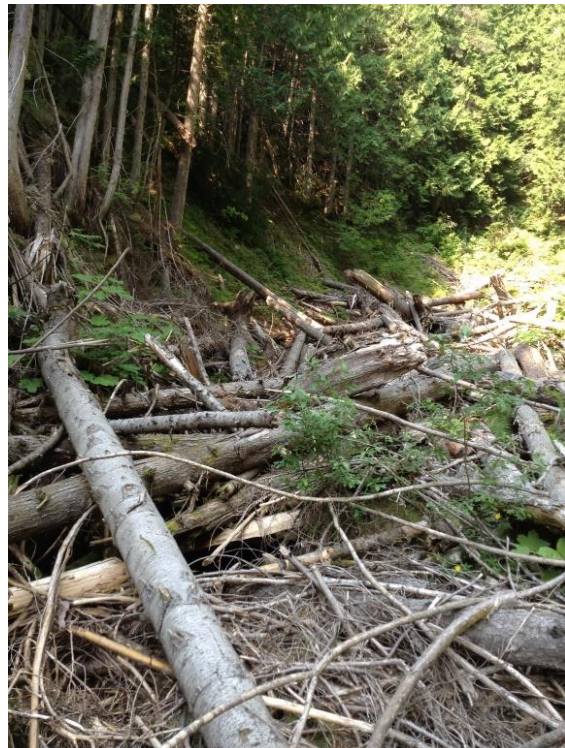
Photo 13. Looking downstream (left) and upstream (right) on Tributary 1 at the mid elevations. Survey site is located just at the bottom end of a large recent (2012) snow avalanche deposit of broken LWD.

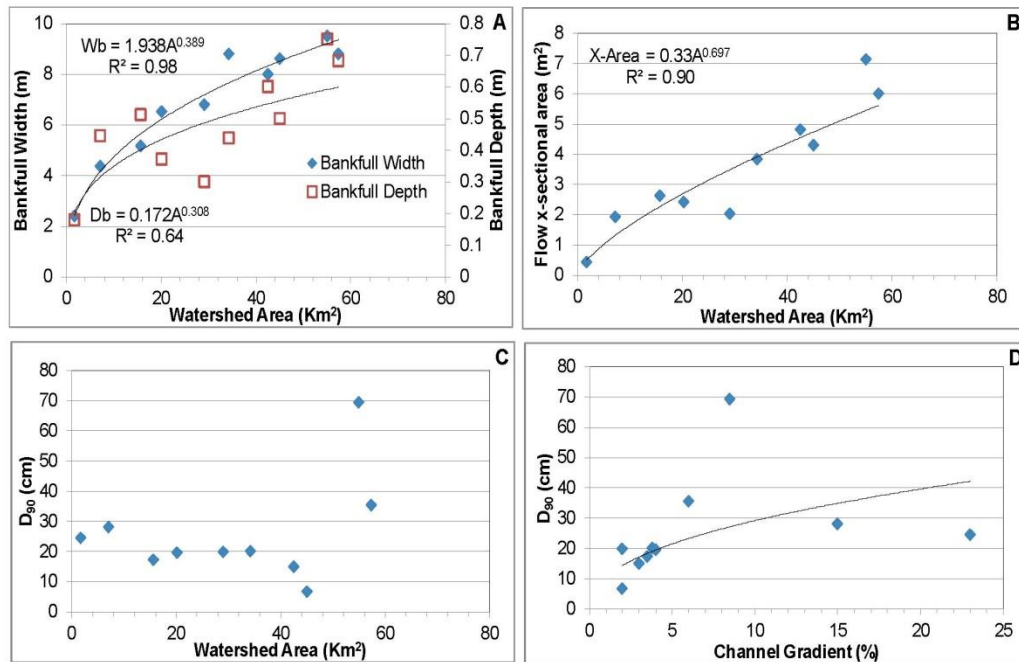
and watershed area is somewhat weaker ( $R^2 = 0.64$ ) but typical for coarse textured mountain streams.

Figure 10. Hydraulic geometry of Duhamel Creek (A,B) defines a robust power law relation between channel width and watershed area. The higher degree of variability between bankfull depth and watershed area is typical of coarse textured mountain streams. The graphical representation of maximum mobile grain size and watershed area highlight the effect of dozens of colluvial cones (1) on the sediment supply along the length of Duhamel Creek and (2) channel gradient. The large jump in mobile grain size at 55 Km<sup>2</sup> corresponds to the confluence of Tributary 1. The poor relation between channel gradient and maximum mobile grain size also relates to the effect of the colluvial inputs.

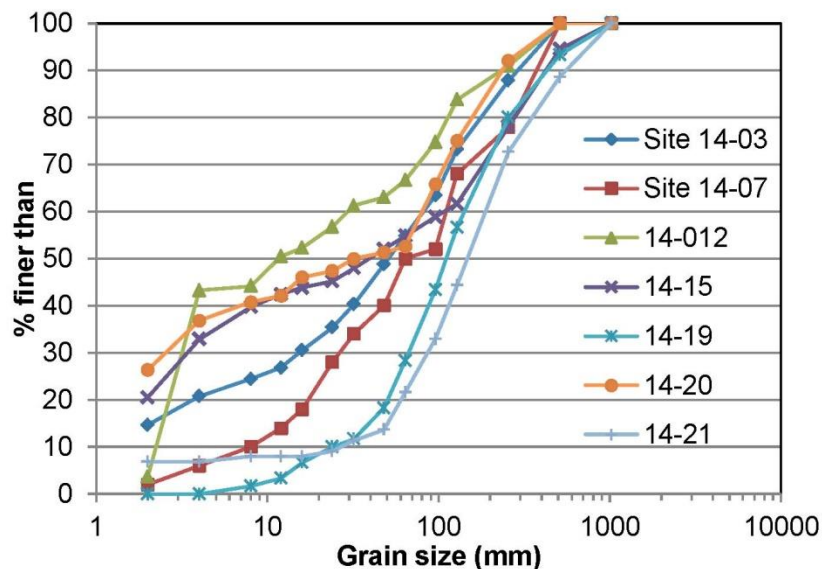
Despite the lack of a trend between maximum mobile grain size and watershed metrics there is a general coarsening of the channel bed in the downstream direction (Figure 11). Grain size distributions for 7 sites determined using the method of Wolman pebble counts are ordered from the upstream-most site (14-03) to the most downstream site (14-21). This figure shows that sites 14-19 and 14-21 (with curves furthest to the right) have the coarsest channel beds. It is interesting to note that site 14-12, which is downstream from sites 14-03 and 14-07 has the finest textured bed of all the sites. The fine textured bed at 14-12 reflects the fact that this site is situated immediately below the beaver-dammed wetland reach directly upstream from the confluence of Tributary 2. Sites 14-03 and 14-07 are located upstream from the wetlands and, for this reason, have less fine grained material in their bedload.

Figure 11. Channel bed grain size distribution along Duhamel Creek. Sites are in order from upstream (14-03) to downstream (14-21). Graph shows that the channel bed is generally becoming coarser.

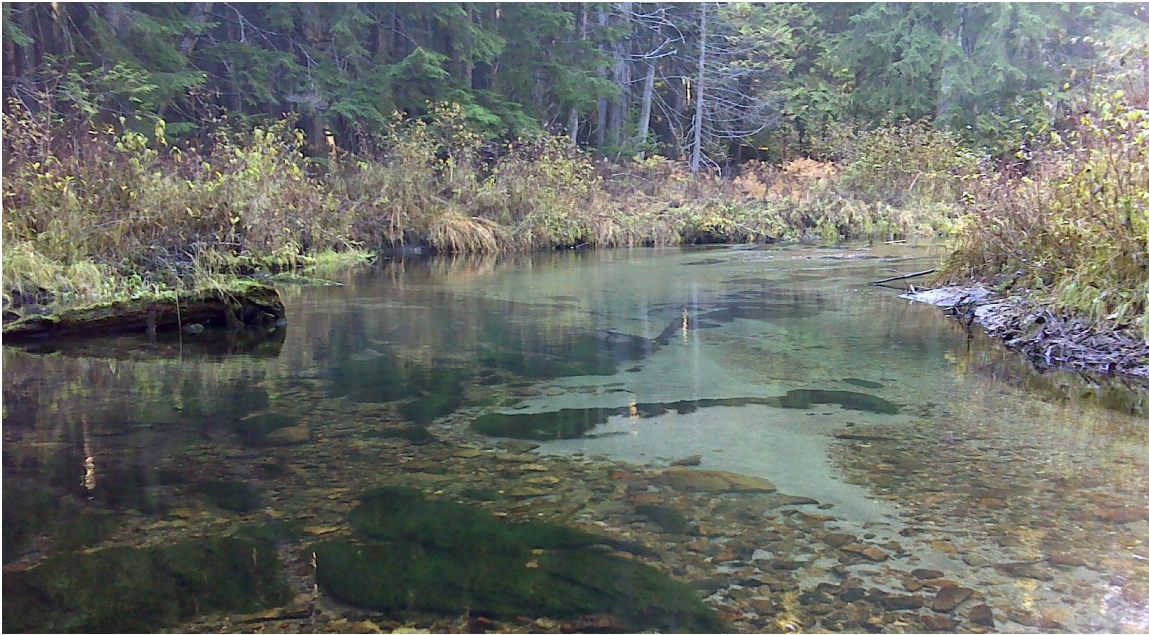
Photo 15. Typical wetland segment with sand, gravel and small cobble bed.

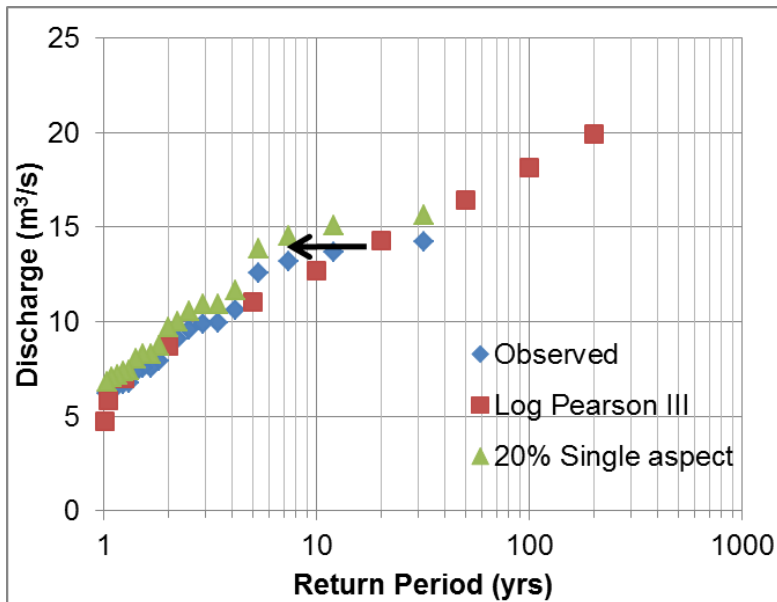
the hazardous event (20 year return period flood) by over 2 times (20 year to about 7.5 year RI) (see black arrow in Figure 13). This increases the probability of a damaging flood from moderate to high (Table 2).

Figure 14. Hypothetical change in frequency if harvesting of 20% of the watershed area is concentrated on a single aspect slope. The blue diamonds show the ranked distribution of floods from the actual 19 years of flow data from Duhamel Creek. The red squares show the estimated flood frequency distribution using the Log Pearson III function which is calculated using the 19 years of gauging in Duhamel Creek. The green triangles show the estimated ranked distribution of floods given an 8% increase in flood magnitude across the full range of return periods.

Hydrological modeling undertaken in Redfish Creek suggests that harvest levels below approximately 20% when situated across aspects in the lower third of the watershed will not result in detectable changes in the frequency distribution of floods (i.e. have a low likelihood for increasing the existing frequency of the hazardous event). Currently the majority of blocks in Duhamel Creek are situated on a single aspect (E - NE). Concentrating harvesting on a single aspect is more likely to increase synchronization of runoff from a watershed compared to distributing blocks across aspects. A recent study by Green and Alila, 2012 found that the effects of harvesting on the flood regime are increased where harvesting functions to increase the synchronization of runoff from slopes. To maintain a low likelihood of altering the frequency of larger floods it is recommended that harvest levels in Duhamel Creek be limited to less than 20% and any future blocks should be planned so as to balance the cut across aspects on slopes below 1350m elevation.

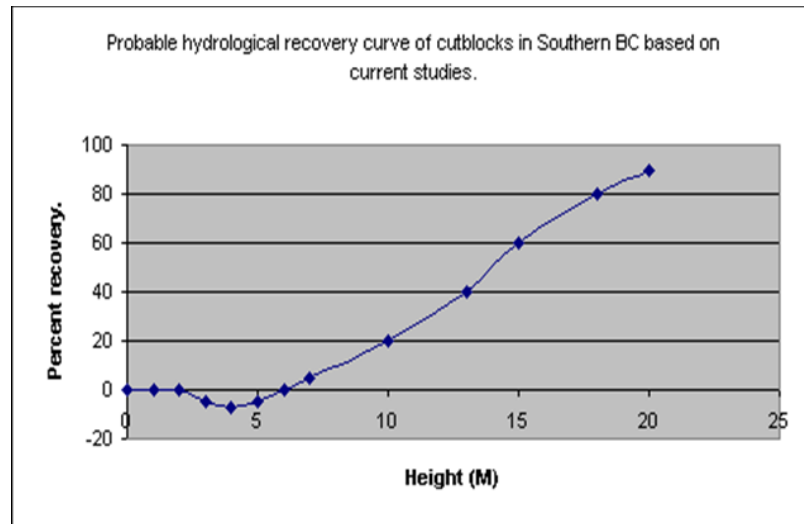
- While this graph shows hydrological recovery by height in meters - it is probably more accurate to represent height as a percentage of the height of the unharvested stand rather than an absolute value.
- Crown closure (or canopy density) is an important factor in hydrological recovery. Studies suggest that crown closure must reach upwards of 30% (absolute) or 50% of the unharvested stand before recovery of melt rate begins. Regenerating stand with low basal area relative to the forest will take longer to recover. Stands with higher basal area will probably recover faster.
- This curve is likely to be substantially different for blocks with north, south, east and west aspects. Much more research is necessary to understand the effect of slope aspect on recovery
