**Forest  
Practices  
Board**

## **Audit of Timber Harvesting, Road Construction, Maintenance and Deactivation**

*Western Forest Products Inc.  
Tree Farm Licence 39/Block 6*

**FPB/ARC/107**

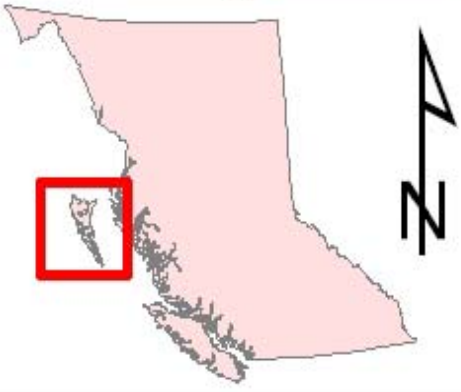
-   TFL 39
-   Water
-   Road
-   Ferry Route

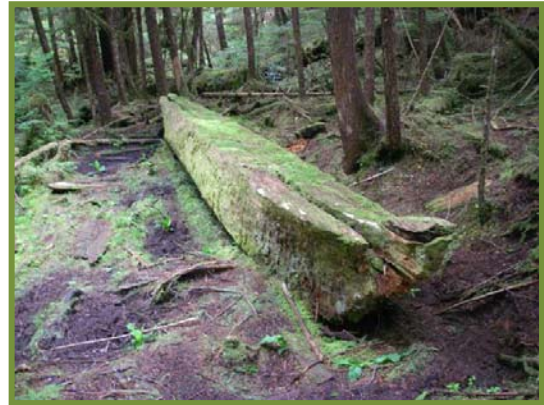
Figure 1. Skedans Bay on Louise Island within TFL 39.

Figure 2. Unfinished Haida canoe.

- the referral of cultural heritage resource (see example, Figure 2) information to the Council of the Haida Nation;
- strategies for sediment control during road construction in community watersheds, such as the Honna community watershed; and
- reserving suitable marbled murrelet nesting habitat, as defined in the land use agreement.

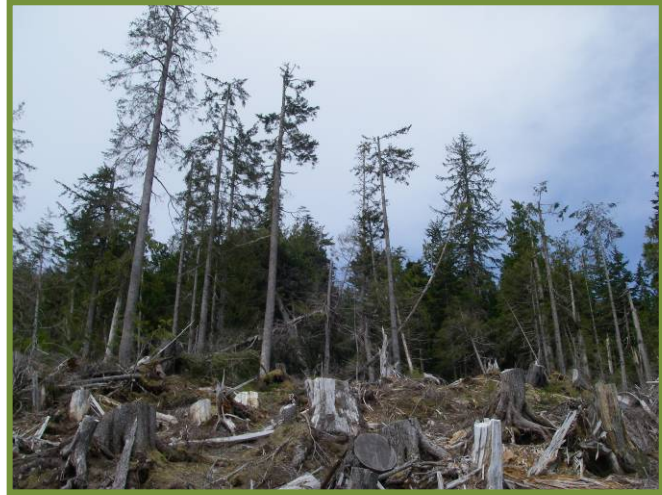
Figure 3. Tree topping in a riparian management zone to reduce the potential for windthrow.

In all significant respects, riparian management zones and riparian reserve zones were established and managed as required under FRPA. In particular, the audit team observed numerous examples of high-intensity treatments—such as topping of selected trees in an effort to minimize windthrow damage—in the riparian management zone adjacent to fish streams (see Figure 3).

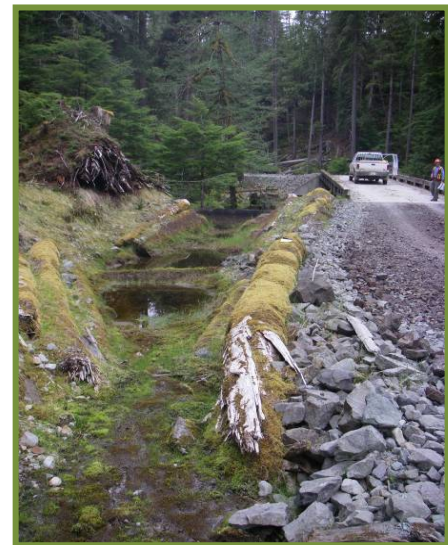
Almost all roads assessed, with the exception of those on Louise Island, were capped with ballast rock (see Figure 4). While this practice adds significant costs to road construction, it is necessary to support off-highway logging trucks. However, a significant secondary benefit of this practice, observed during the audit, is the reduction of road surface erosion, which in turn reduces sedimentation of streams.

As well, the audit team observed numerous cut slopes, fill slopes and ditches that had been well seeded, particularly on the approach to major and high-value fish stream crossings (see Figure 4). Grass seeding is an erosion control measure intended to bind soil particles, reducing erosion from gravity, rain and wind.

Figure 4. Settling basins and grass seeding on approach to high-value fish habitat.

The audit team also observed several examples where sumps and check dams were strategically positioned in ditches on approach to high-value fish streams (see Figure 4). These structures reduce the water velocity in ditches, causing sediment to drop from suspension prior to entering the stream.

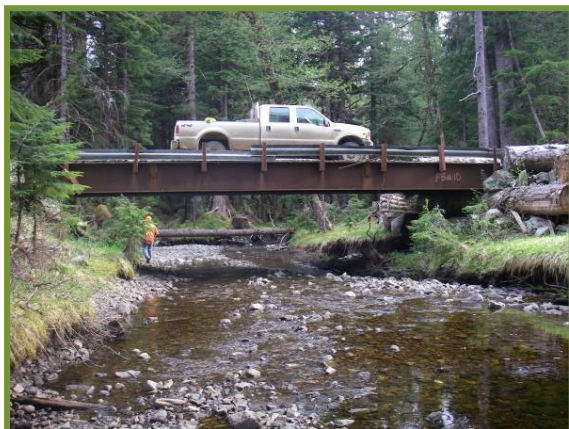
Figure 5. Bridge abutments set well back from the high water mark.

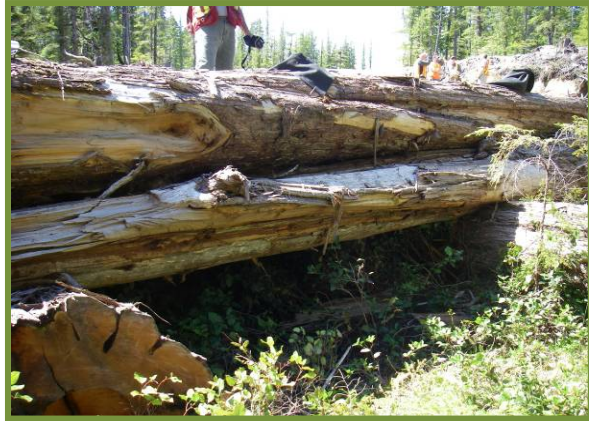
Figure 6. Open bottom structure (wood box culvert) on a small fish stream.

With few exceptions, crossings on smaller fish streams (i.e. S3<sup>v</sup>, S4<sup>vi</sup>) were constructed with wood box culverts (see Figure 6). If properly sized, these open bottom structures provide fish passage at all stages of life and ensure the natural downstream movement of bedload and woody debris.

All wood box culverts inspected during the audit provided for fish passage.

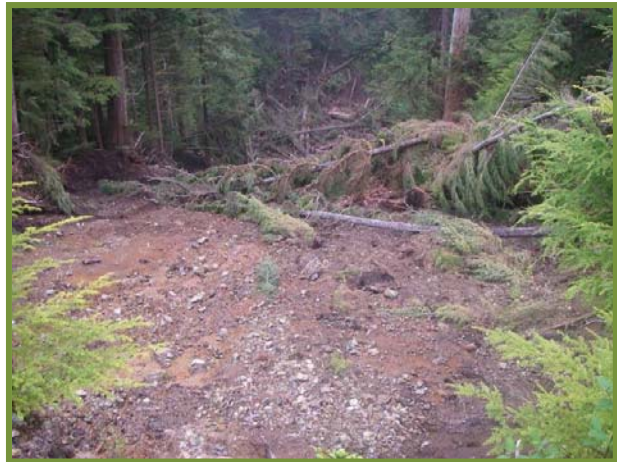
While some of these old road systems were appropriately deactivated through funding by Forest Renewal BC<sup>vii</sup> (FRBC) in the mid 1990s—and continue to be deactivated today using Ministry of Forests and Range Forest Investment Account<sup>viii</sup> (FIA) funding—many of these roads have not been deactivated (see Figure 7). In some cases, the older deactivation has proved ineffective, and these old roads are now causing harm to the environment through road failures causing landslides.

Figure 7. Landslide from an old road depositing into an important fish stream.

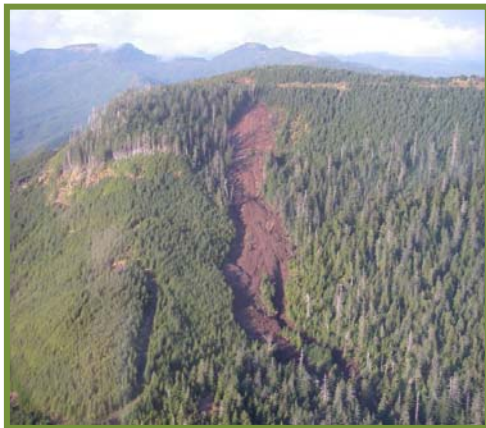
Figure 8. A landslide initiated from a pre-Code road deactivated during the mid-1990s.

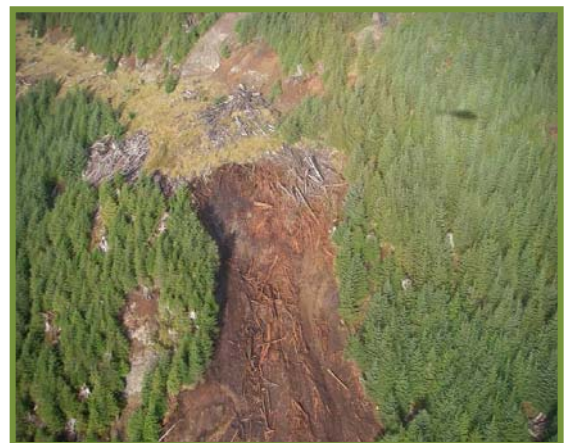
As neither WFP, nor any of the former tenure holders on TFL 39/Block 6, have used these old road systems since June 1995, WFP is not obligated to ensure their stability. Some of these old roads, constructed in the 1960s, 1970s and 1980s, continue to trigger slope failures. Some of these slides were seen during the course of the audit, and some occurred subsequent to the audit (see Figures 8 and 9). Some of these failures are directly, and likely significantly, impacting important fish-bearing streams.

Figure 9. A landslide initiated from a pre-Code road deactivated in the mid-1990s.
