**Forest
Practices
Board**

Forestry Audit: BC Timber Sales and Timber Sale Licence Holders

*Stuart-Nechako Business Area
Fort St. James District*

May 2013

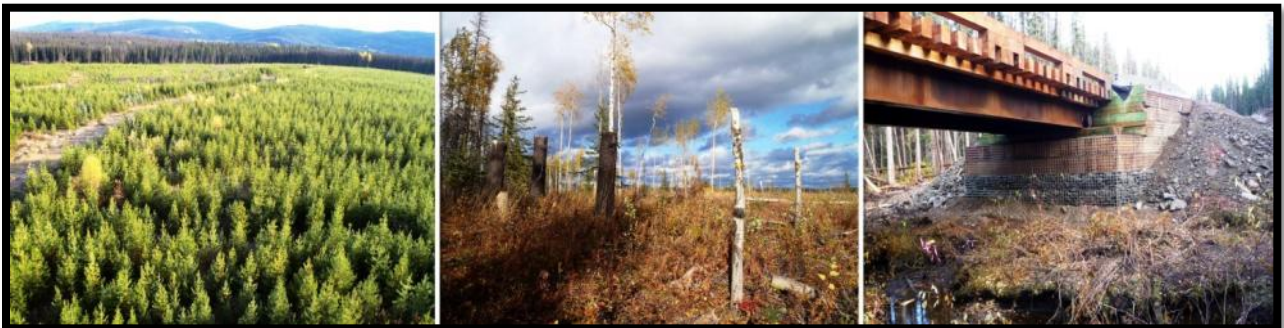
A free growing plantation near Fort St. James.

Stubbing trees and marking a machine-free zone to protect a cultural site.

Bridge construction over a fish stream.

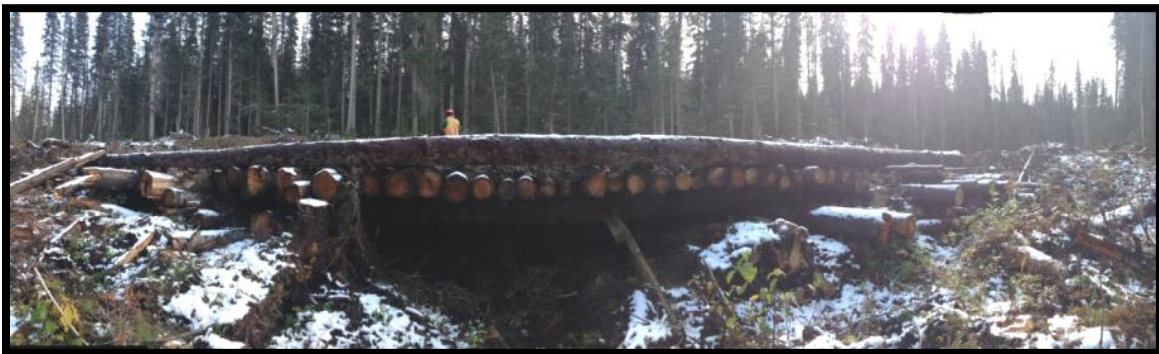
A TSL holder, Larworth Logging Ltd. (Larworth), built a 1.2 kilometre section of road under a road permit to access timber sale licence A86644. The road construction included installation of a log culvert to cross a fish-bearing stream. A professionally prepared road plan specified that the culvert installation was to meet the design criteria in Section 4 of the 2002 *Forest Road Engineering Guidebook*.² Auditors found that the culvert did not meet the design requirements.

Overview of the log culvert installation.

Section 72 of the *Forest Planning and Practices Regulation*ⁱ (FPPR) requires that a person who constructs a road must ensure that the culverts associated with the road are structurally sound and safe for use by industrial users. To meet the safe load rating of 64 tonnes (CL-625ⁱⁱ), for a structure with a span of 6 metres, the culvert design specified that the installed log stringers were to be a minimum of 675 millimetres in diameter; when installing the culvert, Larworth used 500 millimetre stringers spanning 6.5 metres. After the audit, Larworth commissioned a

post-construction inspection that, because of these deficiencies, recommended the culvert load rating be conservatively reduced to 27 tonnes, which does not meet the safe load rating required for hauling logs. Larworth did not meet the design requirements when installing the log culvert and, as a result, did not comply with section 72 of FPPR.

Subsequent to the audit, Larworth commissioned a post-construction inspection and certification of the culvert to ensure the safety of lighter industrial and public use of this road.

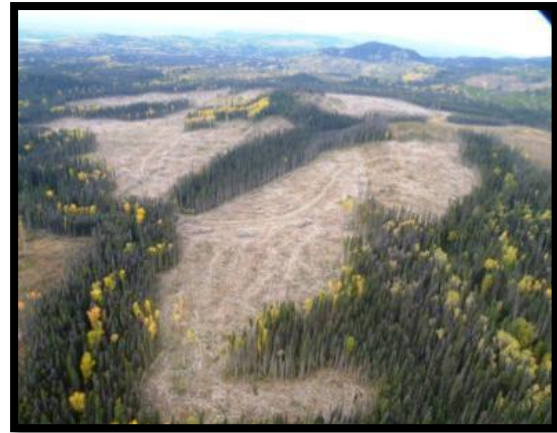
A typical cutblock in the Fort St. James District

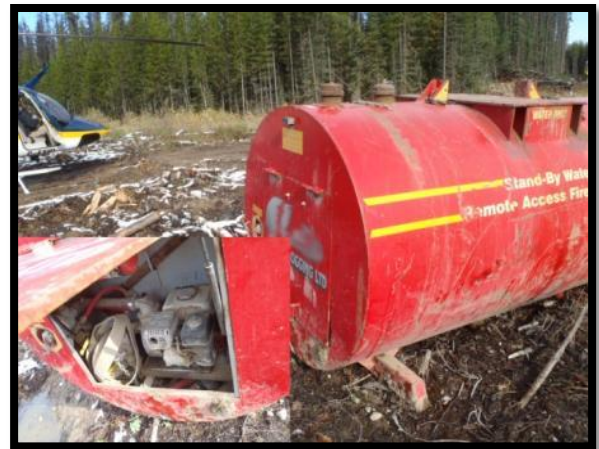
Two active TSL holder operations were reviewed and, at the time of the field inspection, both operations had sufficient fire tools and a functional water delivery system on site.

Water delivery system on an active logging site.
