**Forest
Practices
Board**

Harvest Planning and Practices in the Hunaker Creek Watershed

Complaint Investigation #121022

January 2014

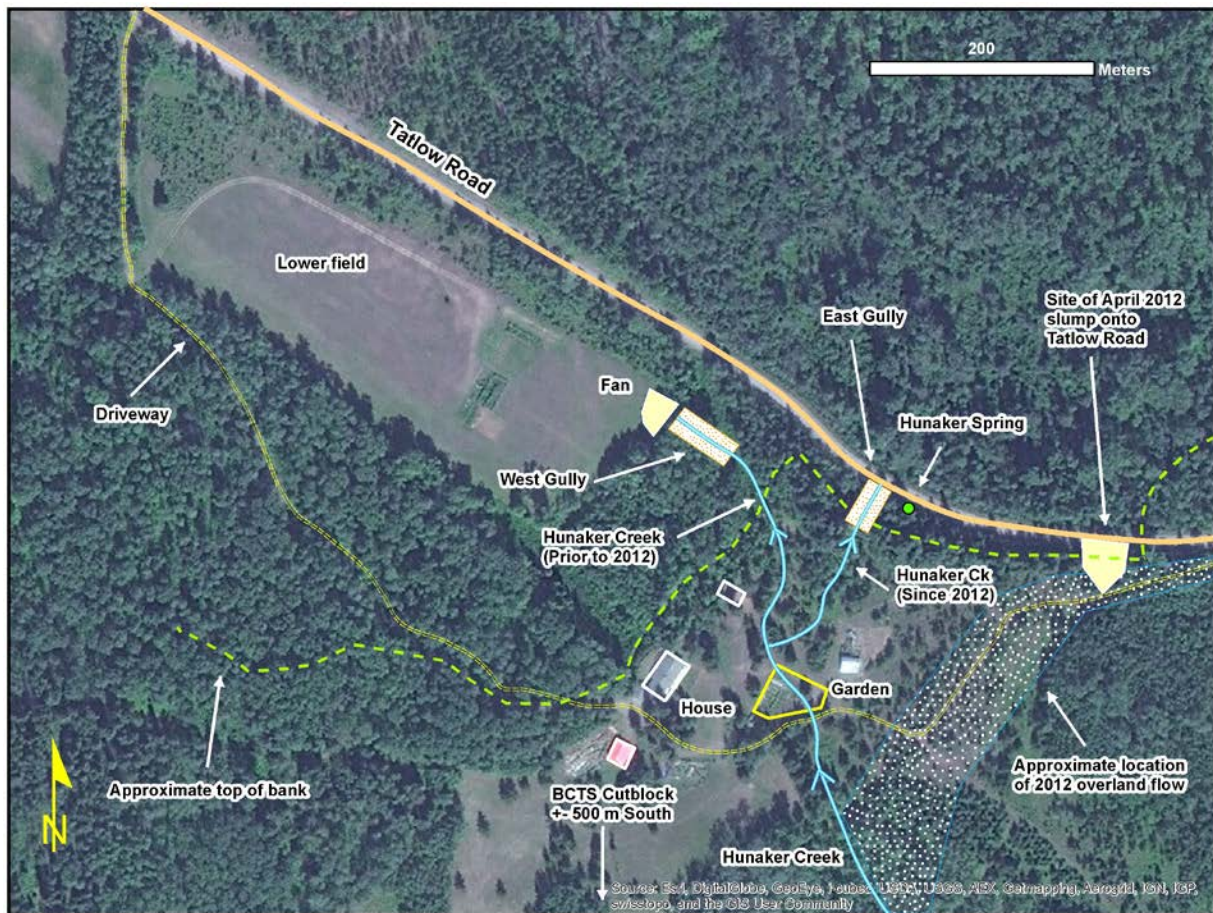
Figure 2. Site details.

In about 1990, a previous owner of the property diverted the creek to lead it from the east gully to the west gully (Figure 2). The current owner says that when he took up residence in 2004, he saw no

erosion evident and high spring peak flows only started eroding the gully in 2009, leading to formation of a fresh alluvial fan in the lower field.

A rare phenomenon occurred during the spring 2012 freshet. On April 14, water-logged snow acted like a dam, inhibiting water flow in Hunaker Creek and causing flooding and overland flow on the complainant's property. The pooled water flowed over the hillcrest in a new location—a slope above Tatlow Road—where it caused a minor landslide and washout, temporarily closing Tatlow Road. The location of the overland flow is shown on Figure 2.

Before the 2012 spring freshet, BCTS rerouted the stream to the location it was in prior to the 1990 diversion, the east gully. Since this redirection back to the east channel, there has been no additional erosion in the west gully or soil deposition in the lower field.

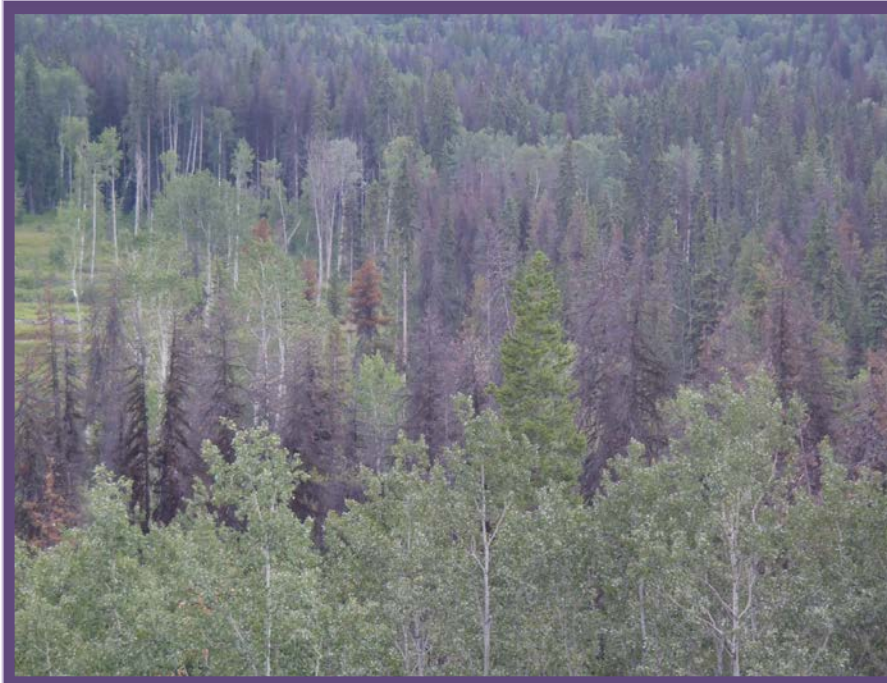
Figure 4. MPB affected forest near the BCTS cutblock, August 2012.

Recent research also indicates that affected pine cease to transpire (release water vapour) within weeks of being attacked by MPB.^v The resulting reduction in transpiration makes more water available for runoff and infiltration to groundwater.

MPB damage was clearly evident when the initial timber cruise was completed for the cutblock in 2007. At that time, lodgepole pine, which comprised 91 percent of the timber in the cutblock, was classified as 17 percent green attack (recently attacked) and 3 percent red and grey attack (older beetle attack). By early 2009, 50 percent or more of the lodgepole pine trees in the cutblock had been attacked by MPB.³ Board staff observed continued MPB activity in unlogged parts of the watershed during site visits in 2012 and 2013.

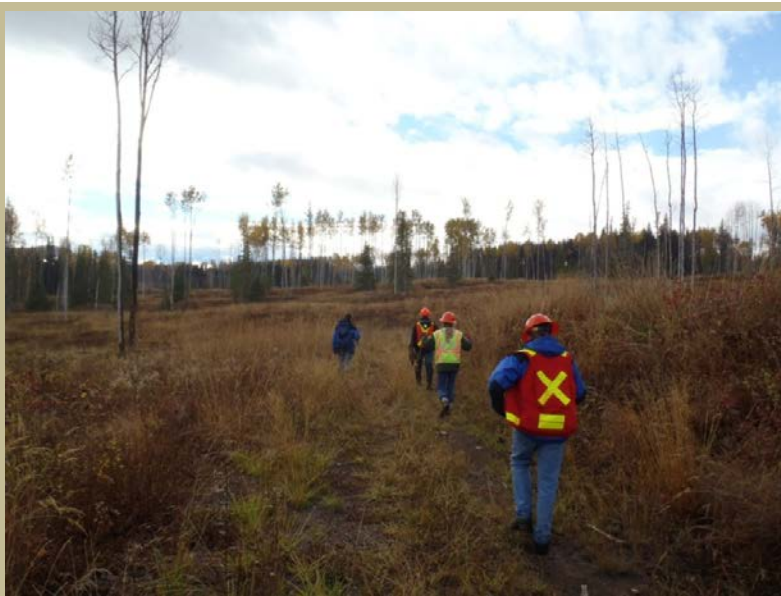
Figure 5. A deactivated road in the cutblock (October 2012). Note the retained deciduous trees and wildlife tree patches in the background.

Road construction and ditching can intercept and redirect both surface and subsurface drainage. Where interception and diversion is significant and flows are concentrated into unconditioned areas, the result can be accelerated rates of runoff. The hydrologist that BCTS engaged in planning the harvesting also worked with a geomorphologist to complete a deactivation plan for the roads. The deactivation work was planned to mitigate possible hydrological consequences of the road network.

The road network built to access the cutblock was not excessive and effects on natural drainage patterns were minimal, with any effects corrected through deactivation shortly after harvest.

Based on these observations, it is unlikely that forest road construction and deactivation had a measurable effect on peak flow timing or magnitude. Although the degree to which roads and harvesting contributed to the hydrological results is unclear, BCTS completed a thorough job of the technical aspects of planning and the practices were within industry norms.
