**Forest
Practices
Board**

Forestry Audit: BC Timber Sales

*Prince George Business Area
Mackenzie District*

FPB/ARC/138

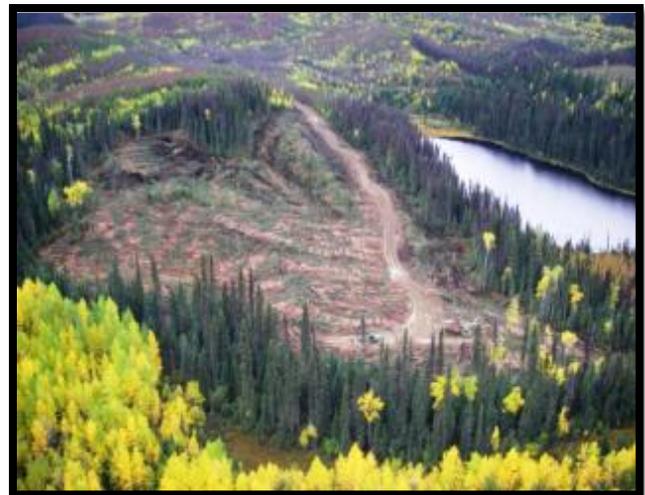
Active timber harvesting east of Mackenzie.

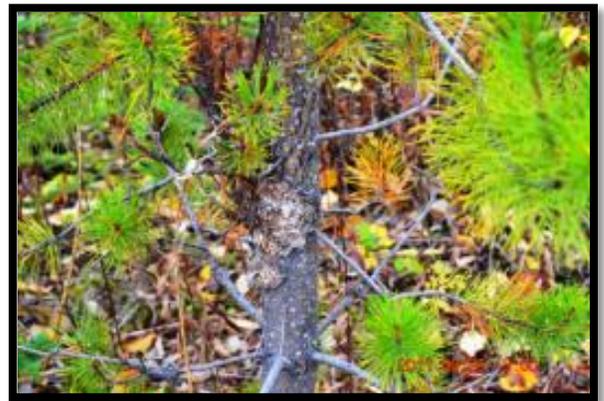
Comandra blister rust in a plantation near Mackenzie.

BCTS has adopted the Rust Management Strategy for the Mackenzie Timber Supply Area.^{viii} The strategy provides ecosystem based operational guidance to best manage stands with rust incidence, using a rust hazard rating approach. This strategy will assist in determining silviculture treatments to achieve free growing in rust infested cutblocks.

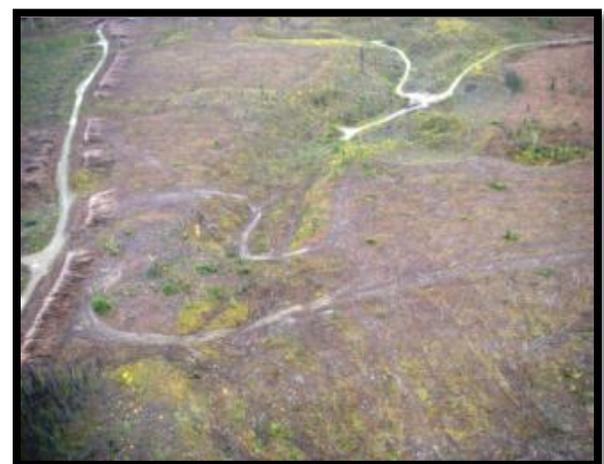
Slash piles are arranged along the roadside, in the left of the photo, for chipping.

BCTS augments TSL holder abatement activities by chipping logging debris to produce secondary wood products.
