**Forest
Practices
Board**

**Audit of Forest and Range Planning
and Practices Affecting Water Quality
in Oyama and Vernon Creek
Community Watersheds**

Okanagan-Shuswap District

August 2012

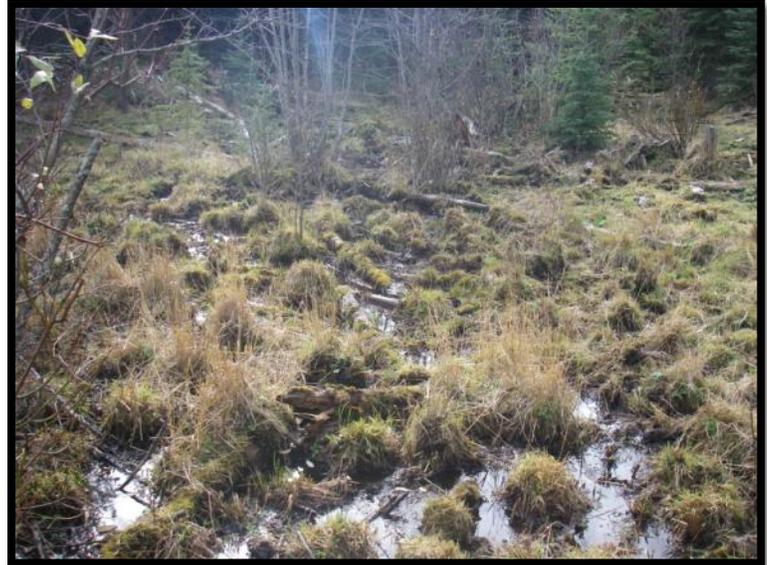
Figure 3 – Example of an 'unclassified riparian area' in the Oyama Creek watershed that does not meet the definition of riparian area because the area assessed is not adjacent to, but rather within, the wetland.

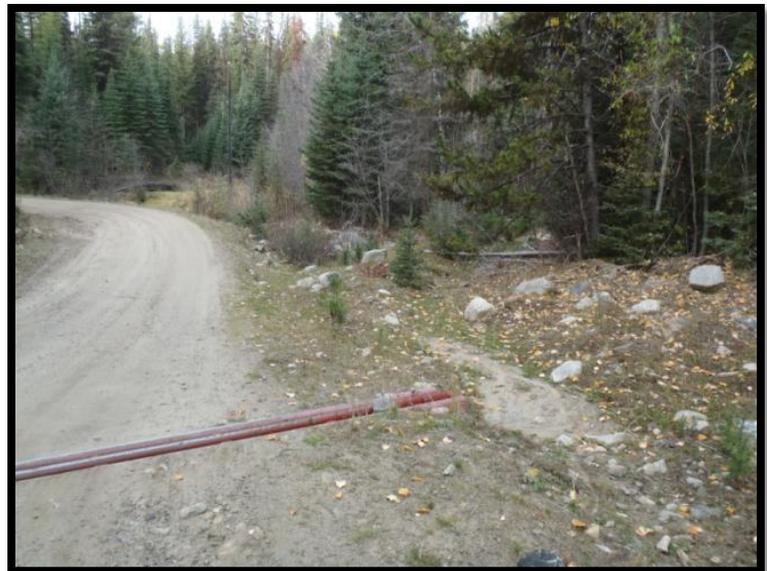
Figure 4 – Metal water-bar used to intercept and disperse road sediment across a BCTS FSR in the Oyama Creek watershed.

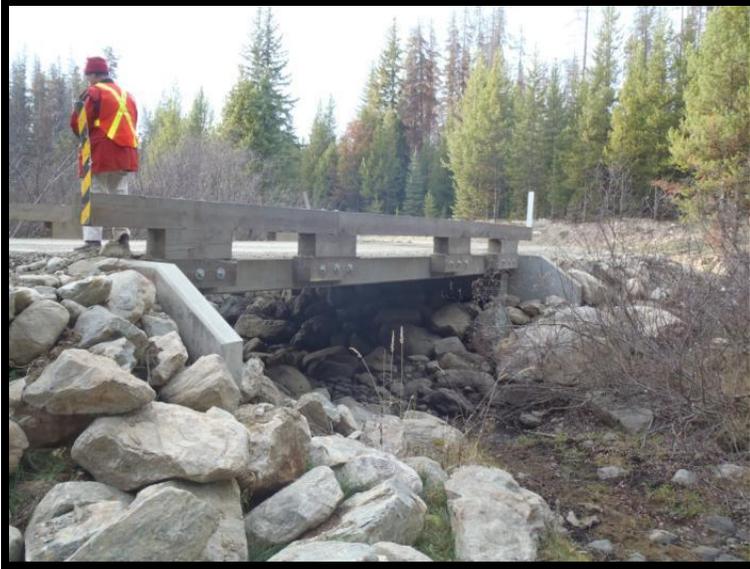
Figure 5 - Armouring with large rocks around the bridge protects the structural integrity of the bridge footings, and can sometimes deter cattle from accessing water at the crossing.

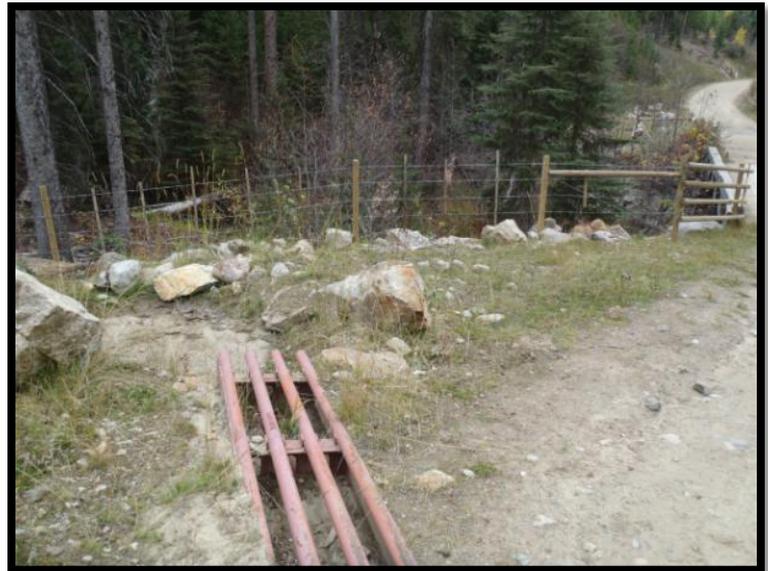
Figure 6 – Metal cross drain used to intercept sediment-laden road surface runoff and ditch water and direct it onto the forest floor away from the watercourse. Fencing and rip rap around the crossing exclude cattle from the watercourse.

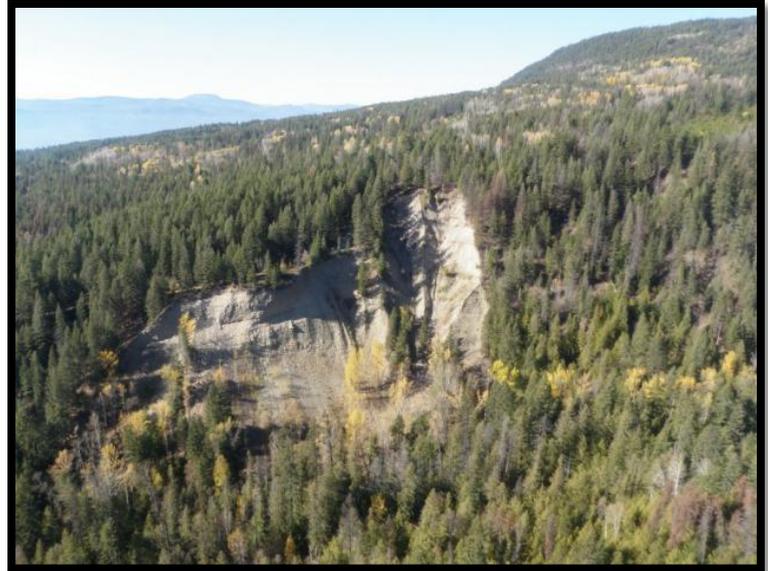
Figure 7 – Natural slides adjacent to Vernon Creek.

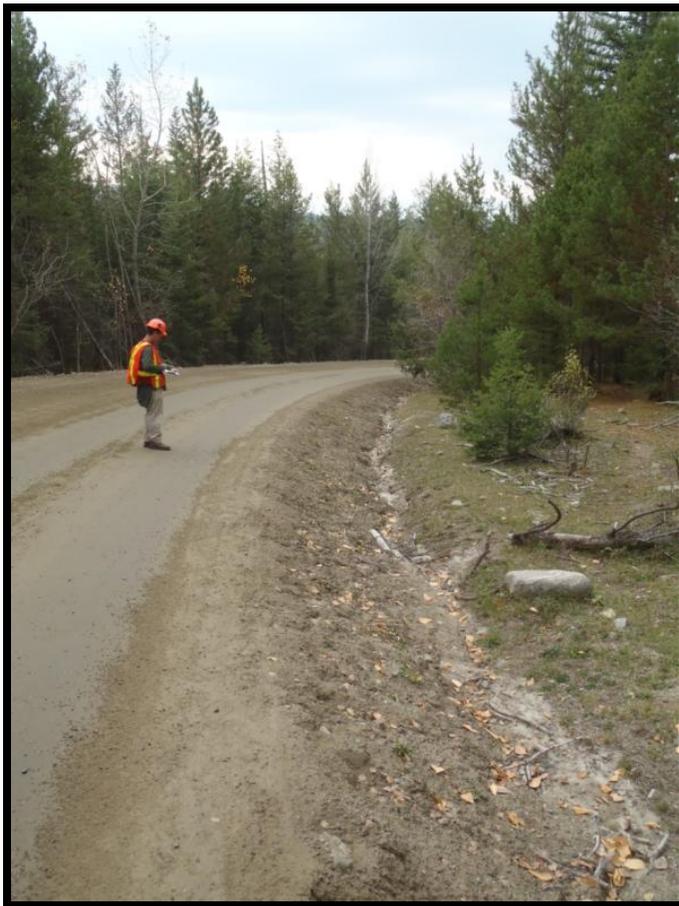
Figure 8 – Beaver Lake Road.

The audit identified 13 moderate sediment delivery sites under MOTI jurisdiction on Beaver Lake Road. This road is the main access into Vernon Creek. Although MOTI is not subject to this audit, this road was assessed because it is within the watershed and sediment from this road network affects water quality. However, the audit found that this road was well maintained, with water well directed off the

running surface and culverts in appropriate locations. The road is about eight metres wide — almost double the width of most other roads in the watershed — and has a relatively high level of use. These factors lead to a larger amount of sediment yield compared with most forest roads.

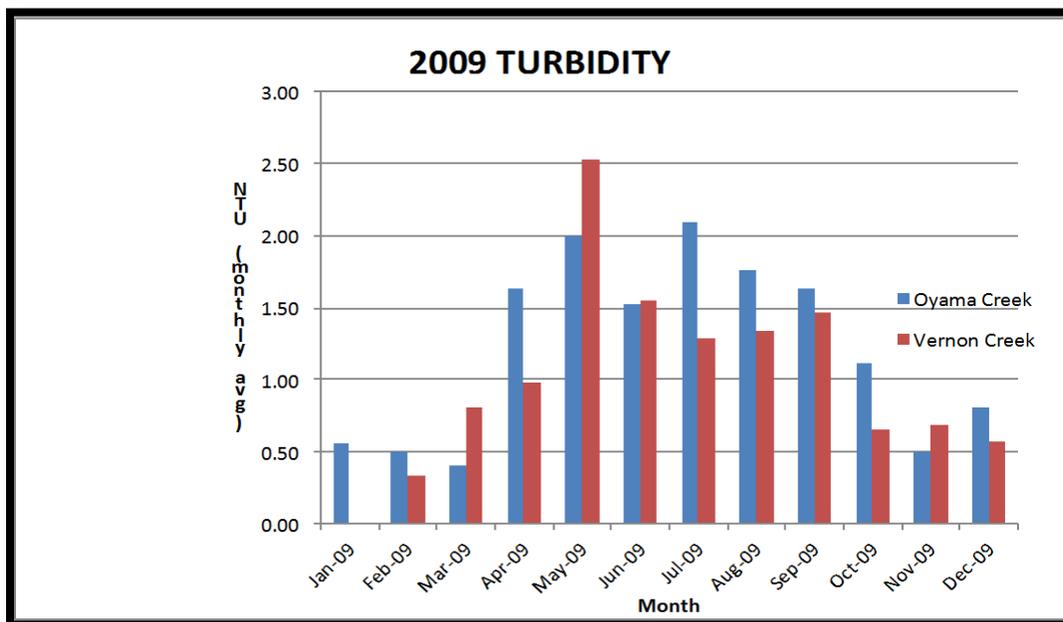
Figure 11 – 2009 average monthly turbidity levels for the watersheds.

For 2009, the monthly untreated water turbidity levels at the intakes for the two watersheds were below the one NTU level recommended by the CDWG for about half of the year and below two NTU most of the time. As typical for interior watersheds, the highest turbidity levels are associated with spring runoff.

These averages mask peak turbidity events that may occur over a few minutes, hours or days as a result of upstream erosion and sedimentation. Maximum values occasionally exceeded 10 NTU and usually could be traced to specific sites upstream. In the cases reported on Vernon Creek, stream bank failures and small landslips were the primary source of fine sediment causing the turbidity spikes.

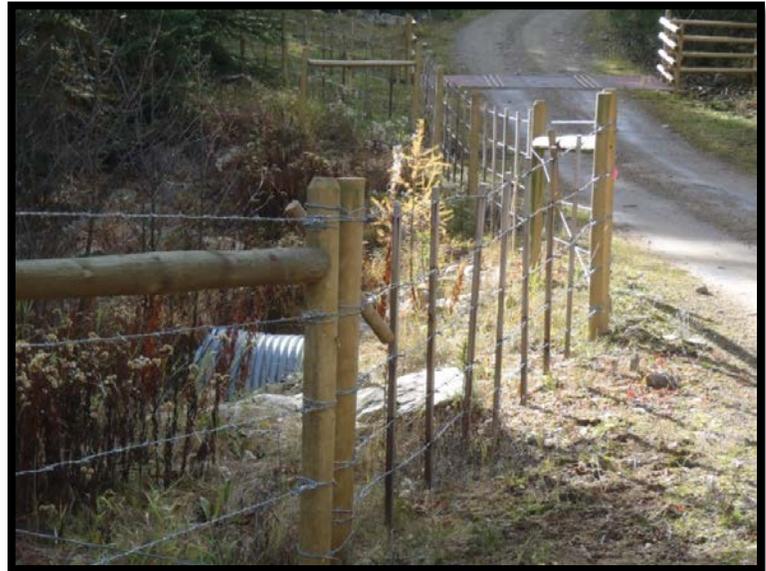
Figure 12 - fencing effectively excludes cattle from the riparian area at this crossing.

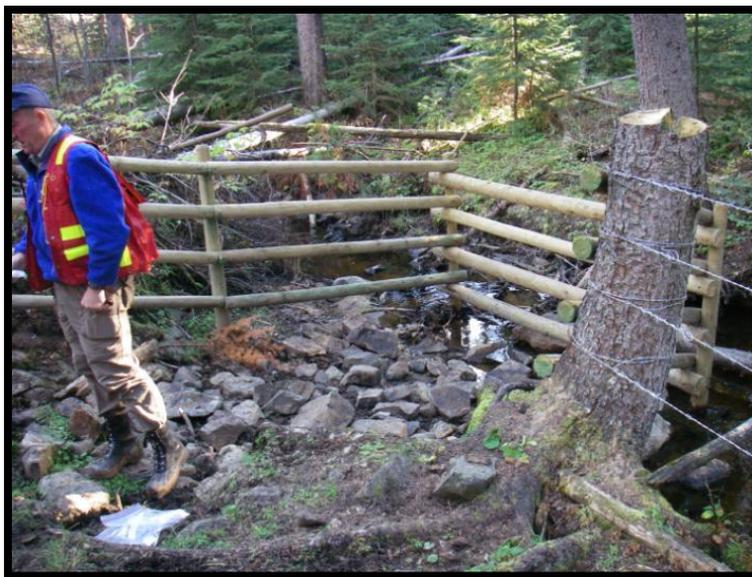
Figure 13 – “nosehole” on North Fork of Oyama Creek.

- A nose hole (cattle watering facility) that was reconstructed on Oyama Creek during the audit period (see figure 13). The nose hole was effective in confining cattle access to this part of the stream. Cobbles placed around the nose hole also helped minimize streambank damage and sedimentation. However, the nose hole site also had fecal material located within the high water mark, which is a potential source of pathogens into the unbuffered part of the watershed. One fecal pat sampled at the nose hole tested positive for *Cryptosporidium*.

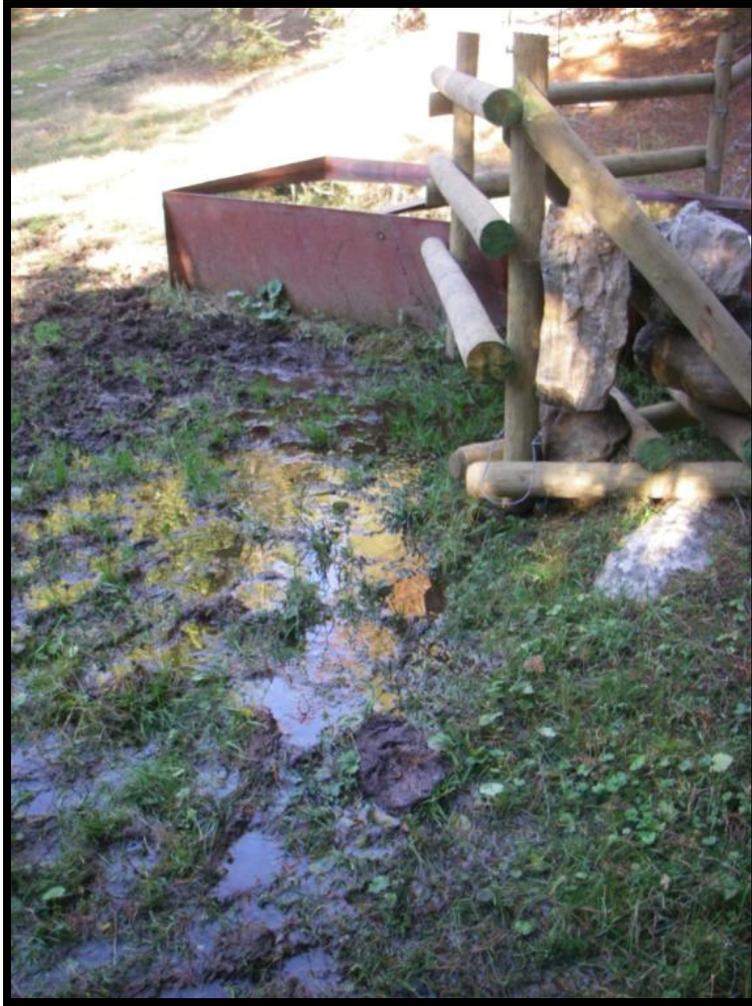
Figure 14 – water trough in Oyama Creek located away from stream and riparian area.

- Auditors observed three off-channel, gravity-fed cattle watering troughs in the Oyama Creek watershed. In general, off-channel watering can be quite effective at reducing cattle impacts on streamside areas. Two of the three water troughs were located in close proximity (around 30 metres) to Oyama Creek and overflow runoff from the trough was directed towards the creek. When congregating around watering troughs, cattle deposit fecal matter, which may be

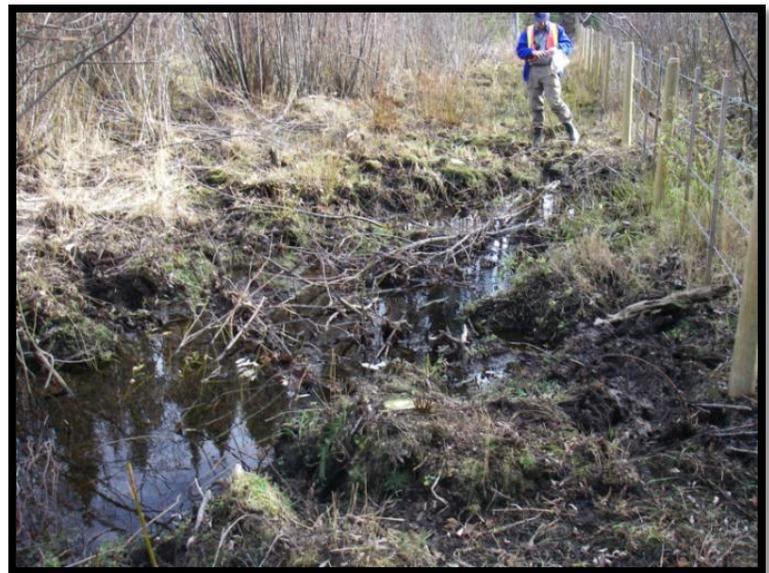
Figure 15 – fence crossing North Fork of Oyama Creek.

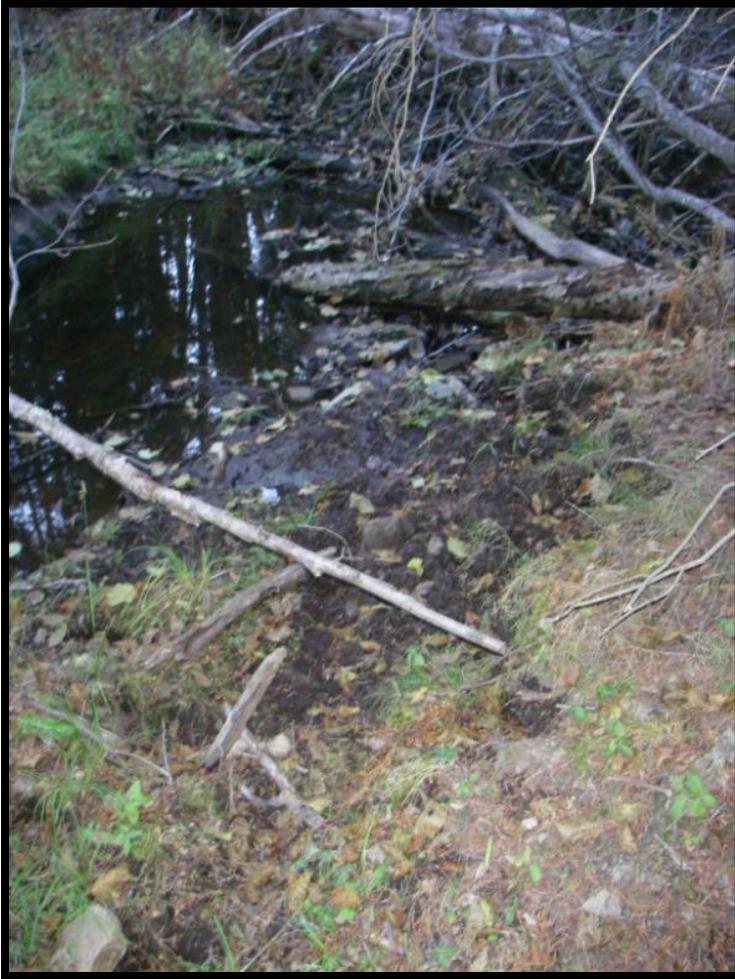
Figure 16 – impacted stream bank in North Oyama Creek.

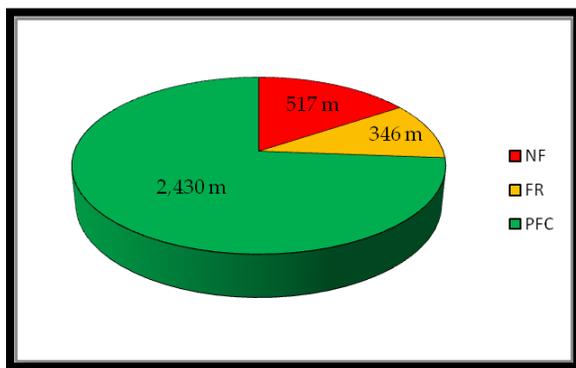
Figure 17: Oyama Creek watershed - length (m) of riparian area transect by riparian health assessment result.

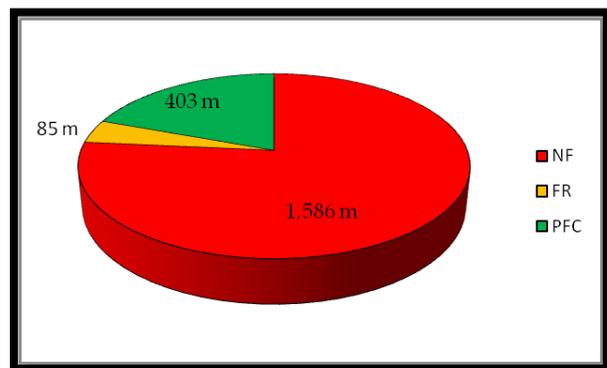
The audit found numerous instances in the Oyama Creek watershed where range practices failed to adequately protect unclassified riparian areas. The amount of unclassified riparian areas found impacted in the audit is pervasive. Although compliant, this range practice is not considered to be effective.

Figure 18: Oyama Creek watershed - length (m) of 'unclassified riparian area' transect by riparian health assessment result.

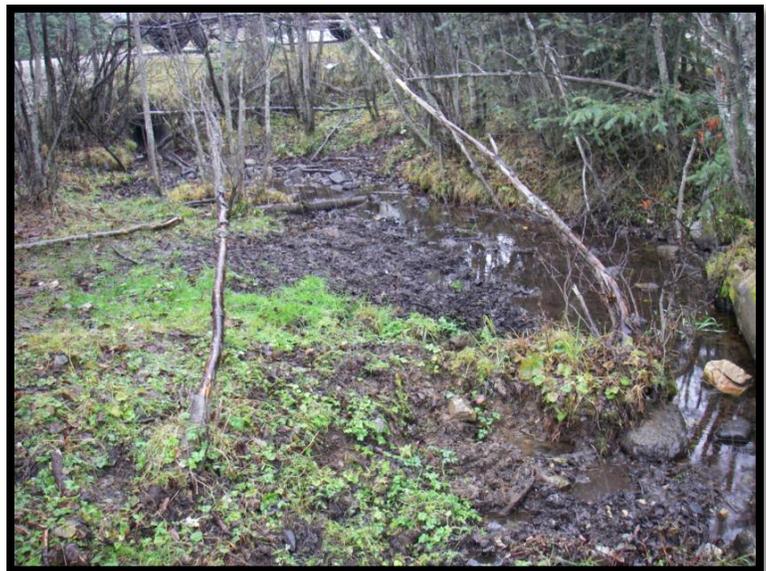
Cattle activity in the watersheds has impacted fish habitat. None of the agreement holder's range practices were conducted at a time and in a manner to minimize the likelihood of this damage occurring.

Figure 19 – example of impacted fish habitat in Vernon Creek watershed.

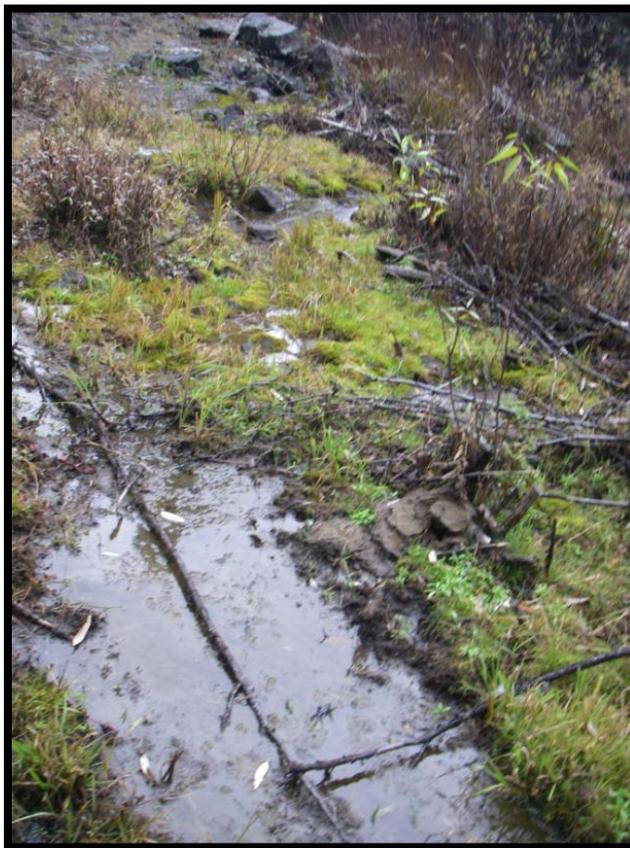
Figure 20 – example of a fecal deposit sampled from a watercourse in the Vernon Creek watershed.
