**Forest
Practices
Board**

Road Deactivation and Impacts to Fish Habitat near Kelowna

Complaint Investigation #17050

June 2019

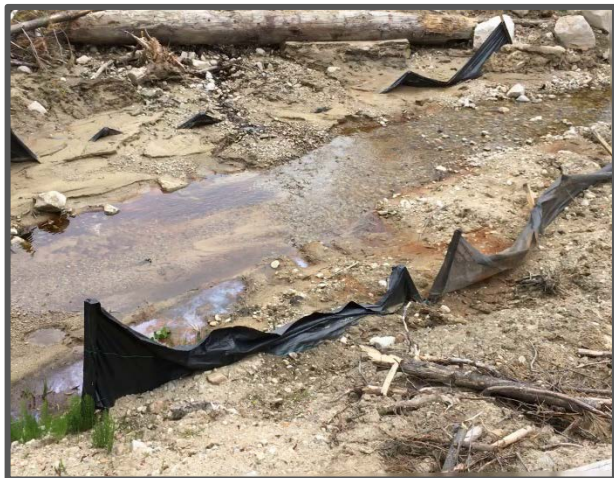
At the main stream crossing (fish-stream crossing #3 in Figure 1), a significant amount of damage to fish habitat was evident for a minimum of 100 metres downstream of the crossing. When compared to the moderate quality of fish habitat immediately upstream of the crossing, the fish habitat downstream of the crossing is no longer functional. Residual pools and the channel bed have been filled with sediment, affecting cover, overwintering and spawning habitat (see Figures 3 and 4).

Figure 3. Damaged fish habitat at the main stream crossing.

Investigators determined two sources of sediment that caused damage to fish habitat. One source was the deposit of sediment that likely occurred when the culvert was removed and soil was placed into the channel. The second and more significant source of sediment was from an access trail that continues beyond the stream crossing. The licensee modified approximately 180 metres of this access trail (part of which is a road permit road and part is an in-block road) to provide ATV access for replanting (see location of ATV trail on Figure 1). The ATV trail did not have any drainage structures (e.g., water bars) to maintain natural surface drainage patterns. A significant amount of erosion is evident on the trail and it is sloped directly towards fish-stream crossing #3.

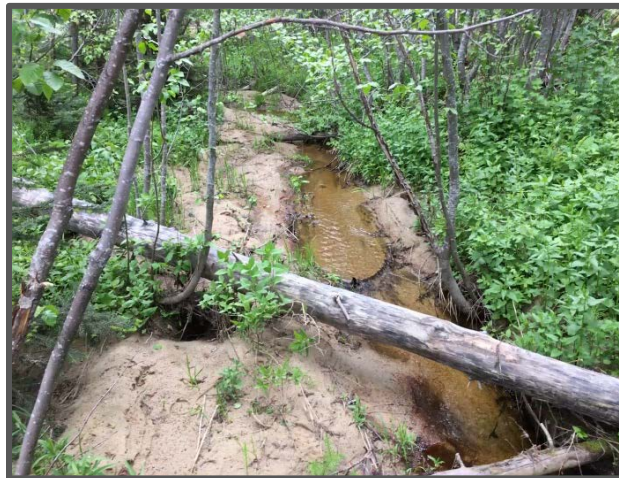
Figure 4. Damaged fish habitat 50 metres downstream of the main stream crossing.

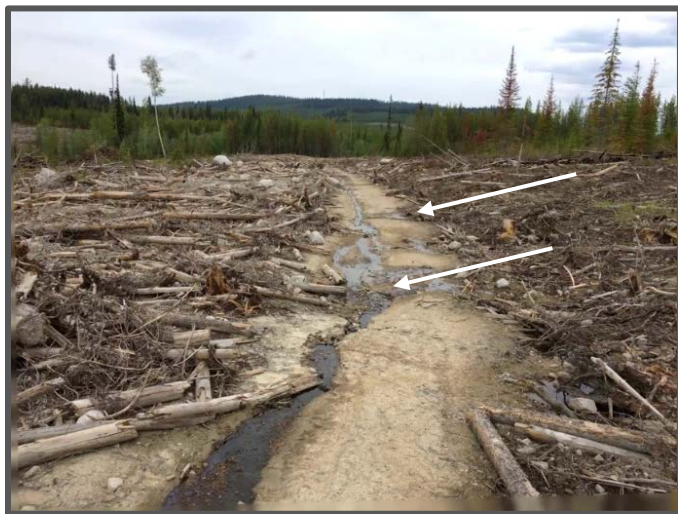
Investigators also determined that a portion of an in-block road—which extends off the licensee’s road held under a road permit²—is being used by the licensee to provide ATV access for silviculture purposes. The in-block road (referred to hereafter as the ATV trail) was constructed by the licensee in a manner that caused natural surface drainage patterns to be intercepted and directed onto a portion of road permit road then into the main fish-stream crossing (see Figures 5, 6 and 7). It is likely that this diversion of water, and resulting deposition of sediment into the fish-stream, was the major contributing factor to the significant damage to fish habitat at that site.

Figure 5. After harvesting, the licensee converted an in-block road to an ATV trail to provide access for replanting. During the 2018 snowmelt, this trail intercepted surface flows (see arrows) which were directed towards the main stream crossing.

The Board recognizes the licensee took steps to remove dirt from the nine crossings once it was notified by the Board of the situation. The licensee has subsequently advised the Board that it has restored natural surface drainage patterns along the ATV trail.

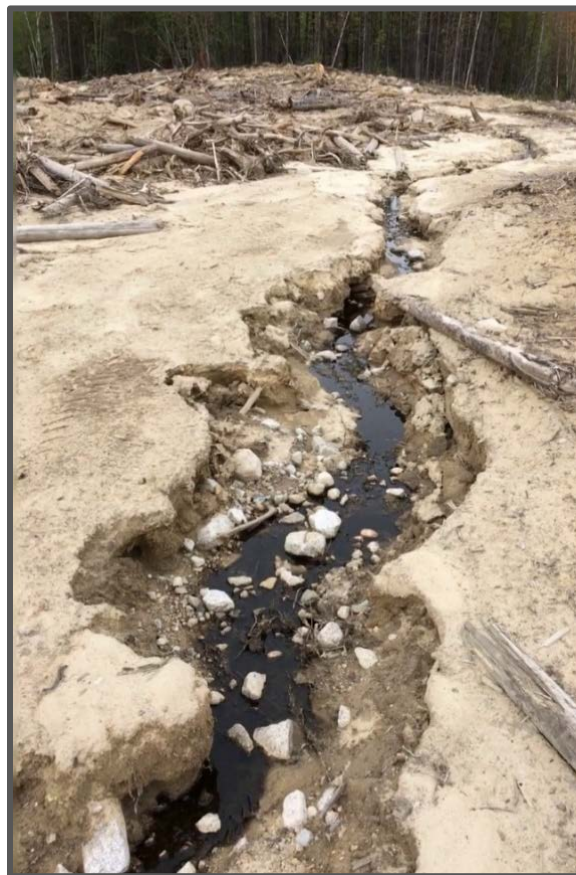
Figure 6. Significant soil erosion about 100 metres upslope of the main stream crossing.

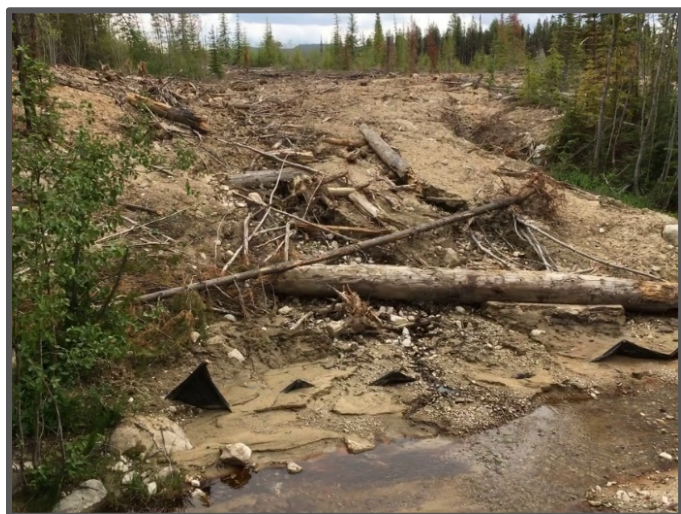
Figure 7. Photo shows where the sediment from the eroded ATV trail enters the main stream. The silt fence was put in place by the licensee during the removal of dirt in November 2017, and it was not installed to address sediment from the ATV trail.
