**Forest
Practices
Board**

Audit of Forest Planning and Practices

*Northern Engineered Wood Products
Non-Replaceable Forest Licence A85566*

FPB/ARC/232

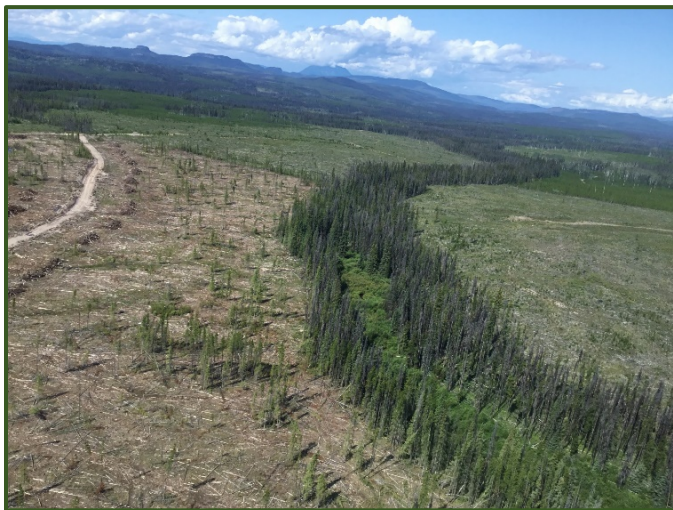
Natural drainage patterns were maintained, and streams and wetlands were well managed. NEWP demonstrated sound riparian management by keeping most streams and wetlands outside of the block boundary, and protected them with mature timber buffers, machine free zones and understory retention.

Timbered buffer maintained against riparian features.

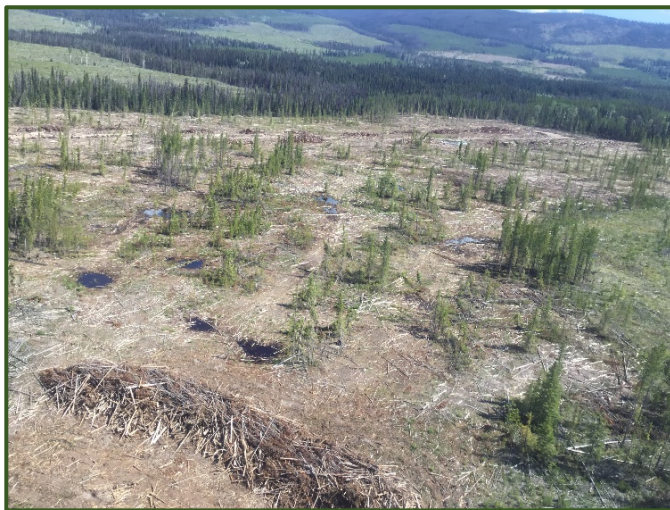
The FSP requires that at least 7 percent of the total area of the cutblock be retained as wildlife trees. NEWP exceeded the 7 percent minimum and maintained an average of 16.65 percent of the gross block area in wildlife trees. Most of the wildlife tree retention was in patches around riparian areas adjacent to the harvested area. The retained individual stems and advanced regeneration helped to supplement the wildlife tree patches. This level of retention meets the intent of the *Chief Forester's Guidance on Landscape- and Stand-level Structural Retention in Large-Scale Mountain Pine Beetle Salvage Operations* (December 2005). NEWP also retained understory and healthy advanced regeneration within blocks, subject to operational constraints.

Advanced regeneration retained in a cutblock.

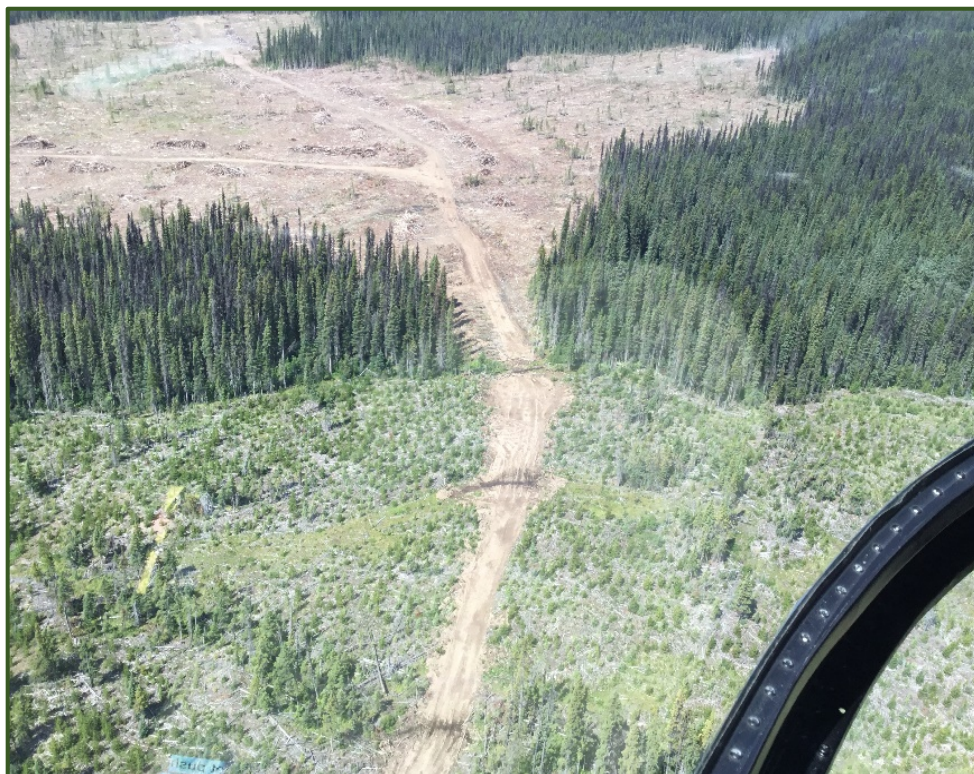
Road construction utilized conventional construction techniques and there were no rock or steep slope sections to contend with. Natural drainage patterns were maintained over the road segments auditors reviewed in the field and there was no evidence of erosion or slope failures associated with the roads.

The terrain was low risk with respect to stability. Natural drainage patterns were maintained over the road segments reviewed and the ditches were functioning.

Roads in NEWP's operating are typically on flat terrain with few streams.

NEWP was diligent in ensuring the roads remained stable. A number of in-block roads were seasonally deactivated after harvesting, even though there was little water and a low risk of erosion and sedimentation. In addition, NEWP removed most stream culverts and grass seeded soon after harvesting and planting activities. Streams were running unimpeded.

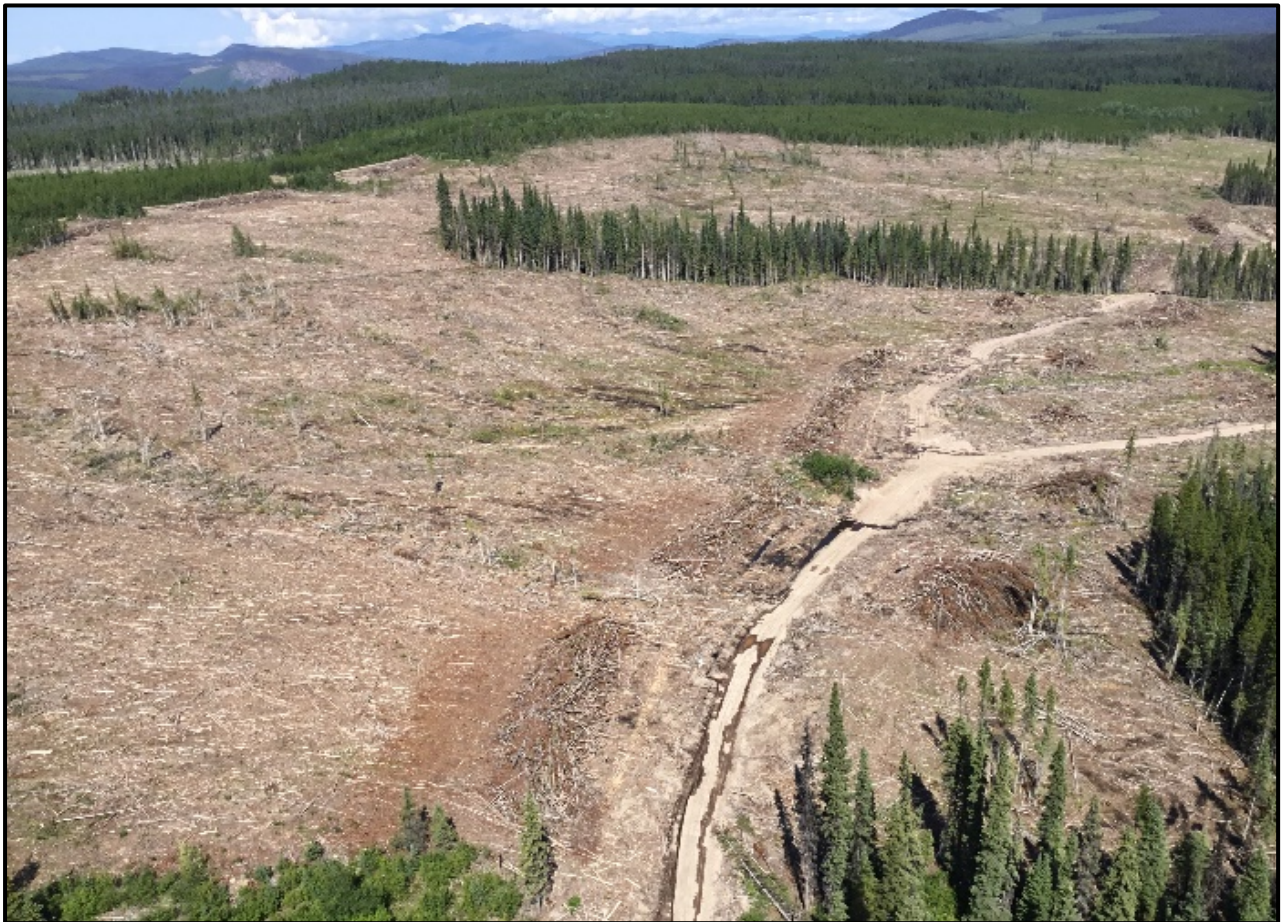
Fire hazard was not yet required to have been abated on any of the audited cutblocks. However, fire hazard was abated on four of the cutblocks in the harvest sample by burning the slash piles. On the remaining four cutblocks, the slash was piled in a manner that will facilitate disposal by burning. Auditors had no issues or concerns with wildfire protection activities.

It is NEWP's standard practice to pile slash and burn it when it is safe to do.
