Follow-up Investigation of Bridge Planning, Design and Construction

SPECIAL INVESTIGATION

APRIL 2020

FPB/SIR/51

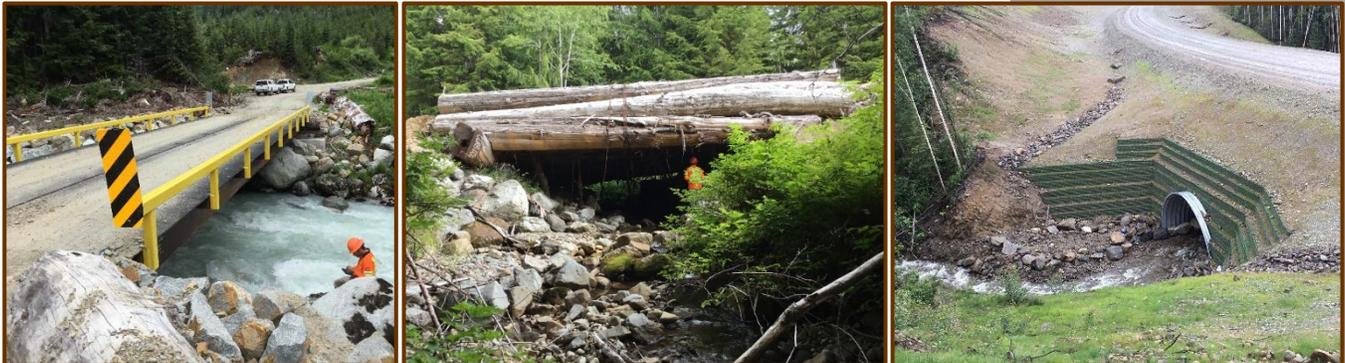
Three examples of crossings (from left to right): 27-metre steel girder bridge, log stringer bridge, and an engineered open-bottomed arch culvert.

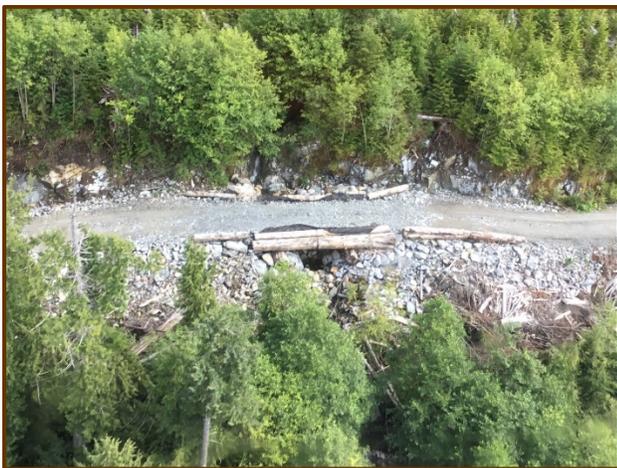
A wood box culvert. This is not a log stringer bridge because the span is less than six metres.

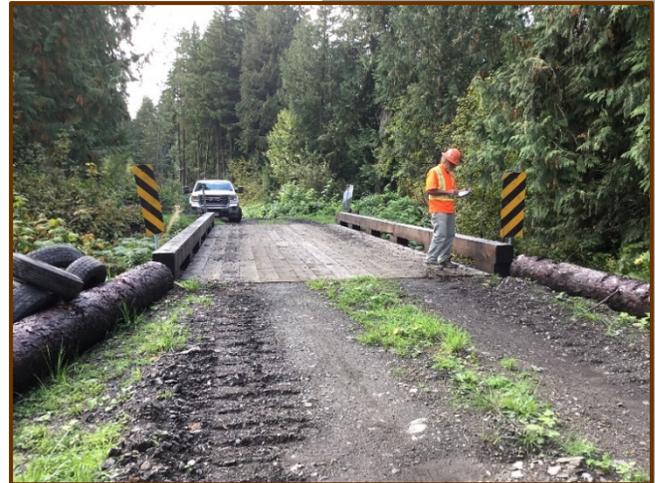
This 12-metre portable steel girder bridge with a timber deck sitting on double log sill abutments is a simple crossing.

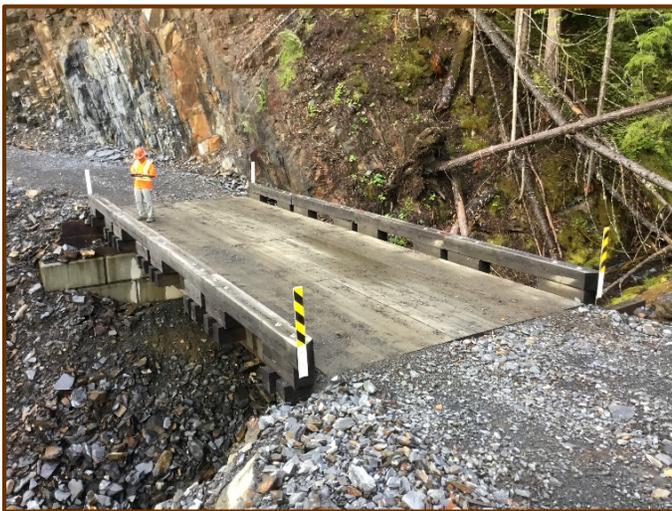
A 12-metre steel girder bridge with timber deck. The substructure of this bridge required extensive engineering expertise to determine the design bearing capacities, as well as the safety and stability of approach excavations. This is a complex crossing.

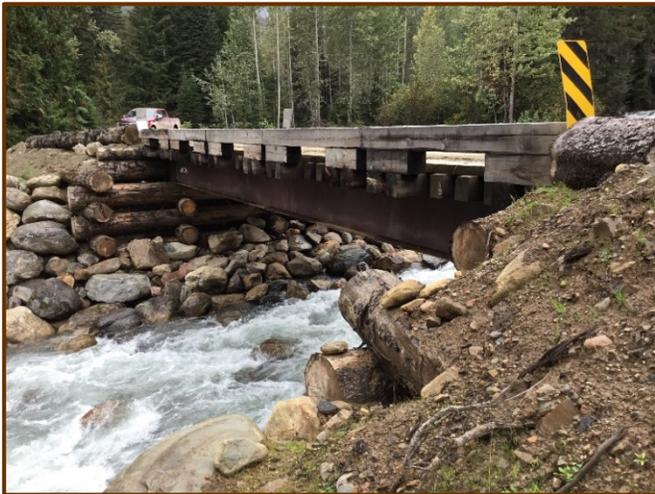
This 15.24-metre bridge was designed to accommodate the peak flow expected in 50 years (Q50). It will remain in place for up to 15 years.

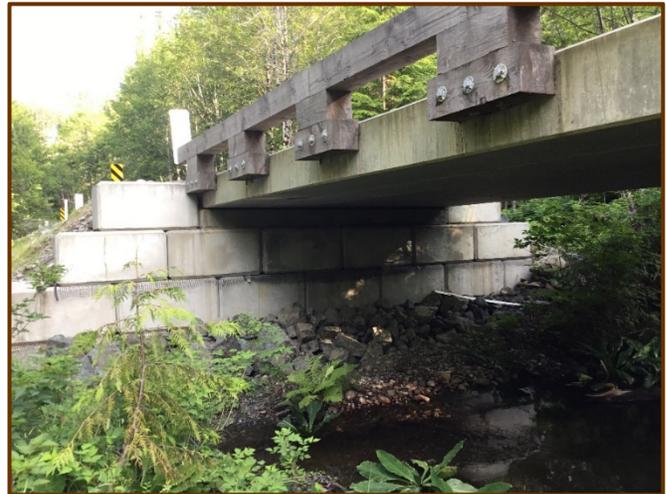
This 12-metre permanent pre-cast concrete girder bridge is designed to accommodate the peak flow expected in 100 years (Q100).

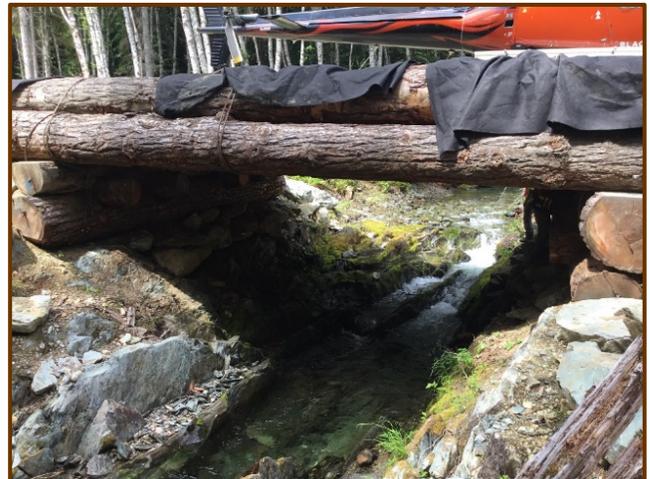
This log stringer bridge maintains natural surface drainage patterns.

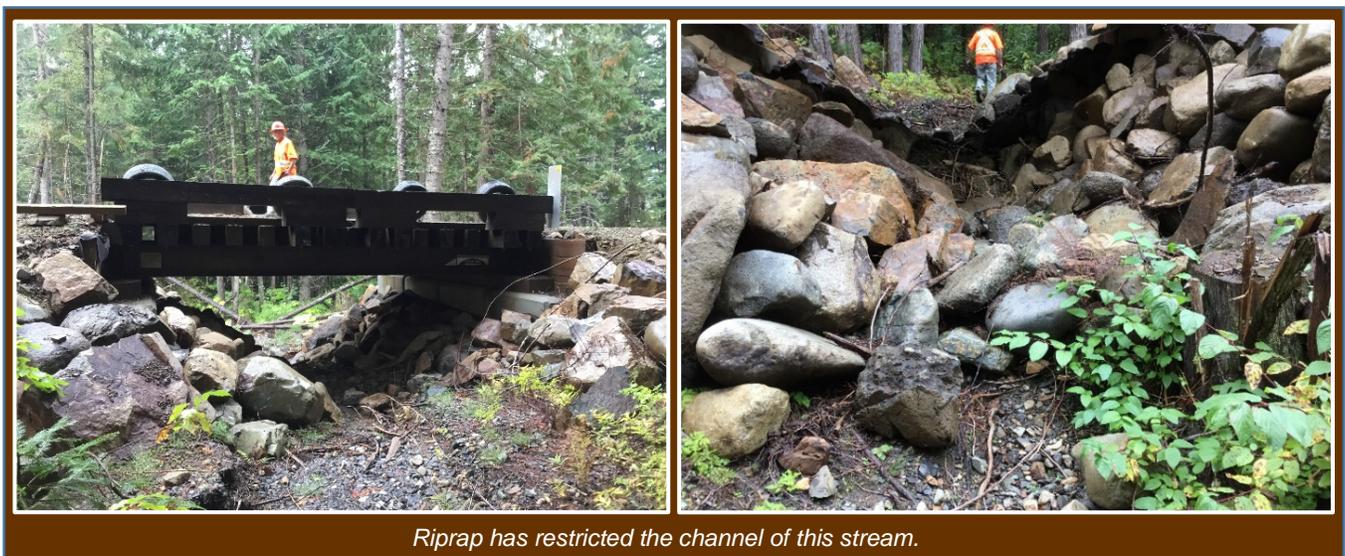
Riprap has restricted the channel of this stream.

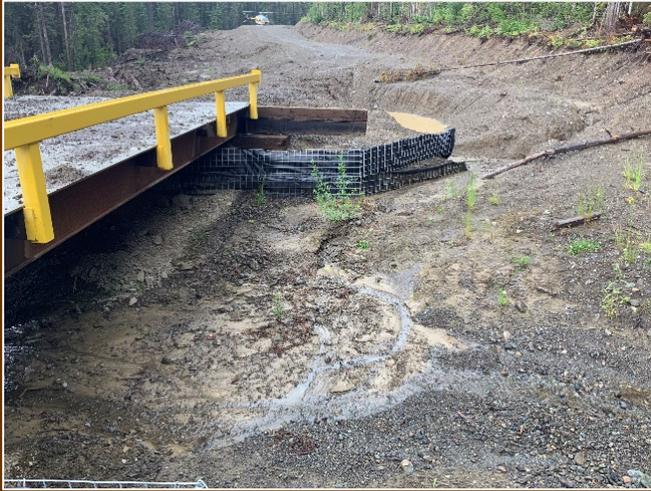
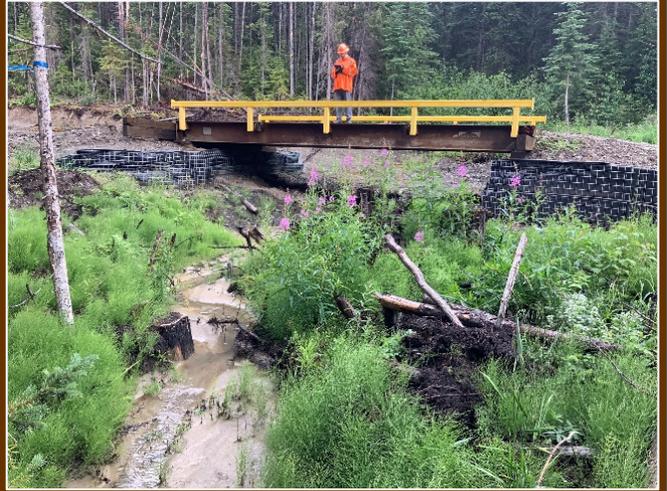
This crossing is contributing significant amounts of sediments to this fish-bearing (S4) stream.

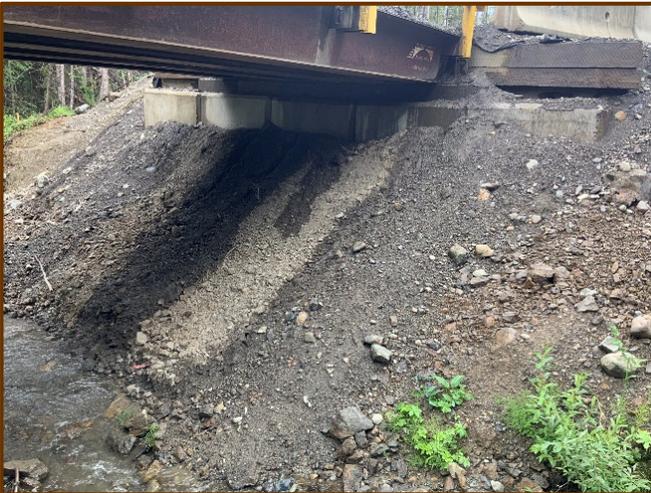
This stream bank is not armoured with rock and sediment is being introduced to the stream.

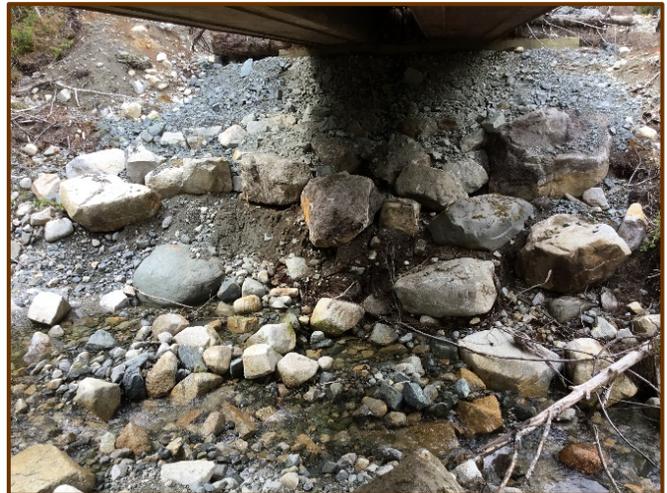
Inadequate armouring of the bank. Rock is not properly keyed in to withstand the stream flow and to retain the fill.

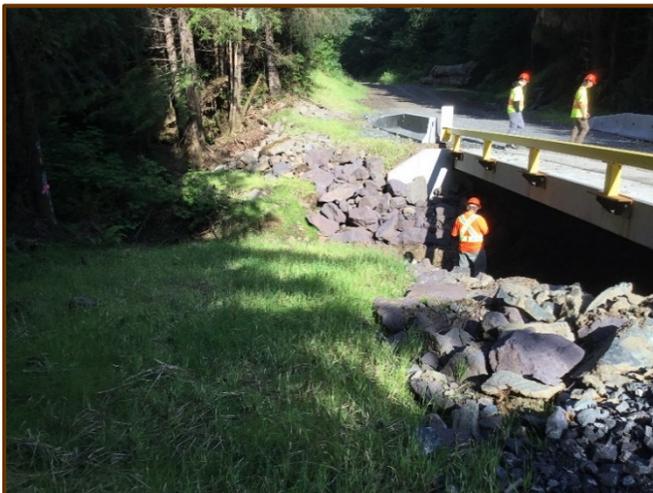
These banks are well armoured and disturbed areas have been seeded with grass to minimize sedimentation.

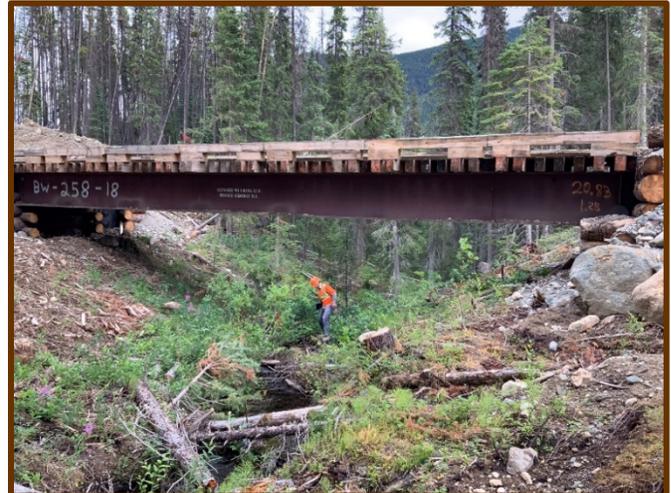
These banks were relatively undisturbed during construction.

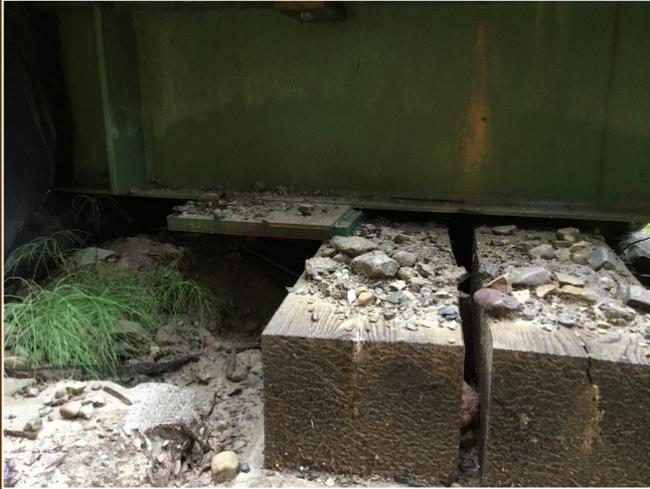
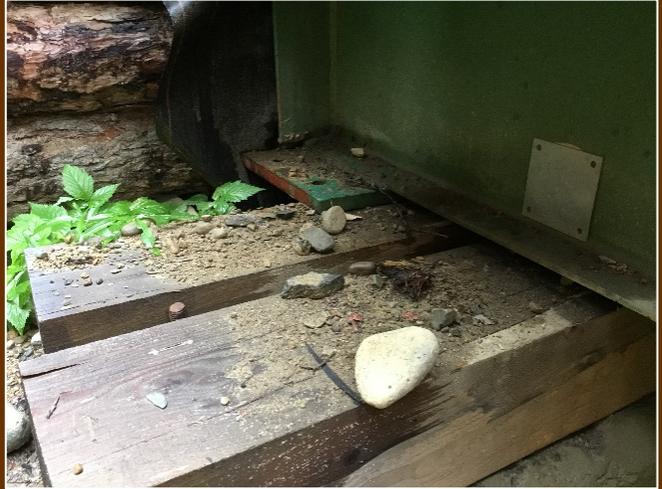
Three of the four bearing plates for this structure were not adequately supported by the timber sills. This structure was not sound and safe for use. The Board immediately notified the licensee and it promptly lifted the structure and repositioned the timber sills.

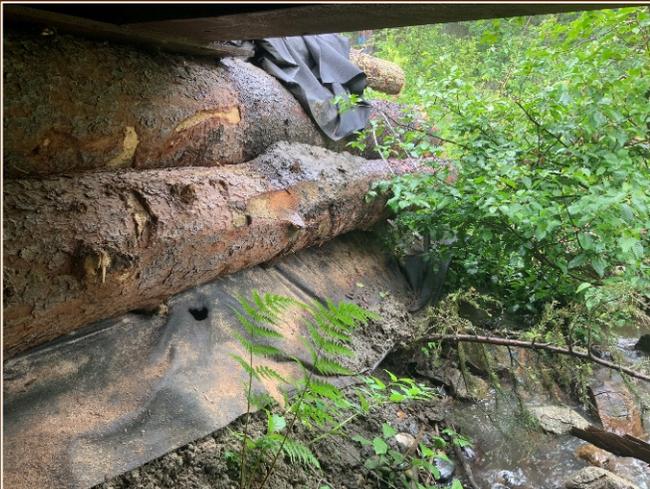
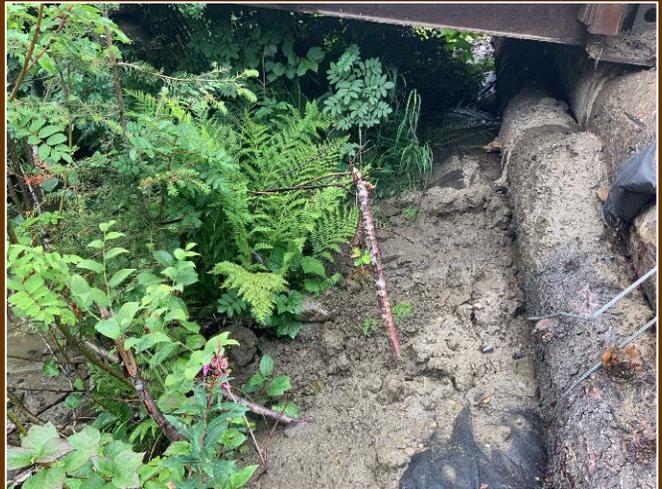
Both sills of this structure were undermined by the creek. The foundation materials supporting these log-bundle abutments have been eroded and are not structurally sound. This structure is unsafe for hauling.

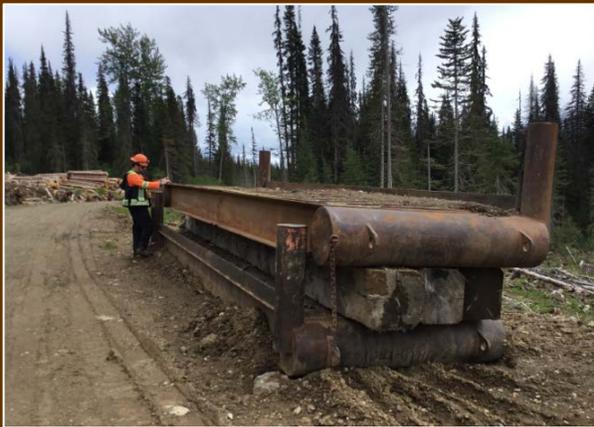
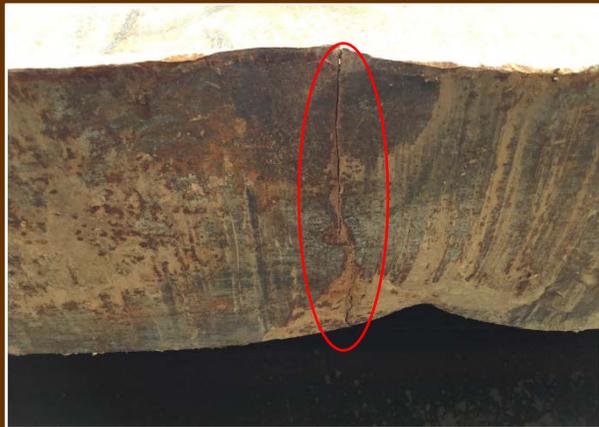
This 8-metre structure was used for a few weeks in the winter and then pulled for reuse elsewhere. It had severe installation damage and was completely fractured full width (circled in red). This structure was unsafe for use. This highlights the importance of inspecting portable structures prior to re-use.

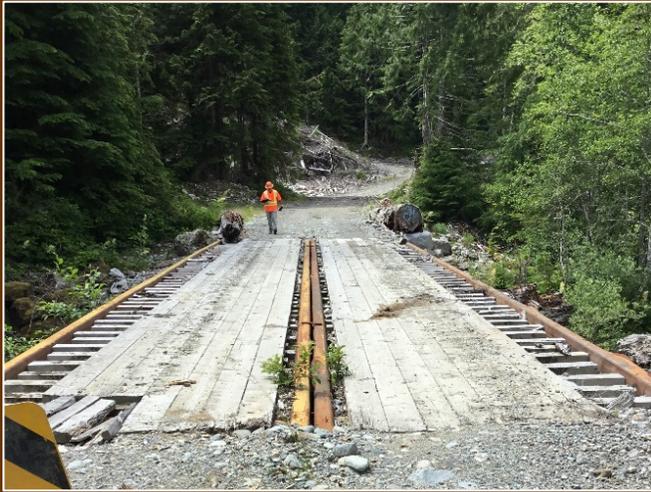
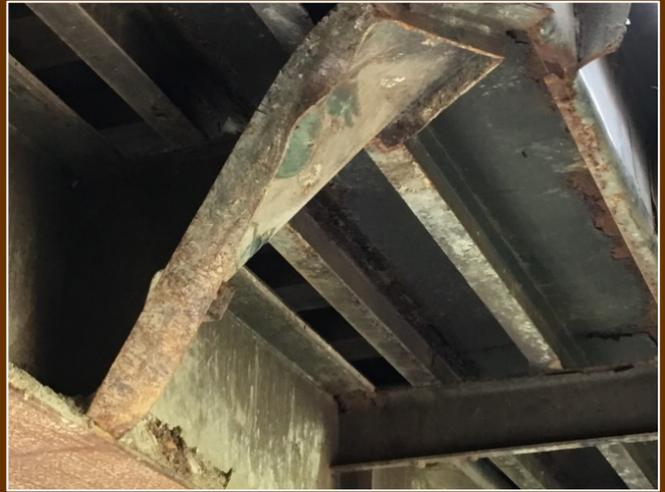
This 19.3-metre span was made up of two railcars. There was no information provided indicating that the railcars had been inspected prior to use by a qualified structural professional. Parts of the superstructure were also damaged. No load rating had been determined for the structure. Access had been blocked after industrial use.
