# Special Investigation: Conserving Fish Habitat under the Forest and Range Practices Act

PART 2: An Evaluation of Forest and  
Range Practices on the Ground

May 2020

FPB/SIR/52

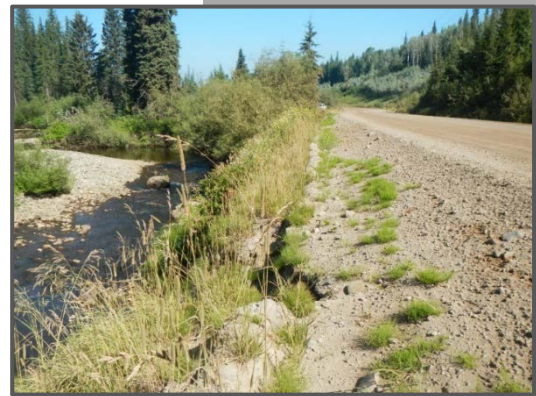
*In some areas, the Morice-Owen Forest Service Road is located immediately adjacent to Owen Creek—a high value fish-stream. Sediment from the road directly enters the stream. In these areas, the riparian buffers have also been impacted.*

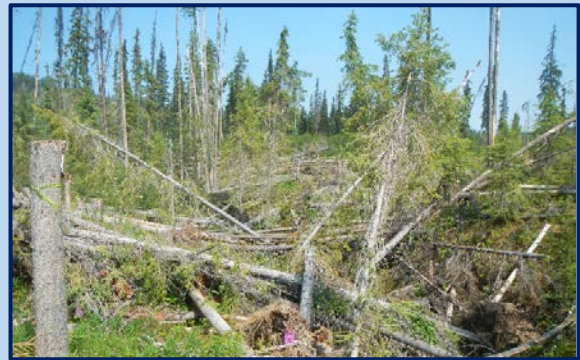
There are well-established best management practices to reduce or prevent windthrow (see photo). The principles are the same for managing windthrow risk on the coast and the interior but timing and patterns of winds are complex and differ significantly based on local topography, harvesting patterns and soils.

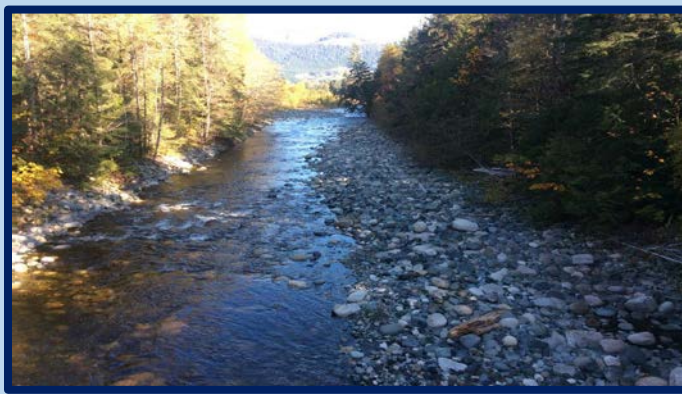
The Memekay watershed has a long history of harvesting with over 70 percent of the watershed logged since the 1940s and very high road densities at 2.7 km/km<sup>2</sup>. Watershed-scale monitoring by FREP in 2012 found that riparian and stream channel condition was impaired, mainly due to the effects of pre-1995 logging and roads. The lower Memekay, in particular, exemplifies the changes to fish habitat quality and productivity that occurred when streams were routinely logged to the their edge and large instream woody debris—critical for channel stability and fish habitat—was removed or disappeared over time from the stream.
