**Forest  
Practices  
Board**

## **Laird Creek Landslide**

*Complaint Investigation 111006*

**FPB/IRC/186**

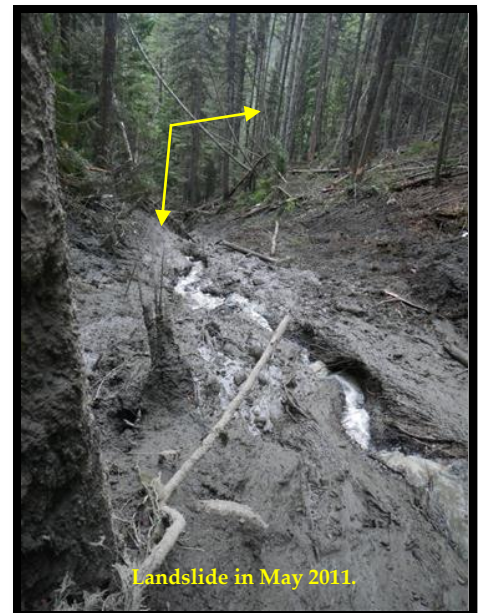
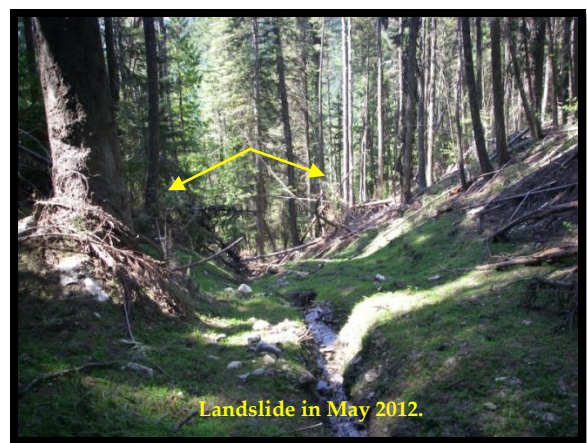
*Arrows point to same feature.*

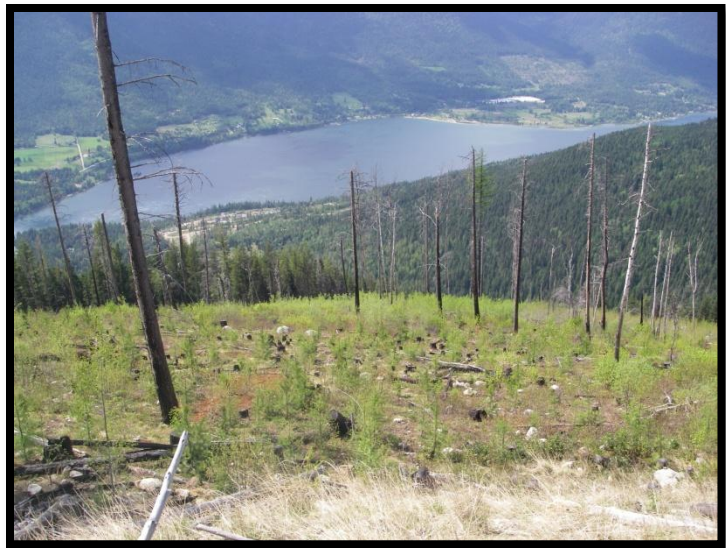
*Cable harvest portion of TSL A63763.*
