**Forest
Practices
Board**

Impacts of Wildfire and Harvesting Near Silver Hills

Complaint Investigation 20032

FPB/IRC/242

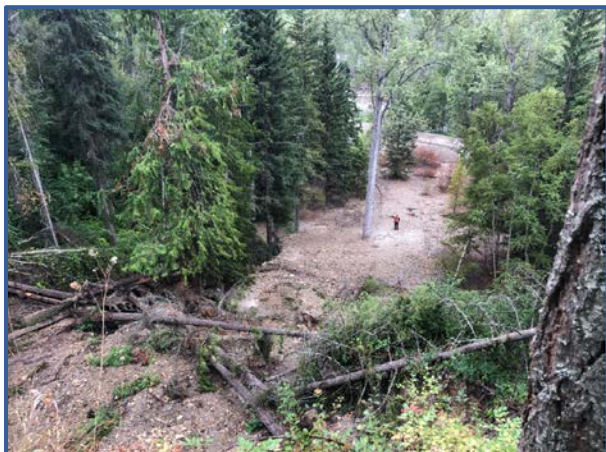
Photo 1. Debris from a landslide which crossed the Shuswap River Road, a private driveway and deposited some sediment into the Shuswap River.

Four landslides occurred on private land on the McPherson Creek alluvial fan in late April and early May of 2020, and one landslide became the focus of this investigation (see Photos 1 & 2). Also in May 2020, water users on Woodward and Hesketh creeks experienced what they considered to be extreme amounts of sediment in their water systems. Harvesting on the plateau over the last few years has also overlapped a range tenure. Tolko and the range tenure holder have been working to mitigate the impacts of harvesting on the range resource.

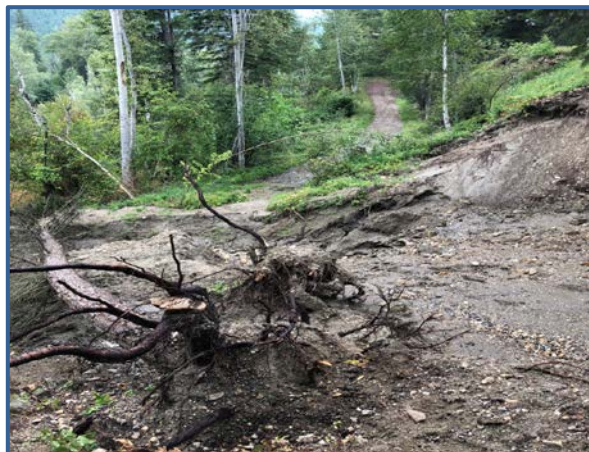
Photo 2. Landslide across a private driveway.

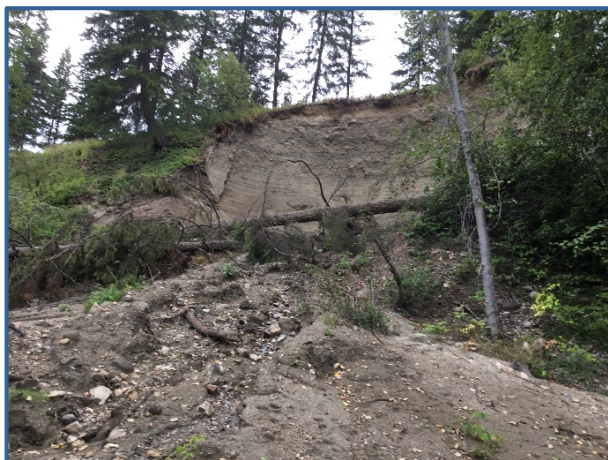
Photo 3. One of the landslides in the terrace along the toe of the McPherson Creek alluvial fan. The face of the landslide shows the depth of the sand and gravel material above the less permeable silt or clay layer.

The investigator reviewed the likely cause of the landslides with three independent qualified individuals (two professional geoscientists and a hydrologist) who had visited the landslide areas. The failure scars exposed deep layers of permeable sand and gravel on top of a relatively impermeable silt or clay layer. Surface water on the alluvial fan infiltrates permeable materials and moves downward reaching less permeable layers. This eventually saturates material above the less permeable clay and silt, and forces water to move laterally. This likely caused all of the landslides. Investigators also observed older and similar landslides along the edge of the terrace and overlying fan associated with McPherson Creek, but did not establish their age (see Photos 3 and 4).

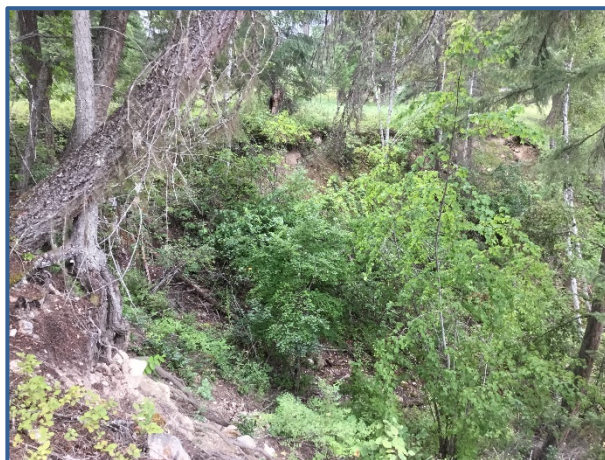
Photo 4. Old landslide immediately adjacent to the recent landslide in photo 1.

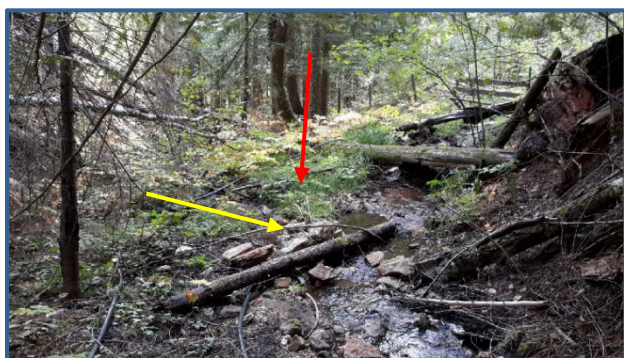
Photo 5. McPherson Creek where it begins flowing down a man-made channel (to the right). The red arrow indicates where the stream jumped this channel and flowed onto the alluvial fan (Photo 4).

The yellow arrow points to the sediment, rocks and log redirecting flow back into its current channel.

The complainant indicated that McPherson Creek left its current channel in the spring of 2020 and flowed over the eastern portion of the fan (see Photos 5 and 6) close to where the eastern most landslide occurred. The change in the overland flow on the McPherson Creek fan was likely due to fine sediment deposition, or high streamflow levels resulting from above average snow accumulation and/or upslope wildfire and subsequent salvage harvesting. Investigators observed that sediment and debris were placed in McPherson Creek, diverting the surface flows back into its current channel to the west.

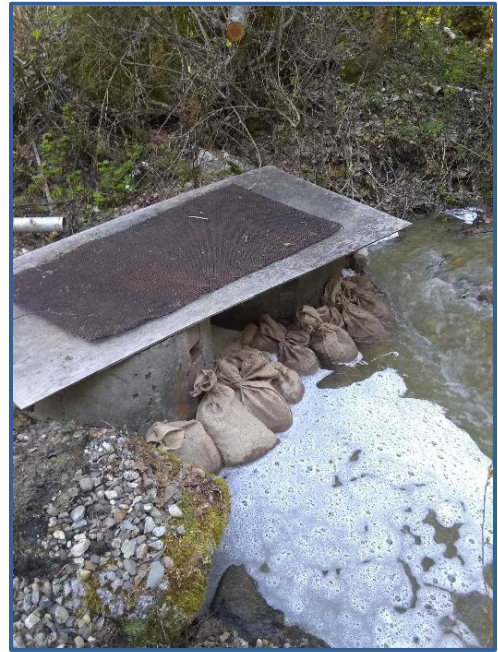
Photo 7. Woodward Creek intake on May 2020. (Photo provided by the complainant)

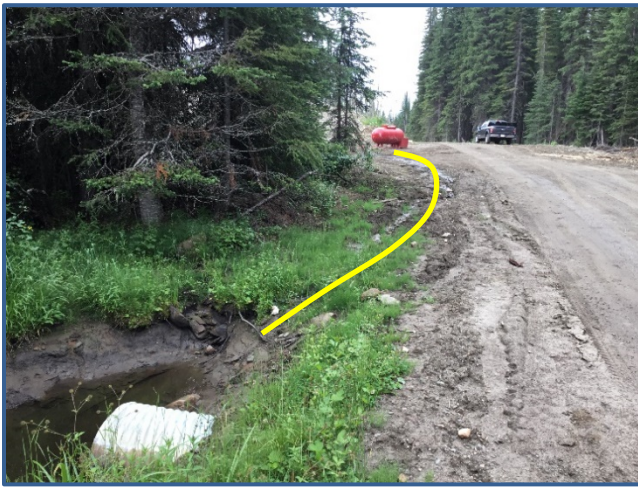
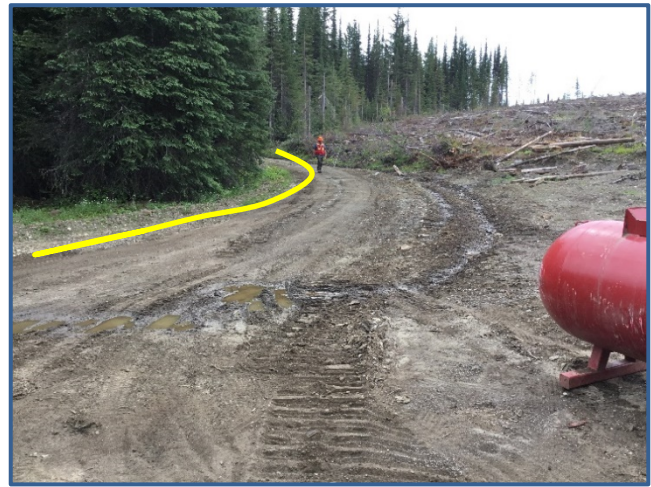
The TSA and site plan for LV3156 recognized that the cutblock is within a domestic watershed. The site plan indicated that sediment delivery risk is very high, primarily due to the hydrophobic soils associated with the wildfire. However, that risk was not reflected in the operational activities. Investigators observed poor water management practices on roads with ditch runs draining directly into streams used for domestic consumption (see Photo 8 and 9). This permitted direct input of sediments from roads into streams.

Photo 8 (left) and **Photo 9** (right). These photos show the ditch line flowing directly into a direct tributary of Woodward Creek. The confluence with Woodward Creek is about 600 metres downstream from this crossing. The yellow line shows the ditch draining directly into the Woodward Creek tributary.

The TSA recommended seasonal deactivation of all permanent and temporary roads, and that all proposed and existing trails used for harvesting should be completely rehabilitated and seeded as soon as practicable after harvesting. Roads and excavated trails were not deactivated or rehabilitated when auditors visited the site in the summer of 2020. However, Tolko told the Board that temporary roads were seasonally deactivated in October and November 2020.

It would be prudent for Tolko to utilize professionals with expertise in soils or hydrology to review existing drainage control and when prescribing and reviewing post harvest road deactivation, given the non-timber values at risk.

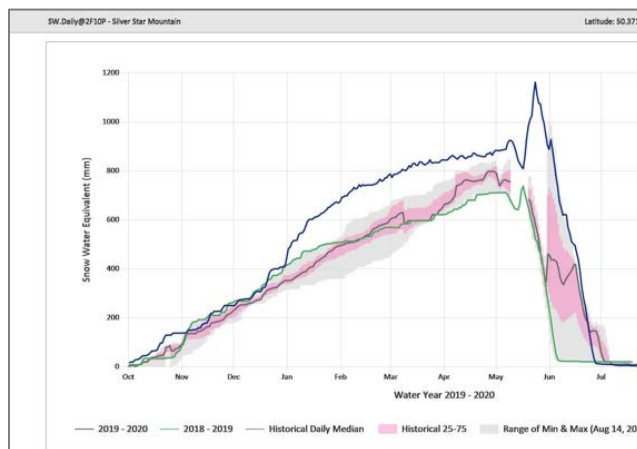
Graph 2. Snow Level Graphs for Silver Star Mountain (left) and Park Mountain (right). Both graphs show that the snow levels in 2019 -2020 winter (blue line) were higher than 2018-2019 winter and also higher than the historic daily median.

Generally, more snow on the ground means more water is available for runoff and streamflow during spring snow melt. The records indicate that the 2019 to 2020 winter had higher than average snowpack at both sites (refer to Appendix 1 for graphs).
