**Forest
Practices
Board**

Impacts of Harvesting and Road Construction on Water Quality in McClure Creek

Complaint Investigation #16041

October 2017

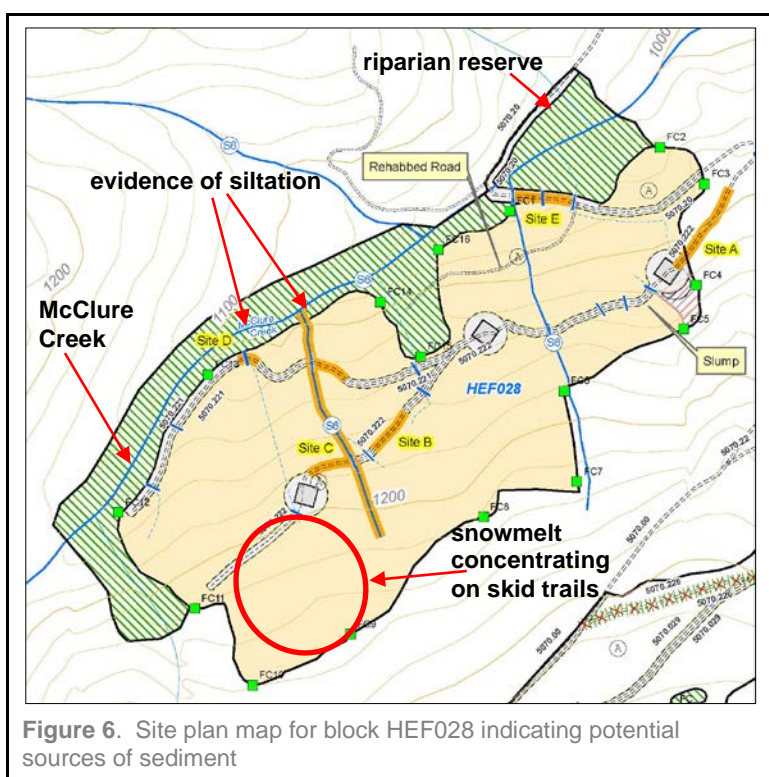
When Board investigators visited the site, they saw evidence of fine sediment from HEF028 entering McClure Creek (Figure 7), but did not observe any significant sources, such as landslides, resulting from the cutblock. The investigators also looked at the implementation of the sediment-control plan and considered that it was poorly implemented and ineffective, primarily because no machinery had been used. (This was due to Interfor and the complainants' previous agreement to not bring machinery back on site.)

Figure 7. Seasonal stream in HEF028 showing the fine particles washed out, some were transported to McClure Creek.

After the investigation field work had been completed, Interfor engaged a hydrologist familiar with the McClure Creek drainage and a geotechnical engineer to review HEF028. The hydrologist developed a remediation plan to address the future risk of sediment entering McClure Creek from HEF028. Interfor reviewed the plan with the complainants and committed to implementing the plan.
