Road Failures on Vedder Mountain near Chilliwack

Complaint Investigation 020398

FPB/IRC/90

December 2002

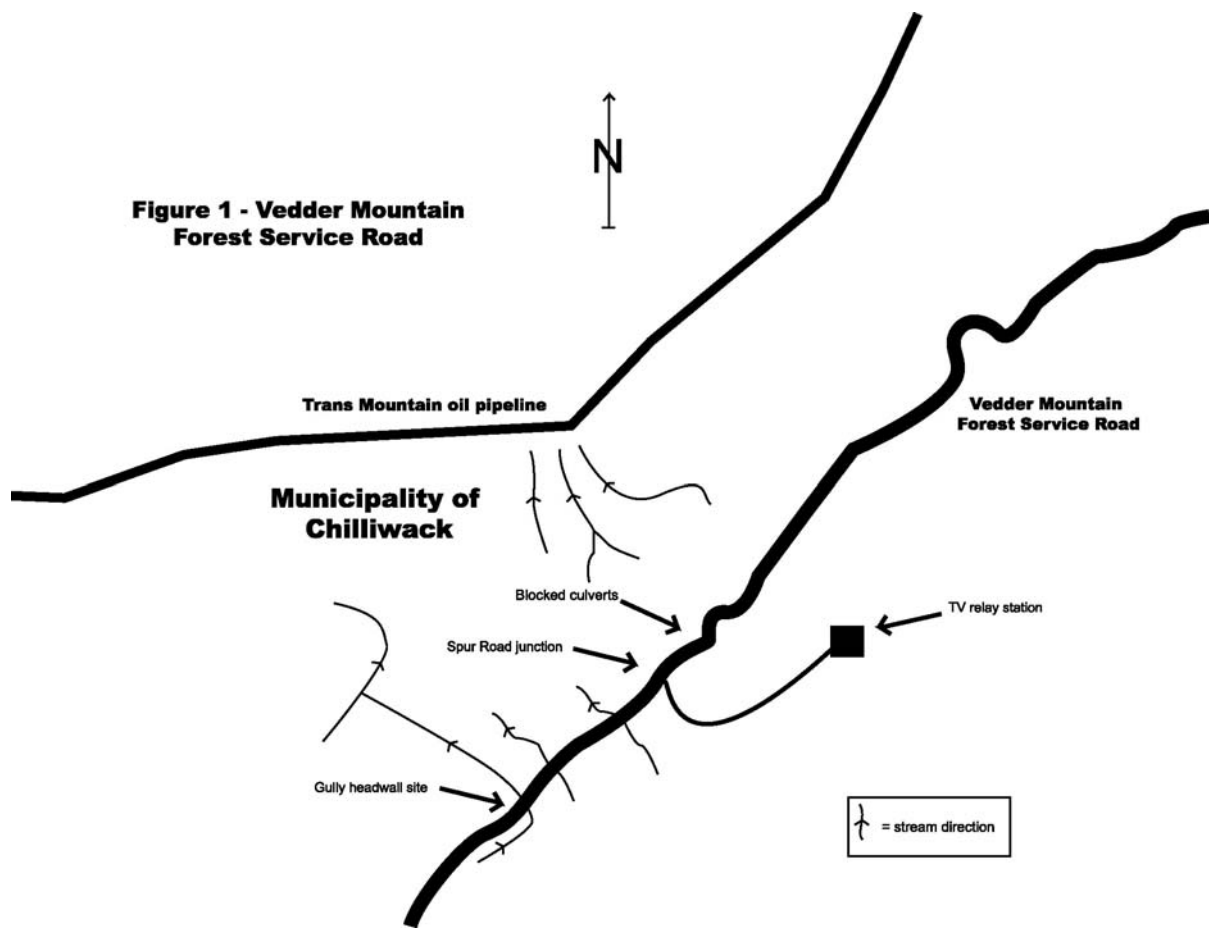
The investigation dealt with three sites (see Figure 1):

- Two blocked culverts
- The spur road junction
- The gully headwall
