**Forest
Practices
Board**

Forestry Activities in the Peachland and Trepanier Creek Community Watersheds

Complaint Investigation #17046

September 2019

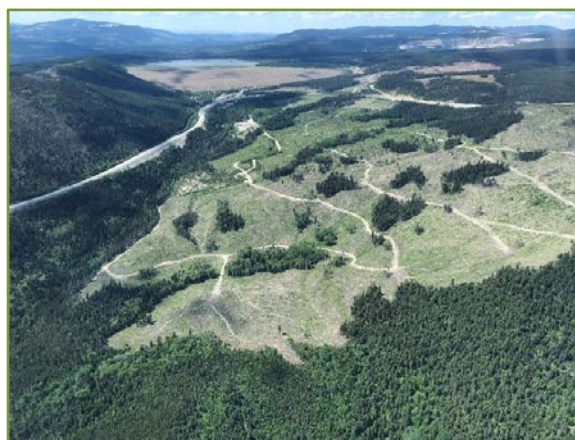
Picture 2. Recent harvesting in Trepanier watershed. Highway 97C is to the left and Brenda Mines is in the upper portion of the picture.

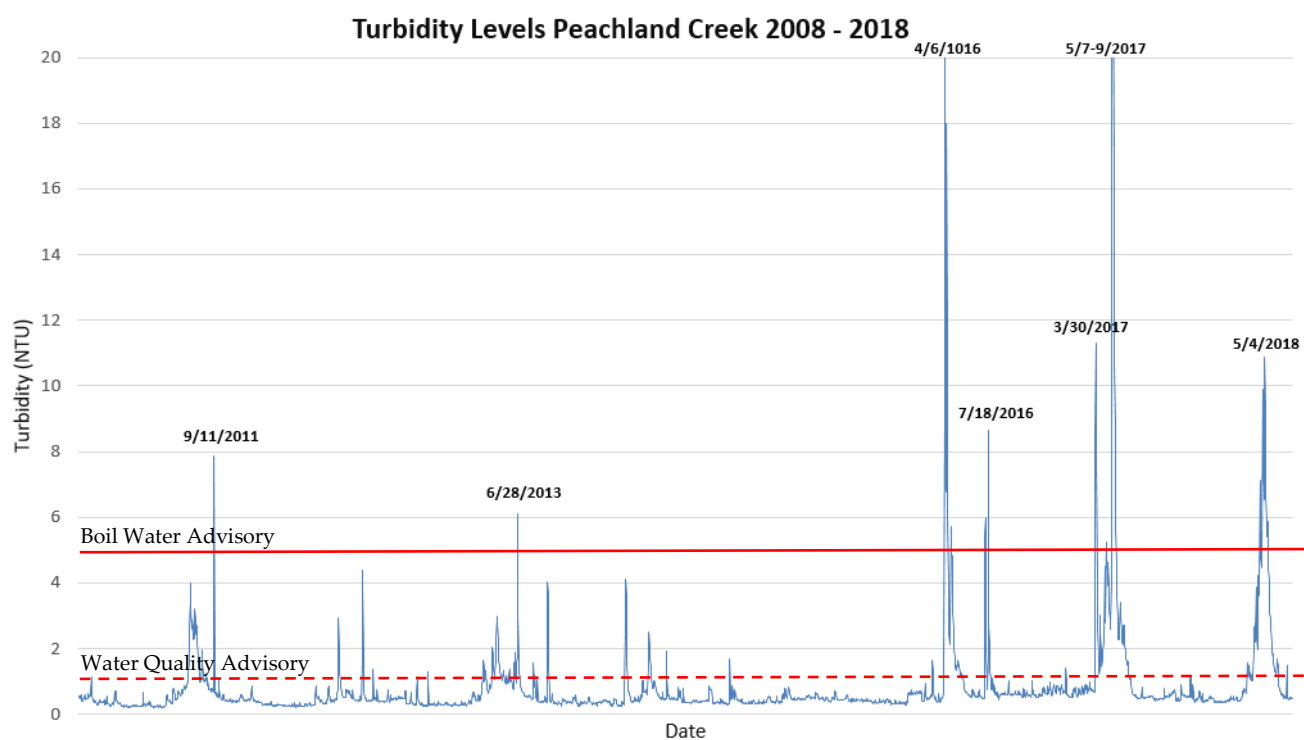
Graph 1. Turbidity levels at the Peachland Creek Treatment Facility, 2008 to 2018. The turbidity is from water after it has passed through the settling ponds and the coarse screen filter. Note that 2016 was a very high snow pack year with high spring runoff and 2017 was a 1 in 50 year peak flow event throughout the Thompson-Okanagan area.

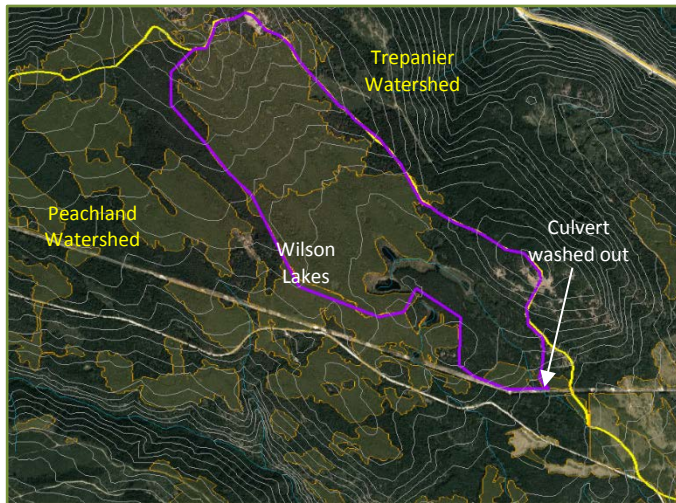
Forestry activities may have an impact at an individual stream drainage level. For example, investigators observed a washed-out culvert on a power line right-of-way within the Wilson Lakes catchment area (picture 9). Forestry activities may have contributed to this event. However, the Board could not determine the extent to

which logging contributed to the wash-out (pictures 10 and 11), given the cumulative effect of the high snow pack, high spring runoff and lack of information on the culvert sizing (picture 12) or road maintenance history.

Picture 10. Wilson Lakes before harvesting. The proposed harvesting targets mountain pine beetle-infested stands and is shaded. The approximate location of the Wilson Lakes drainage is outlined in purple.
