## **Audit of Fire Protection Practices**

*British Columbia Hydro and Power Authority  
Occupant Licences to Cut  
L48655, L48700, L48750, L48751*

**FPB/ARC/156**

November 2013

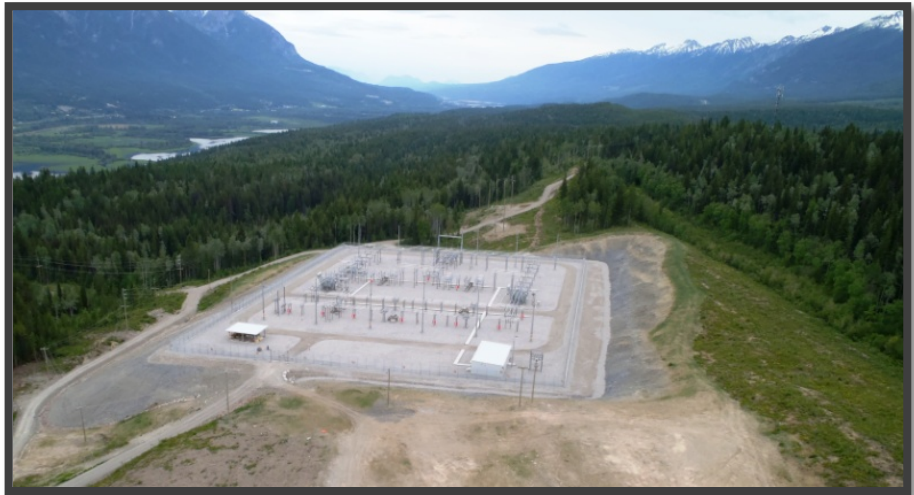
Kicking Horse substation, west of Golden, BC and the Columbia Valley transmission line extending south towards Invermere.

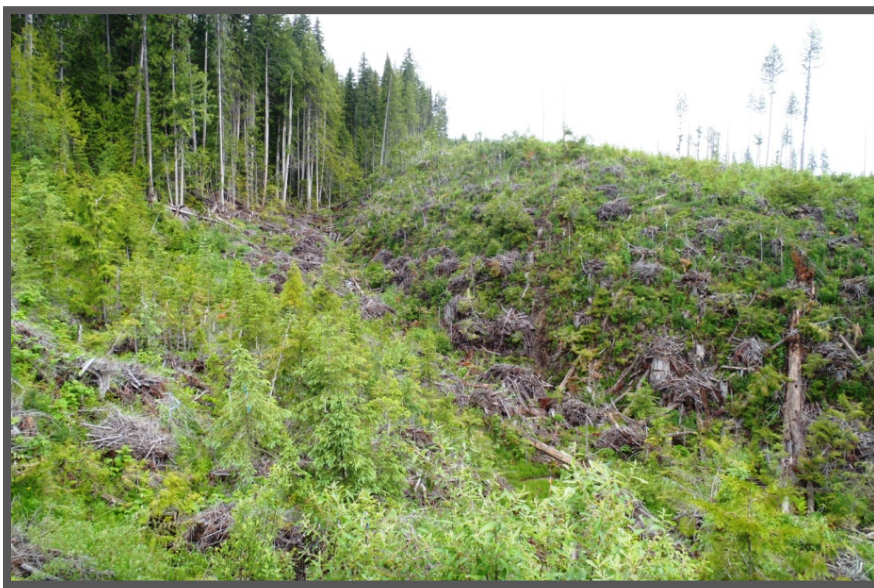
An example of a site where trees were hand felled and cable yarded, and slash was hand piled in order to reduce fire hazard and potential erosion along a stream channel.

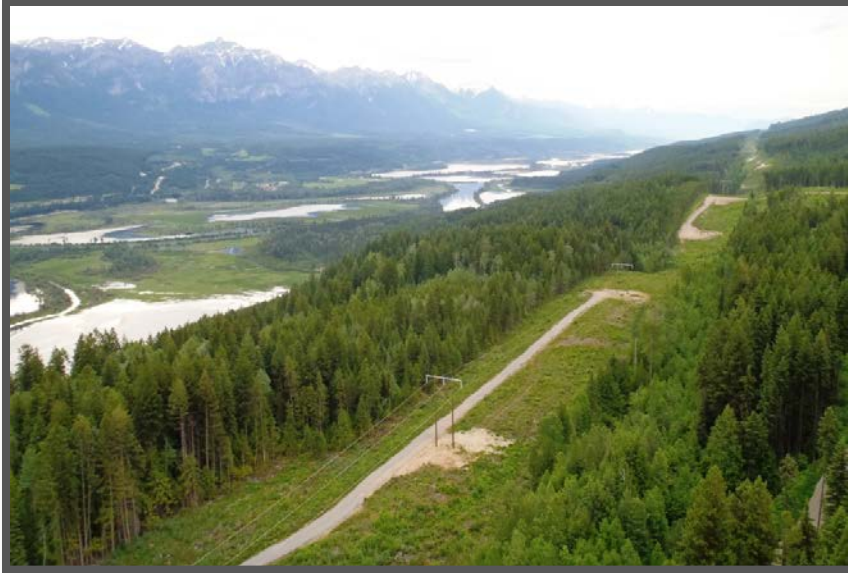
The Columbia Valley transmission line extending south towards Invermere: the low amount of residual slash depicted is typical of the slash levels retained along the entire length of the CVT project.

All hazard assessment and abatement obligations were completed by BC Hydro prior to the field audit, with a full fire hazard assessment done upon the completion of land clearing. Assessments were completed in a timely manner and the Board found that residual slash levels were low. BC Hydro met the hazard assessment and abatement requirements of the WA.
